STOUGHTON DOWNTOWN REDEVELOPMENT PLAN

Volume III: Existing Conditions Memorandum

Appendices

Stoughton, Massachusetts April 2015

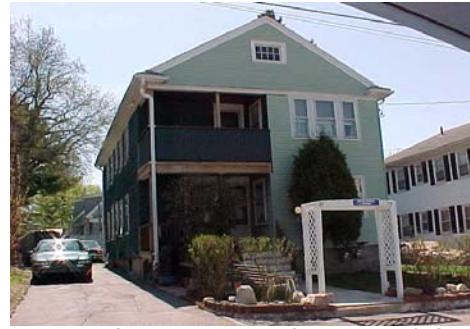
<u>Component</u>	<u>Condition</u>
Roofing	
Windows and Doors	
Exterior Walls	
Porch/Stairs/Deck	
Foundation	
Storefront & Signage	
Parking Lots	
Environmental	Probable lead paint based on age of building
Other:	
Overall Property Rating: (Excellent / Good / Fair / Poor)	
briefly state why.

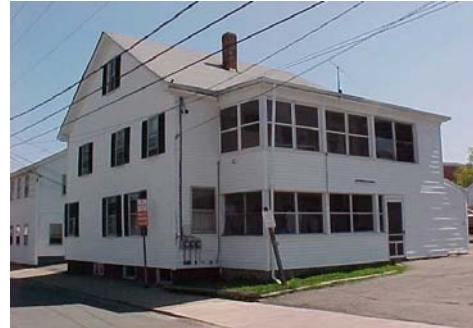
Component	Condition
Roofing	
Windows and Doors	Repairs to basement window sills needed
Exterior Walls	
Porch/Stairs/Deck	
Foundation	
Storefront & Signage	
Parking Lots	
Environmental	Probable lead paint based on age of building
Other:	
Overall Property Rating: (Excellent / Good / Fair / Poor)	
briefly state why.

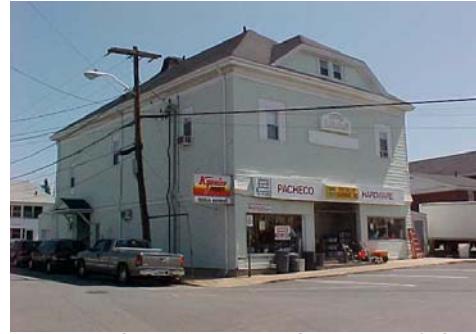
Component	Condition
Roofing	
Windows and Doors	
Exterior Walls	
Porch/Stairs/Deck	
Foundation	
Storefront & Signage	
Parking Lots	
Environmental	Probable lead paint based on age of building
Other:	
Overall Property Rating: (Excellent / Good / Fair / Poor)	
briefly state why.

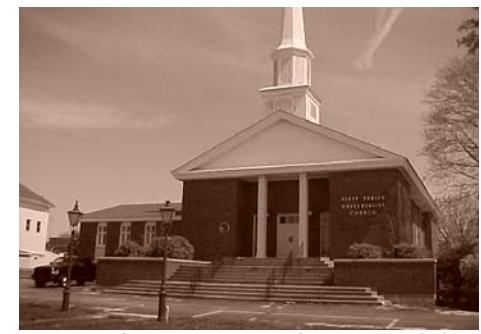
<u>Component</u>	<u>Condition</u>
Roofing	
Windows and Doors	
Exterior Walls	
Porch/Stairs/Deck	
Foundation	
Storefront & Signage	
Parking Lots	
Environmental	Probable lead paint based on age of building
Other:	
Overall Property Rating: (Excellent / Good / Fair / Poor)	
briefly state why.
