STOUGHTON BUILDING AUDITS

KMA audited the following municipal buildings:

TOWN HALL

AUDITED ON: MAY 1, 2024

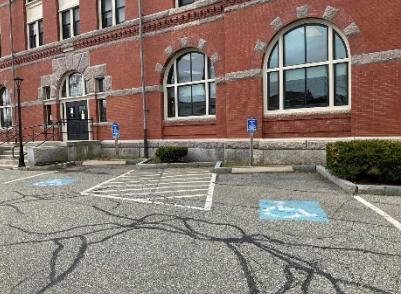
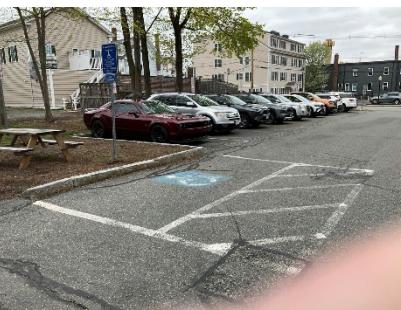
#	<i>Barrier Statement</i>	<i>Code References</i>	<i>Photo</i>	<i>Proposed Mitigation</i>	<i>Cost</i>
1.	<p>Parking</p> <p>The accessible parking spaces near the main entrance have slopes >2%, @ up to 6%.</p> <p>The accessible parking space signage is <60" AFF measured to the bottom of the signs.</p> <p>The surface of the accessible parking spaces is deteriorated and cracked, creating an unstable surface.</p> <p>The van accessible access aisle on the employee parking lot is <96" wide @ 60", measured centerline to centerline.</p>	ADAS 502.4 ADAS 502.6

<p>Regrade and restripe the existing designated parking spaces and their associated access aisles.</p> <p>Unit Cost: \$1,500 ea.</p> <p>Quantity: 3 (2 spaces, 1 aisle)</p> <p>Install a sign with the International Symbol of Accessibility at 60" AFF minimum, measured to the bottom of the sign. Include a van accessible sign where applicable.</p> <p>Unit Cost: \$100 ea.</p> <p>Quantity: 2</p>	\$3,200

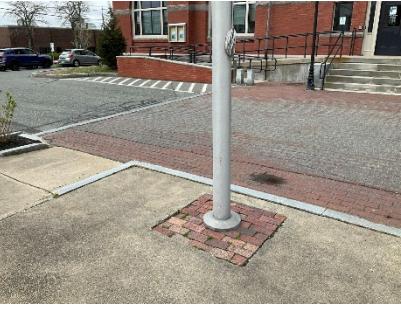
2.	<p>Flagpole</p> <p>The walkway around the flagpole has abrupt changes of levels because of material settlement and deterioration.</p> <p>The rope hook is mounted >48" AFF, @ 60".</p>	2010 ADAS 403.4 2010 ADAS 308

<p>Regrade the brick surface around the flagpole.</p> <p>Unit cost: \$25/SF</p> <p>Est. Quantity: 8 SF</p> <p>Relocate the rope hook.</p> <p>Unit Cost: \$250 ea.</p> <p>Quantity: 1</p>	\$450

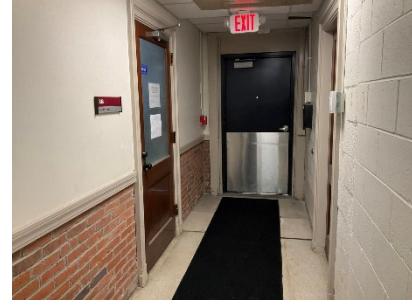
10.	<p>At-grade Egress Door (Basement)</p> <p>The threshold is $>1/2"$ high at the entrance door, @ 1".</p> <p>The door maneuvering clearance is $<12"$ on the latch, push side for a front approach, @ 9".</p>	<p>2010 ADAS 404.2.5 2010 ADAS 404.2.4.1</p>

<p>Replace the threshold. Unit Cost: \$250 ea. Quantity: 1</p> <p><i>See remediation for automatic door opener on item above.</i></p>	\$250

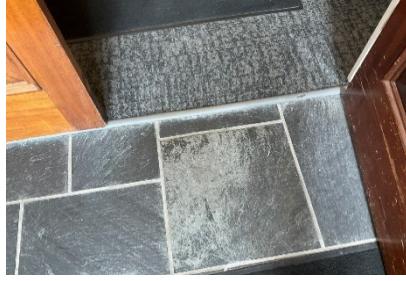
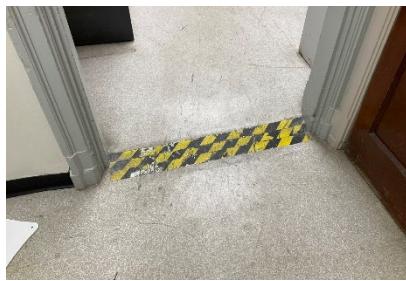
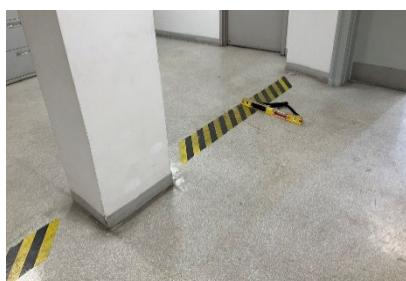
11.	<p>Interior Accessible Route</p> <p>The floor transition strip of the vestibule door on the first floor is not beveled at 1:2.</p> <p>The doorway to the elevator lobby on the basement level has a running slope $>5%$, @ 18.9%.</p> <p>The walkway within the basement hall has running slopes $>5%$, @ 8.6%.</p>	<p>2010 ADAS 303.2 2010 ADAS 403.3</p>

<p>Replace the transition strip. Unit Cost: \$250 ea. Quantity: 1</p> <p>Regrade the flooring adjacent to the doorway. Unit Cost: \$2,500 ea. Quantity: 1</p> <p>Regrade the flooring within the basement hall. Unit Cost: \$5,000 ea. Quantity: 1</p>	\$7,750

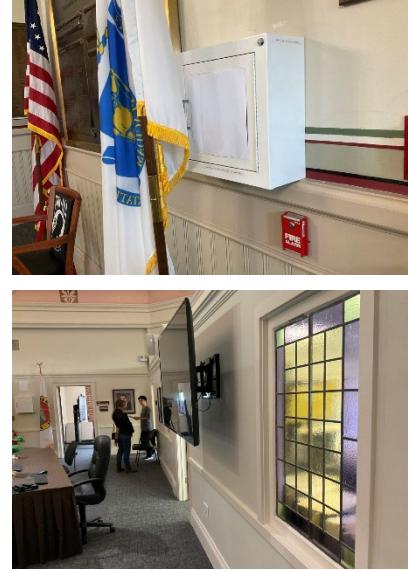
12.	<p>Protruding Objects</p> <p>The wall-mounted cabinet in the lobby of the first floor protrudes >4" into the circulation space, @ 4.5".</p> <p>The televisions protrude >4" into the circulation area in the Great Hall on the third floor, @ up to 12".</p>	2010 ADAS 307.2

<p>Install a cane detectable object below the box.</p> <p>Unit Cost: \$250 ea.</p> <p>Quantity: 1</p> <p>Install a cane detectable object below the televisions.</p> <p>Unit Cost: \$250 ea.</p> <p>Quantity: 2</p>	\$750
13.	<p>Door Hardware (Typical)</p> <p>The door hardware of the Credit Union and IT Department on the basement level require tight grasping, pinching, or twisting of the wrist to operate.</p>	2010 ADAS 404.2.7

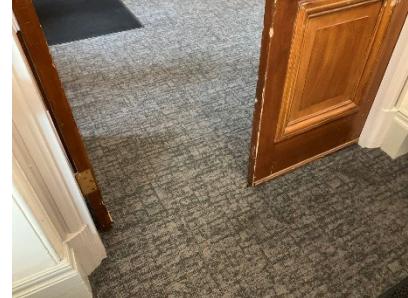
14.	<p>Door Width (Typical)</p> <p>The doors to the Assessor's Office, Tax Collector, and HR/Payroll on the first floor provides <32" clear width, @ 28 1/4".</p>	2010 ADAS 404.2.3

<p>Replace the doors with off-set doors and a wider door leaf. Unit Cost: \$1,000 Quantity: 3</p>	\$3,000
15.	<p>Door Maneuvering Clearances (Typical)</p> <p>The maneuvering clearance at the doors to the Public Access Office and Economy Development are <12" on the latch, pull side for a front approach, obstructed by a chair.</p> <p>The maneuvering clearance at the doors to Economic Development and Town Accountant are <18" on the latch pull-side, obstructed by the counter and trash cans/file cabinet, respectively.</p>	2010 ADAS 404.2.4

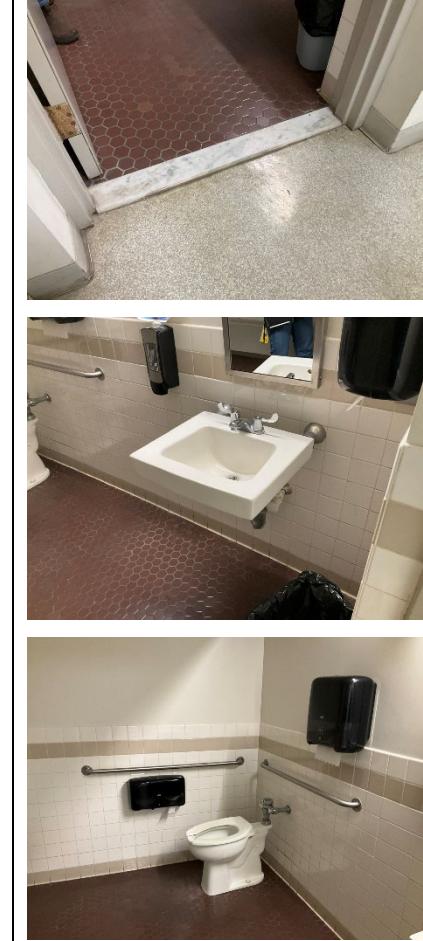
22.	<p>Men's & Women's Single-User Toilet Rooms (Basement)</p> <p>The threshold to the Women's toilet room is $> \frac{1}{2}$", @ $\frac{3}{4}$".</p> <p>The maneuvering clearance at the door of both toilet rooms is <18" on the latch pull-side, due to the sink.</p> <p>The sink in the Women's toilet room pipes lack insulation.</p> <p>Toilet flush controls the Women's toilet room are not mounted on the open side of the toilet.</p> <p>The paper towel dispenser in both toilet rooms protrudes >4" into the circulation area, @ up to 7".</p> <p>The coat hooks in both toilet rooms are mounted >48", @ 62".</p> <p>The doors of both toilet rooms have hardware that is >48" AFF, @ 60".</p> <p>The side grab bar in the Men's toilet room extends <54" from the rear wall, @ 48".</p>	<p>2010 ADAS 303.2 2010 ADAS 404.2.5 2010 ADAS 606.5 2010 ADAS 604.6 2010 ADAS 307.2 2010 ADAS 603.4 2010 ADAS 404.2.3 2010 ADAS 604.5.1</p>

<p>Replace the threshold. Unit Cost: \$250 Quantity: 1</p> <p>Install an automatic door opener. Unit Cost: \$2,500 ea. Quantity: 1</p> <p>Insulate the pipes underneath the sink. Unit Cost: \$50 ea. Quantity: 1</p> <p>Switch the toilet flush controls to the open side or provide automatic flush controls. Unit Cost: \$250 ea. Quantity: 2</p> <p>Relocate the paper towel dispenser. Unit Cost: \$50 ea. Quantity: 2</p> <p>Install a coat hook mounted no higher than 48" AFF. Unit Cost: \$50 ea. Quantity: 2</p> <p>Lower the door locks. Unit Cost: \$100 ea. Quantity: 1</p> <p>Relocate the side grab bar. Unit Cost: \$50 ea. Quantity: 1</p>	\$3,650

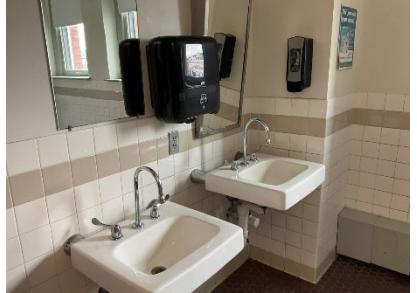
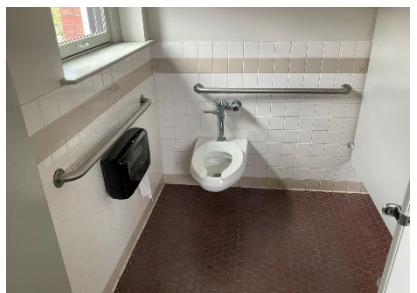
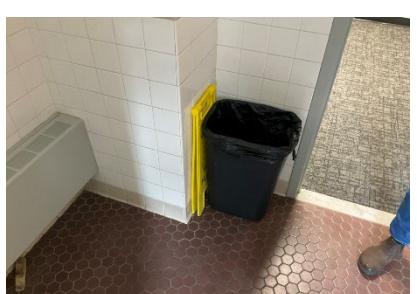
23.	<p>Men's & Women's Multi-User Toilet Rooms (Second Floor)</p> <p>The door lacks tactile/Braille signage mounted 60" max. on the latch side (Women's).</p> <p>The threshold is > 1/2", @ 3/4" and is not beveled (Men's).</p> <p>The bottom of the reflective surface of the mirror is >40" AFF, @ 42" (Men's/Women's).</p> <p>The soap dispenser and the paper towel dispenser are >58" AFF, @ up to 50" (Women's).</p> <p>The toilet centerline is not 16"-18" from the nearest adjacent side wall, @ up to 21" (M/Women's).</p> <p>Toilet flush controls are not mounted on the open side of the toilet (Women's).</p> <p>The side grab bars are not located 12" from the interior corner of the wall, @13" (Men's/Women's).</p> <p>The rear grab bars are mounted >6" from the interior corner of the wall, @13" (Men's/Women's).</p> <p>The maneuvering clearance at the door is <18" on the latch pull-side, obstructed by the trash can (Men's).</p> <p>The accessible toilet stall is <60" wide, @ 58" (Men's).</p> <p>The paper towel dispenser in the Men's toilet room protrudes >4" into the circulation area, @ up to 7".</p>	<p>2010 ADAS 216.2 2010 ADAS 303.2 2010 ADAS 603.3 2010 ADAS 307.2 2010 ADAS 604.2 2010 ADAS 604.6 2010 ADAS 604.5.1 2010 ADAS 604.5.2 2010 ADAS 404.2.5 2010 ADAS 604.3.1 2010 ADAS 307.2</p>

<p>Install tactile/ Braille signage on the latch side of the door at 60" AFF maximum. Unit Cost: \$100 per sign Quantity: 1</p> <p>Replace the threshold. Unit Cost: \$250 Quantity: 1</p> <p>Lower the mirror. Unit cost: \$50 ea. Quantity: 2</p> <p>Lower the soap dispenser and the paper towel dispenser. Unit Cost: \$250 ea. Quantity: 2</p> <p>Reposition the flush valve or install an automatic flush control. Unit cost: \$1,500 Est. Quantity: 1</p> <p>Relocate the grab bars. Unit cost: \$50 ea. Quantity: 4</p> <p>Relocate the trash can. Unit cost: \$50 ea. Quantity: 4</p> <p>Reconfigure the toilet stall. Unit cost: \$5,000 ea. Quantity: 2</p> <p>Relocate the paper towel dispenser. Unit Cost: \$50 ea. Quantity: 1</p>	\$12,900

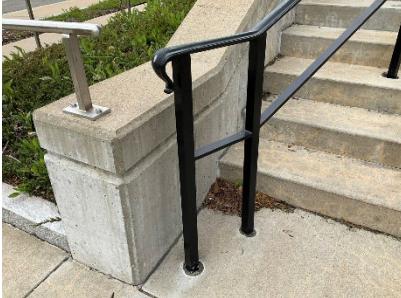
3.	<p>Exterior Stair</p> <p>The handrail gripping surface of the stairs between the parking lot off Park Street and the main entrance does not have a perimeter dimension between 4"-6 1/4".</p>	2010 ADAS 505.7.1

<p>Install compliant handrails on both sides of the stairs. Unit Cost: \$50/LF Est. Quantity: 28</p>	\$1,400

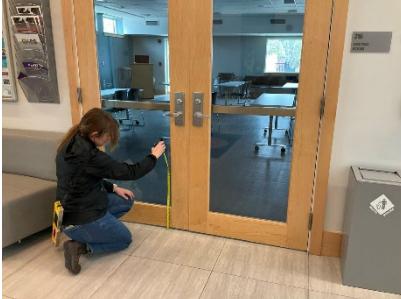
4.	<p>Door Kickplate (Typical)</p> <p>Certain doors provide a smooth surface <10" AFF on the push side, @ up to 8 3/4".</p> <p><i>Observed at entrance vestibules, 316 Meeting Room, 217 Historical Room, 224 Literacy Coordinator, Quiet/Tutor Rooms, 223 Program Administrator, 232 Library Director, and 231 Conference Room.</i></p>	2010 ADAS 404.2.10

<p>Replace the door with a door with a bottom rail at least 10" min. AFF. Unit Cost: \$1,000 ea. Quantity: 12</p>	\$1,200

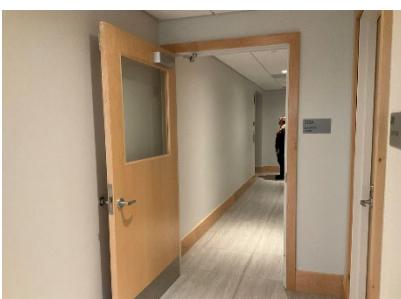
5.	<p>Door Vision Lights (Typical)</p> <p>A few doors have a glazing panel >43" AFF, @ up to 48".</p> <p><i>Observed at 205 Tech Services, 208 Custodian Office, and elevator lobby.</i></p>	2010 ADAS 404.2.11

<p>Replace the door with a door with a compliant glazing panel. Unit Cost: \$1,000 ea. Quantity: 3</p>	\$3,000

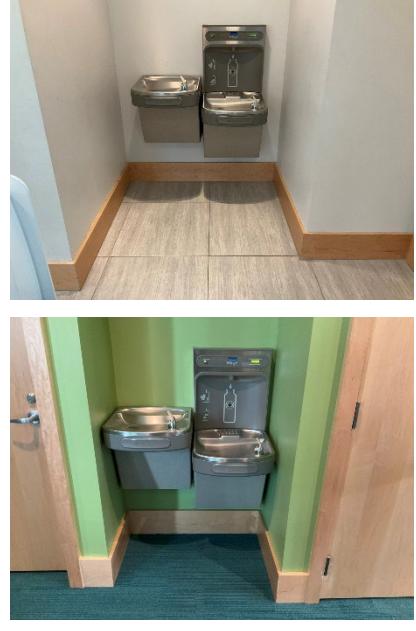
6.	<p>Drinking Fountains</p> <p>The knee space is <27" AFF under the fountain, @ 26 1/4".</p> <p><i>Observed at drinking fountains on both the first and second floors.</i></p> <p>The knee space is not centered under the drinking fountain on the second floor, @ 10".</p>	ADA 602.2

<p>Raise the drinking fountain. Unit Cost: \$750 ea. Quantity: 1</p> <p>Relocate the drinking fountain. Unit Cost: \$1,500 ea. Quantity: 1</p>	\$2,250
7.	<p>K-cup Dispenser</p> <p>The knob at the top of the K-cup dispenser on the second-floor lobby is mounted >48" AFF, @ 66", and requires tight grasping, pinching, and/or twisting of the wrist to operate.</p>	2010 ADAS 308.2 & 308.3 2010 ADAS 309.4

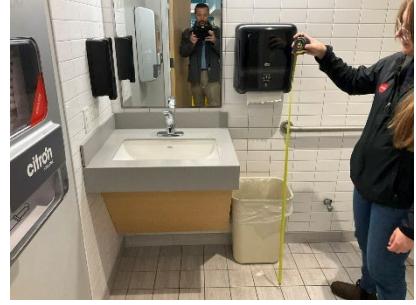
12.	<p>Single-user Toilet Room (First Floor)</p> <p>The threshold to the toilet room is >1/2", @ 5/8".</p> <p>The paper towel dispenser and the feminine care dispenser protrude >4" into the circulation space, @ 8".</p>	<p>2010 ADAS 404.2.5</p> <p>2010 ADAS 307.2</p>

<p>Replace the threshold. Unit Cost: \$250 Quantity: 1</p> <p>Relocate the paper towel dispenser and the feminine care dispenser. Unit Cost: \$50 ea. Quantity: 2</p>	\$350
13.	<p>Family Toilet Room (First Floor)</p> <p>The threshold to the toilet room is >1/2", @ 5/8".</p> <p>The paper towel dispenser protrudes >4" into the circulation space, @ 8".</p>	<p>2010 ADAS 404.2.5</p> <p>2010 ADAS 307.2</p>	<p>No Photo</p>	<p>Replace the threshold. Unit Cost: \$250 Quantity: 1</p> <p>Relocate the paper towel dispenser. Unit Cost: \$50 ea. Quantity: 1</p>	\$300

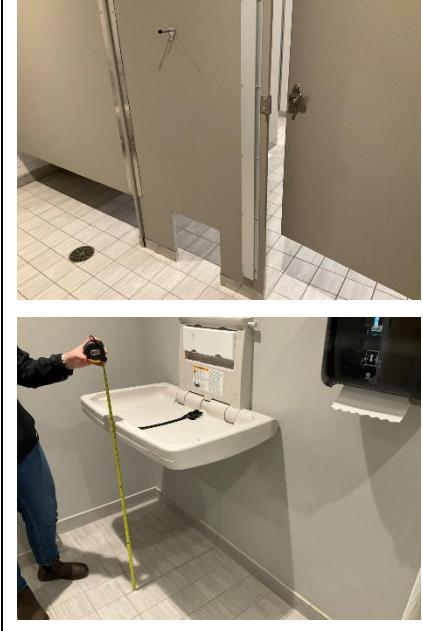
14.	<p>Men's and Women's Toilet Rooms (Second Floor)</p> <p>The coat hook is mounted >48" AFF, @ up to 52".</p> <p>The paper towel dispenser protrudes >4" into the circulation space, @ 8".</p> <p>The changing station is >34" AFF, @ 36" AFF.</p>	<p>2010 ADAS 308.2 & 308.3</p> <p>2010 ADAS 307.2</p> <p>2010 ADAS 902.3</p>

<p>Install a coat hook mounted no higher than 48" AFF. Unit Cost: \$50 ea. Quantity: 2</p> <p>Relocate the paper towel dispenser. Unit Cost: \$50 ea. Quantity: 2</p> <p>Relocate the changing station. Unit Cost: \$250 ea. Quantity: 2</p>	\$700

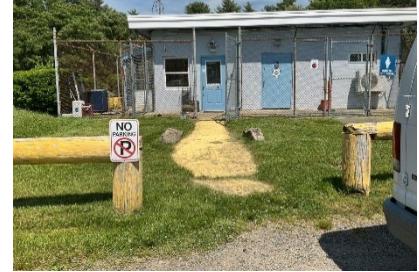
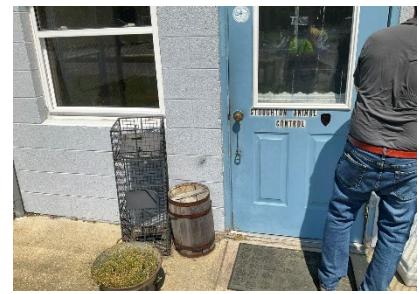
4.	<p>Entrance</p> <p>The door lacks a level landing due to areas of deterioration.</p> <p>The door maneuvering clearance on the pull side is obstructed by the barrel.</p> <p>The door hardware requires tight grasping, pinching and twisting of the wrist due to knob type.</p>	<p>2010 ADAS 302 2010 ADAS 404</p>

<p>Regrade the door landing Unit Cost: \$250 ea. Quantity: 1</p> <p>Replace the door hardware with a lever type. Unit Cost: \$300 ea. Quantity: 1</p> <p>Relocate the barrel. Unit Cost: \$50 ea. Quantity: 1</p>	\$600

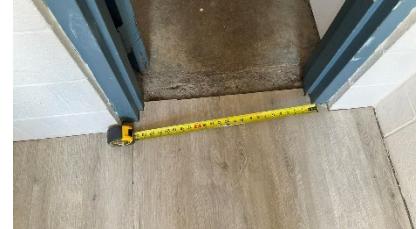
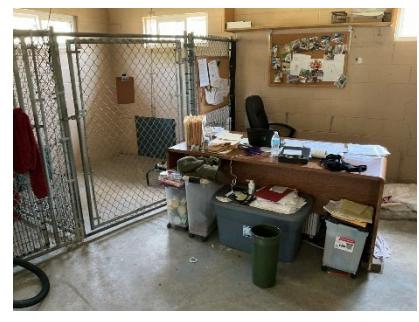
5.	<p>Interior Conditions</p> <p>The building interior lacks multiple accessible spaces and elements, including narrow doors @ up to 22" wide, a toilet room that do not meet dimensional requirements, and a second means of egress leading to an enclosed dog cage.</p>	<p>2010 ADAS 404 2010 ADAS 604</p>

<p>When designing the building renovation, provide an accessible route to and within the building and ensure that the building is fully accessible. Further design study is required. Unit Cost: \$10,000 ea. Quantity: 1</p>	\$10,000
TOTAL FOR ANIMAL CONTROL:					\$22,950

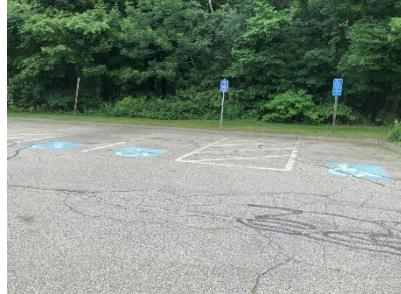
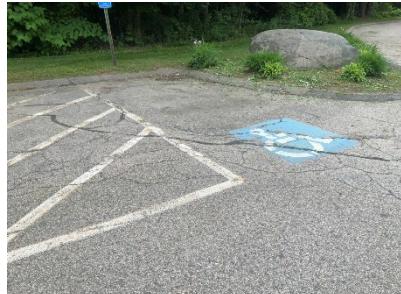
#	<i>Barrier Statement</i>	<i>Code References</i>	<i>Photo</i>	<i>Proposed Mitigation</i>	<i>Cost</i>
1.	<p>Parking at Edge of Parking Lot</p> <p>Some of the designated accessible parking spaces had slopes >2%, @ up to 7.2%.</p> <p>Some of the accessible spaces ground surface is not stable, firm or slip resistant due to material deterioration.</p> <p>One of the three accessible spaces lack signage indicating they are accessible. At others, the signage is mounted <60", @ 38", measured to the bottom of the sign.</p>	ADAS 502.4 ADAS 502.6

<p>Regrade and restripe the existing designated parking spaces and their associated access aisles.</p> <p>Unit Cost: \$1,500 ea.</p> <p>Quantity: 4 (3 spaces, 1 aisle)</p> <p>Install a sign with the International Symbol of Accessibility at 60" AFF minimum, measured to the bottom of the sign. Include a van accessible sign where applicable.</p> <p>Unit Cost: \$100 ea.</p> <p>Quantity: 3</p>	\$6,300

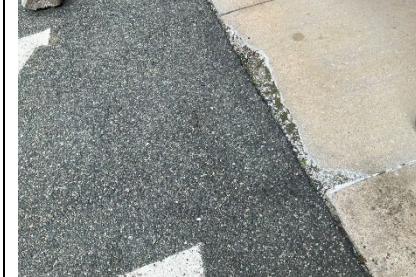
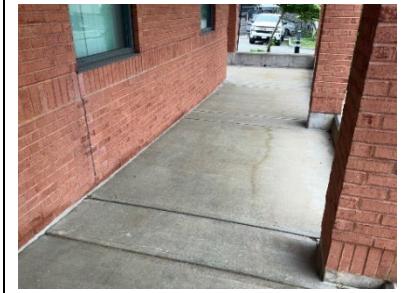
3.	<p>Walkway Between Parking and Accessible Entrance</p> <p>The walkway has abrupt changes of levels $>0.5"$ where two materials meet or due to areas of deterioration/ material settlement.</p> <p>The walkway has running slopes $>5\%$ and is not treated as a ramp, @ up to 6%.</p> <p>The standpipe protrudes $>4"$ into the circulation space, @ 5 1/2".</p>	<p>2010 ADAS 403.4 2010 ADAS 403.3 2010 ADAS 307.2</p>

<p>Modify the transition. Unit Cost: \$250 ea. Quantity: 1</p> <p>Replace the walkway with a compliant ramp with handrails on both sides. Unit Cost: \$15,000 Quantity: 1</p> <p>Install a cane detectable object below the standpipe. Unit Cost: \$250 ea. Quantity: 1</p>	\$15,500

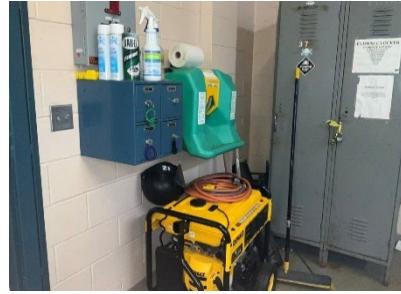
8.	Community Room The podium lacks the required knee/toe clearance for a forward approach and is too high.	2010 ADAS 306.1	No Photo	Replace the podium. Unit Cost: \$500 ea. Quantity: 1	\$500
9.	Sallyport The eye wash control is mounted >44" AFF over a >20"-25" obstruction.	ADAS 308.2.2

Lower the eye wash. Unit Cost: \$50 ea. Quantity: 1	\$50
10.	Booking The pull side door maneuvering clearance is <18" on the latch side, @ 17 3/4". The door vision light is mounted >43" AFF, @ 49".	2010 ADAS 404.2.4.1 2010 ADAS 404.2.11
