STOUGHTON OUTDOOR FACILITIES AUDITS

KMA audited the following municipal outdoor facilities:

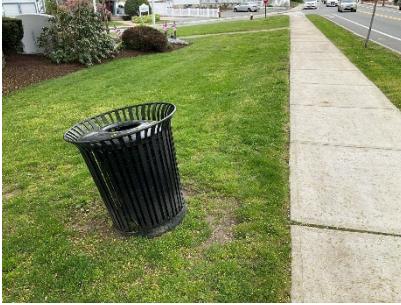
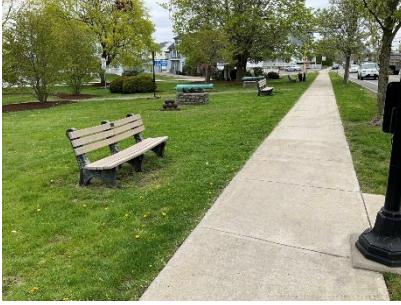
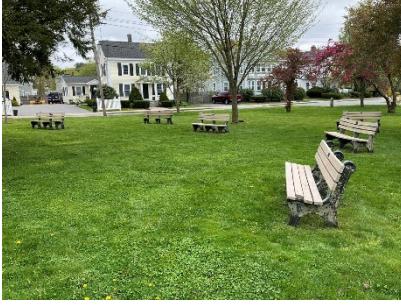
#	<i>Barrier Statement</i>	<i>Code References</i>	<i>Photo</i>	<i>Proposed Mitigation</i>	<i>Cost</i>
1.	<p>Site Amenities</p> <p>The park benches and trash bin are not on an accessible route, due to the grass surface.</p>	2010 ADAS 206.1

<p>Provide an accessible route to at least one of each type of site amenity. Consider benches serving gazebo performances as a unique type of bench.</p> <p>Unit Cost: \$25/ SF Est. Quantity: 1,000 SF</p>	\$25,000

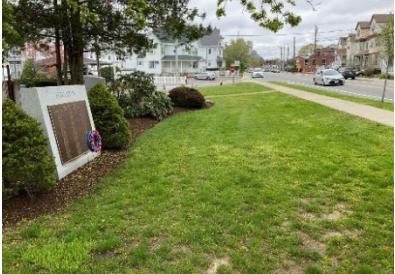
2.	Memorial There is no accessible route to the Honor Roll memorial facing Park Street.	2010 ADAS 206.1

Provide an accessible route between the sidewalk and the memorial. Unit Cost: \$25/SF Est. Quantity: 200 SF	\$5,000

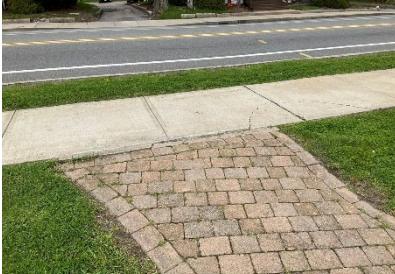
3.	Walkway to Armed Forces Memorial The walkway has a running slope >5%, @ up to 5.6% and has changes in level > 1/4" along the sidewalk, @ 1".	2010 ADAS 403.3

Regrade the walkway. Unit Cost: \$25/SF Est. Quantity: 100 SF	\$2,500

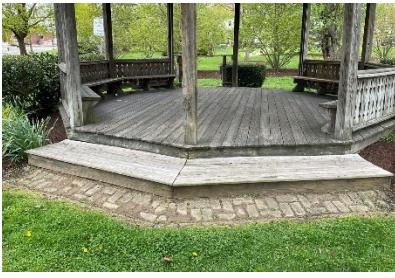
4.	Gazebo The gazebo is not on an accessible route, due to the grass surface. The ramp to the gazebo has running slopes >8.3%, @ up to 8.9%, and has changes in level > 1/4" at the bottom of the run, @ 1". The stair to the gazebo lacks the required handrails on both sides.	2010 ADAS 206.1 2010 ADAS 405.2 2010 ADAS 303.2 2010 ADAS 505.2

Provide an accessible route between the sidewalk and the gazebo. Unit Cost: \$25/SF Est. Quantity: 600 SF Rebuild the ramp. Unit Cost: \$5,000 ea. Quantity: 1 Install compliant handrails on both sides of the stairs. Unit Cost: \$50/LF Est. Quantity: 8	\$20,400
TOTAL FOR FAXON PARK:					\$52,900

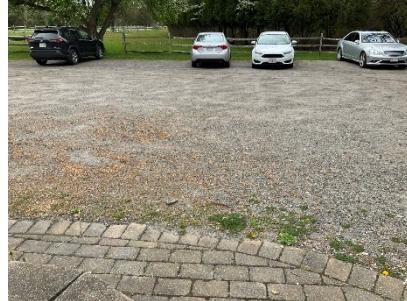
#	<i>Barrier Statement</i>	<i>Code References</i>	<i>Photo</i>	<i>Proposed Mitigation</i>	<i>Cost</i>
1.	<p>Parking</p> <p>The surface of the parking lot is not stable, firm, and slip resistant.</p> <p>There are no accessible parking spaces provided.</p>	<p>2010 ADAS 502.1</p> <p>2010 ADAS 502.4</p>

<p>Pave and stripe a portion of the parking lot to add one van accessible parking space, including its associated sign and access aisle.</p> <p>Unit Cost: \$1,500 per space or aisle</p> <p>Quantity: 2 (1 space, 1 aisle)</p>	\$3,000

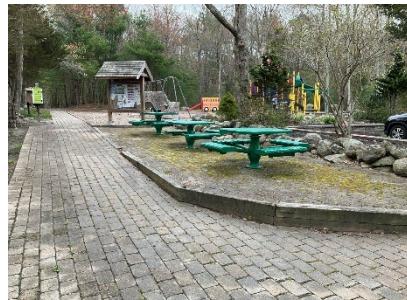
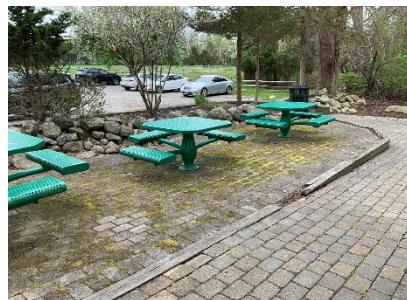
2.	<p>Walkway</p> <p>Both the walkway between the parking lot and the playground (not pictured) and walkway along the picnic tables have a running slope >5%, @ up to 7.9%.</p> <p>The surface of the walkway leading to the accessible picnic table is not slip-resistant due to the moss.</p>	<p>2010 ADAS 403.3</p> <p>2010 ADAS 302.1</p> <p>ADA Title II Maintenance</p>

<p>Regrade and ensure the maintenance of the walkways.</p> <p>Unit Cost: \$25/SF</p> <p>Est. Quantity: 500 SF</p>	\$12,500

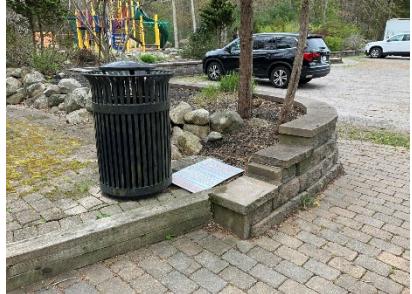
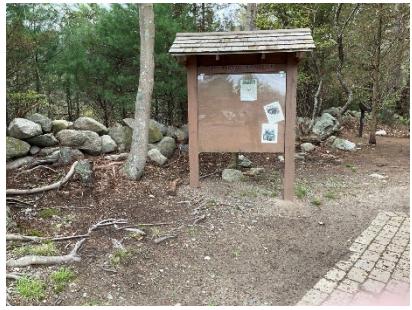
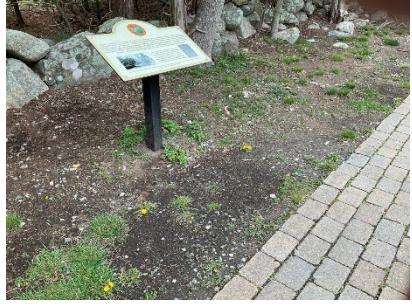
3.	<p>Site Amenities</p> <p>The trash bin and trail displays along the path leading to the trail are not on an accessible route, due to a step and the unpaved surface, respectively.</p>	2010 ADAS 206.1

<p>Relocate the trash can to an accessible location and provide an accessible route to the trail displays.</p> <p>Unit Cost: \$25/ SF Est. Quantity: 100 SF</p>	\$2,500
----	---	-----------------	--	---	---------

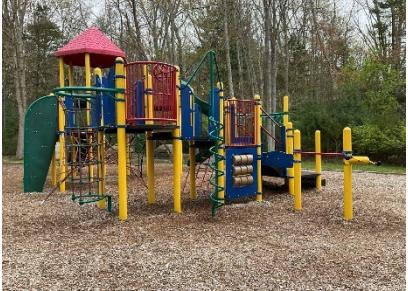
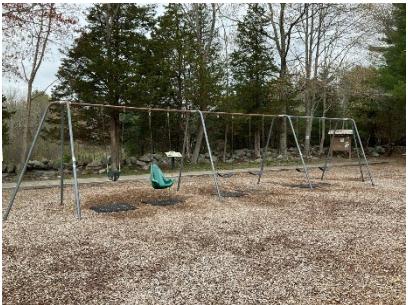
4.	<p>Play Surface</p> <p>There is no accessible route to and within the playground area due to the wood fiber surface.</p>	<p>2010 ADAS 1008.2.6</p>

<p>Resurface the playground. Unit Cost: \$50,000 Quantity: 1</p>	\$50,000
TOTAL FOR BRADLEY LESSA MEMORIAL PLAYGROUND:					\$68,000

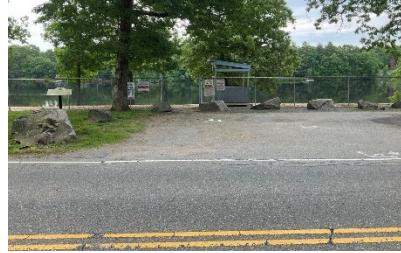
#	<i>Barrier Statement</i>	<i>Code References</i>	<i>Photo</i>	<i>Proposed Mitigation</i>	<i>Cost</i>
1.	<p>Parking</p> <p>There are no accessible parking spaces provided on the parking lot serving the beach. For a lot with 1-25 spaces, one accessible space is required, and it must be van accessible.</p>	2010 ADAS 208

<p>Pave and stripe a portion of the parking lot to add one van accessible parking space, including its associated sign and access aisle.</p> <p>Unit Cost: \$1,500 per space or aisle</p> <p>Quantity: 2 (1 space, 1 aisle)</p>	\$3,000

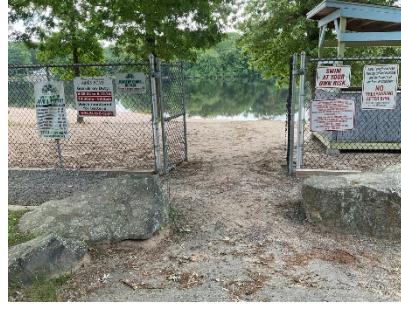
2.	<p>Walkway between Parking and Entry Gate</p> <p>The walkway is not stable, firm or slip resistant due to areas of deterioration/material settlement.</p>	2010 ADAS 403.2

<p>Regrade the walkway.</p> <p>Unit Cost: \$25 SF</p> <p>Est. Quantity: 50 SF</p>	\$1,250

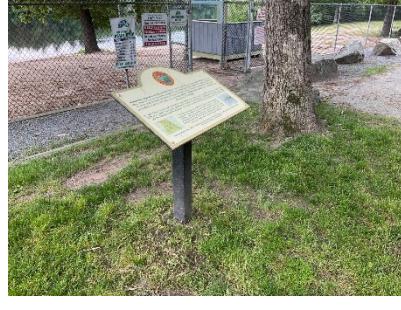
3.	<p>Display</p> <p>The display exhibiting the history of the property is not along an accessible route due to the grass and gravel.</p>	2010 ADAS 206.1

<p>Provide an accessible route to the display.</p> <p>Unit Cost: \$25/SF</p> <p>Est. Quantity: 50 SF</p>	\$1,250

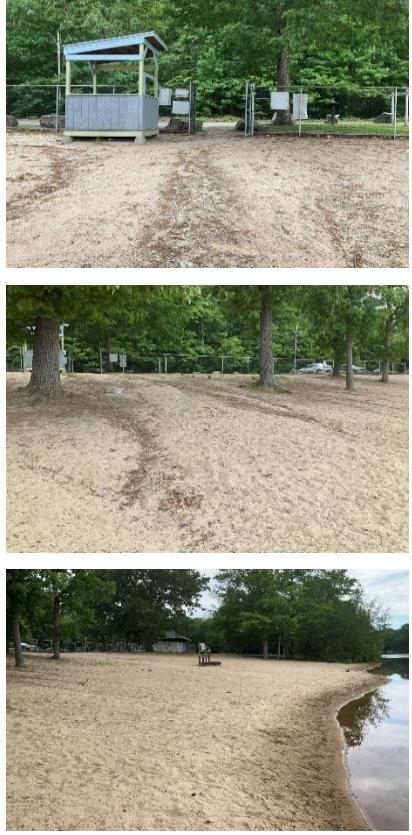
4.	<p>Beach Access</p> <p>There is no accessible route to the water due to the surface condition and excessive slope.</p>	2010 ADAS 206.1

<p>Provide an accessible route to the beach. Additional study required.</p> <p>Unit Cost: \$25,000 ea.</p> <p>Quantity: 1</p>	\$25,000
5.	<p>Outdoor Toilet Rooms</p> <p>The toilet rooms located on the Western side of the building are not along an accessible route due to the sand, grass, and gravel.</p> <p>Note: At the time of this audit, the toilet rooms were still locked for the off-season and were not audited.</p>	2010 ADAS 206.1

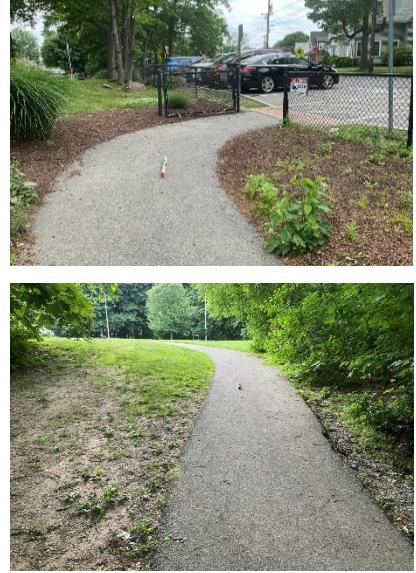
4.	<p>Asphalt Walkway (Throughout Park)</p> <p>The walkway throughout the park has multiple sections with running slopes >5%, and are not treated as ramps:</p> <ul style="list-style-type: none"> • @ up to 7.9%, near accessible parking spaces. • @ up to 5.3%, between school parking and playground. • @ up to 5.4%, near school parking lot. • @ up to 7.9%, between school parking and lawn. • @ up to 5.3%, near play components. • @ up to 7.5%, leading to the top of the slide. 	2010 ADAS 403.3

<p>Regrade the walkways. Unit Cost: \$25/SF Est. Quantity: 480 SF</p>	\$12,000

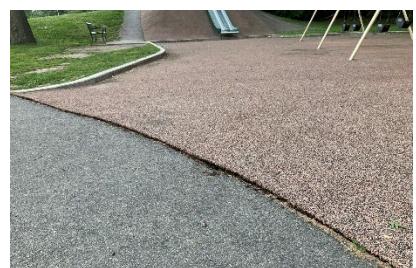
5.	<p>Play Surface</p> <p>There is a change in level > 1/4" AFF at the intersection between the playground and the walking path, @ 1".</p>	2010 ADAS 403.4

<p>Resurface the edge of playground. Unit Cost: \$1,000 Quantity: 1</p>	\$1,000

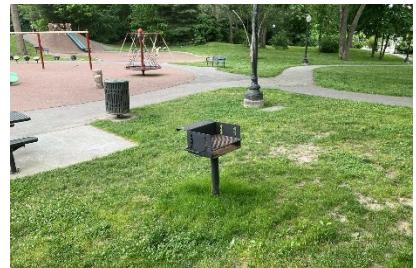
6.	<p>BBQ Pits</p> <p>The BBQ pit near the accessible picnic table is not along an accessible route due to the grass.</p>	2010 ADAS 206.1

<p>Provide an accessible route to the BBQ pit. Unit Cost: \$25/SF Est. Quantity: 50 SF</p>	\$1,250

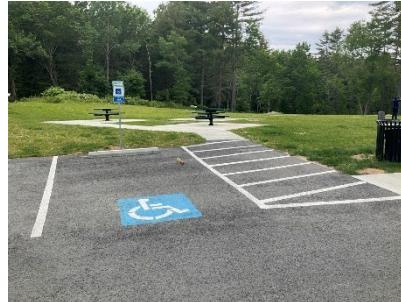
GLEN ECHO PARK					
#	<i>Barrier Statement</i>	<i>Code References</i>	<i>Photo</i>	<i>Proposed Mitigation</i>	<i>Cost</i>
1.	<p>Parking Near Picnic Tables</p> <p>The van accessible parking space and its associated access aisle have slopes >2%, @ up to 7.4% adjacent to the walkway to the picnic tables.</p> <p>The accessible parking space signage is <60" AFF measured to the bottom of the sign, @ 55".</p> <p>The van parking space is <96" wide, measured centerline to centerline, @ 90" at the narrowest point.</p>	2010 ADAS 502

<p>Regrade and restripe the existing designated accessible parking spaces and their associated access aisle.</p> <p>Unit Cost: \$1,500 ea.</p> <p>Quantity: 2 (1 space, 1 aisle)</p> <p>Install a van accessible sign at 60" AFF minimum, measured to the bottom of the sign.</p> <p>Unit Cost: \$100 ea.</p> <p>Quantity: 1</p>	\$3,100

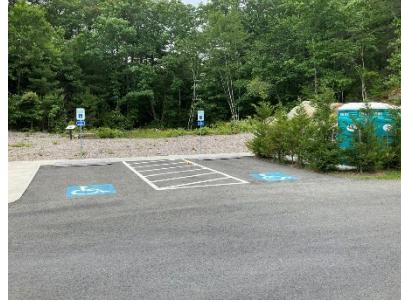
2.	<p>Parking Near Picnic Tables</p> <p>The van accessible parking space and its associated access aisle have slopes >2%, @ up to 3.1%.</p> <p>The accessible parking space signage is <60" AFF measured to the bottom of the sign, @ 54".</p>	2010 ADAS 502

<p>Regrade and restripe the existing designated accessible parking spaces and their associated access aisle.</p> <p>Unit Cost: \$1,500 ea.</p> <p>Quantity: 3 (2 spaces, 1 aisle)</p> <p>Install a van accessible sign at 60" AFF minimum, measured to the bottom of the sign.</p> <p>Unit Cost: \$100 ea.</p> <p>Quantity: 2</p>	\$4,700

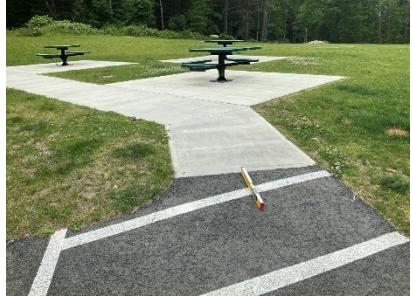
3.	<p>Walkway to Accessible Picnic Table</p> <p>The walkway has running slopes >5%, @ up to 9.7% within the asphalt section and @ up to 6.2% within the concrete section and is not treated as ramps.</p>	2010 ADAS 403.3

<p>Regrade the walkways. Unit Cost: \$25/SF Est. Quantity: 40 SF</p>	\$1,000
4.	<p>Portable Toilet</p> <p>The door to the ADA-compliant, portable toilet lacks an exterior level landing (<2%), @ 2.6%.</p>	2010 ADAS 404.2.4.4

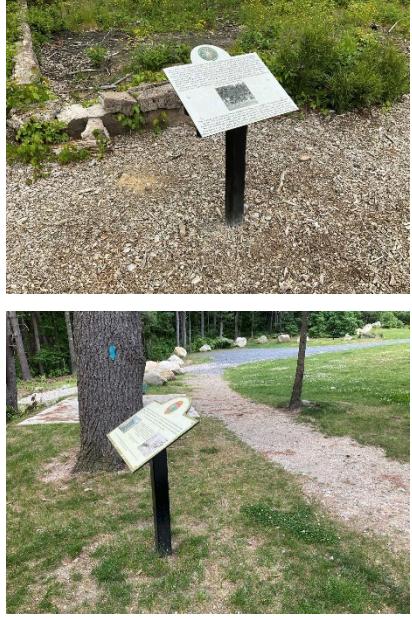
5.	<p>Displays</p> <p>The displays exhibiting the history of the property are not along an accessible route due to the grass, gravel, or mulch.</p>	2010 ADAS 206.1

<p>Provide an accessible route to each display.</p> <p>Unit Cost: \$25/SF</p> <p>Est. Quantity: 400 SF</p>	\$10,000
----	---	-----------------	---	--	----------

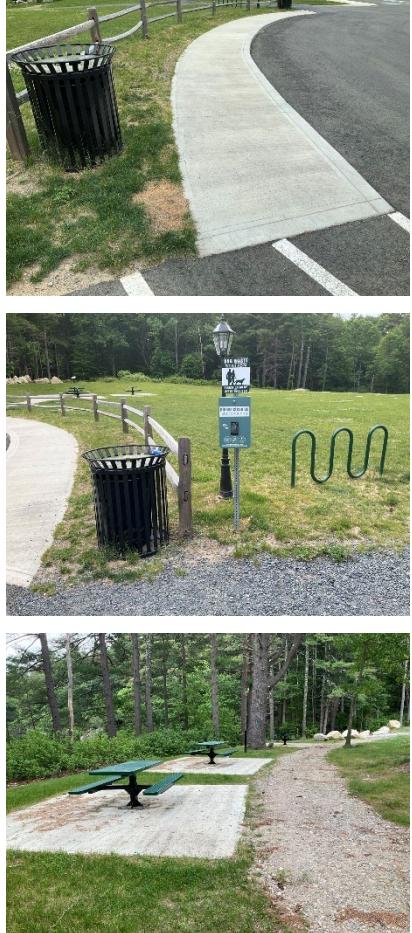
6.	<p>Site Amenities</p> <p>Some site amenities (i.e., picnic tables, trash cans, and dog waste bag receptacle) are not located along an accessible route due to the grass surface.</p>	2010 ADAS 206.1

<p>Provide at least one of each type of amenity along an accessible route. Consider picnic tables along the water's edge as a unique type of picnic table.</p> <p>Unit Cost: \$25/SF Est. Quantity: 1,000 SF</p>	\$25,000
----	---	-----------------	--	--	----------

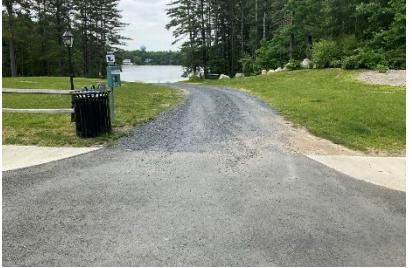
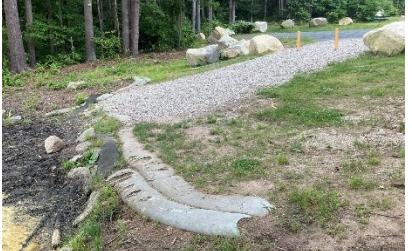
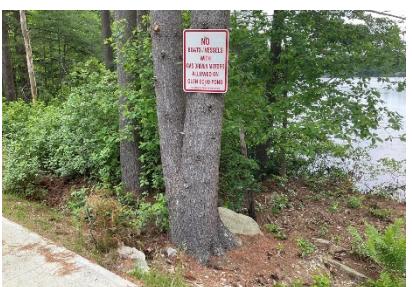
7.	<p>Boat Launch Ramp An accessible boat launch ramp is not provided.</p>	2010 ADAS 206.2.10

<p>Provide an accessible boat launch ramp. Unit Cost: \$25/SF Est. Quantity: 1,000 SF</p>	\$25,000
8.	<p>Trail The hiking trail that loops between the parking lot, the boat launch ramp, and through the woods is not accessible due to the gravel surface.</p>	2010 ADAS 206.1

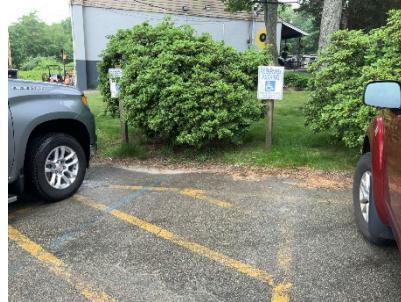
#	<i>Barrier Statement</i>	<i>Code References</i>	<i>Photo</i>	<i>Proposed Mitigation</i>	<i>Cost</i>
1.	<p>Parking</p> <p>The designated accessible parking spaces and their associated access aisles have slopes >2%, @ up to 6%.</p> <p>In addition, the signs for these parking spaces are mounted <60", @ 38" measured to the bottom of the sign.</p>	2010 ADAS 502

<p>Regrade and restripe the existing designated parking spaces and their associated access aisles.</p> <p>Unit Cost: \$1,500 ea.</p> <p>Quantity: 3 (2 spaces + 1 aisle)</p> <p>Install signs at 60" min. AFF, measured to the bottom of the sign.</p> <p>Unit Cost: \$100 ea.</p> <p>Quantity: 2</p>	\$4,700

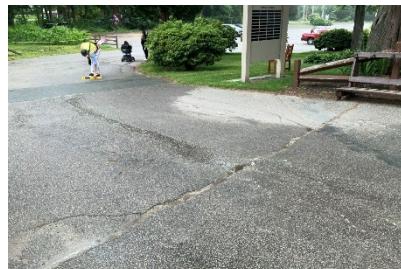
2.	<p>Accessible Route</p> <p>The walkway from the accessible parking spaces to building entrance and golf course has slopes >8.3%, @ up to 9.2%. In addition, the ground surface is not stable, firm, or slip resistant with changes in level > 1/2" due to material deterioration.</p>	2010 ADAS 403

<p>Regrade the walkway.</p> <p>Unit Cost: \$25/SF</p> <p>Est. Quantity: 400 SF</p>	\$10,000

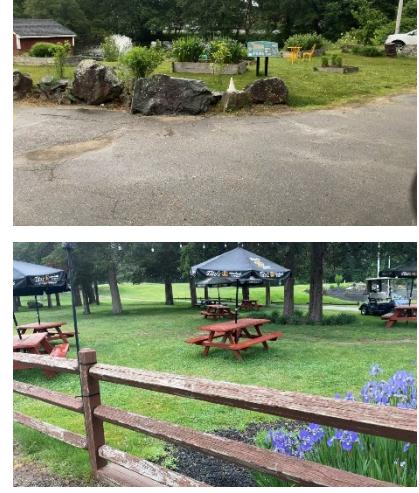
3.	<p>Site Amenities</p> <p>Some site amenities (i.e., picnic tables, gardens) are not located along an accessible route due to the grass surface.</p>	2010 ADAS 206

<p>Provide an accessible picnic table with the required clearance for a forward approach along an accessible route.</p> <p>Unit Cost: \$250 ea.</p> <p>Est. Quantity: 1</p> <p>Provide an accessible route to the gardens.</p> <p>Unit Cost: \$25/SF</p> <p>Est. Quantity: 60 SF</p>	\$1,750
4.	<p>Exterior Ramp</p> <p>At the bottom of the top section of ramp to the main entrance has slopes >8.3%, @ up to 8.8%.</p> <p>The ramp is <48" wide, @ 44".</p> <p>The ramp lacks edge protection on one side.</p>	2010 ADAS 405

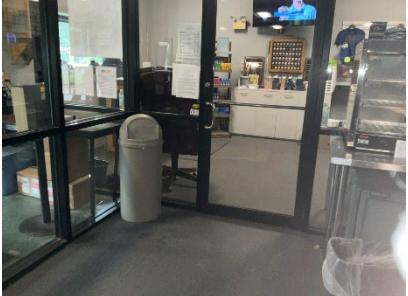
5.	<p>Pro Shop</p> <p>The height of the counter surface measured $>36"$, @ 42".</p> <p>The door maneuvering clearance on pull side obstructed by a trash can.</p>	<p>2010 ADAS 902 ADA Title II Maintenance</p>

<p>Lower a 36" wide portion of the counter to 36" max. AFF.</p> <p>Unit Cost: \$750 ea.</p> <p>Quantity: 1</p> <p>Relocate the trash can.</p> <p>Unit Cost: \$50 ea.</p> <p>Quantity: 1</p>	\$800

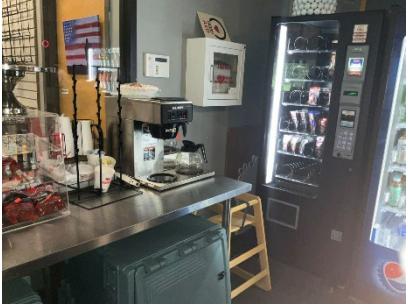
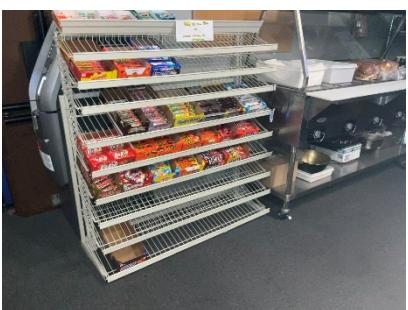
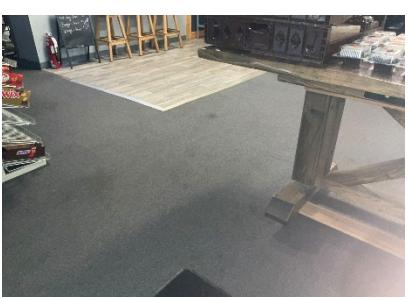
6.	<p>Entrance Lobby</p> <p>The topmost control at the AED box is mounted $>48"$ AFF, @ 58".</p> <p>The top rack at the snack station measured $>48"$ AFF, @ 51".</p> <p>The edge of the high wooden table protrudes $>4"$ into the circulation space.</p>	<p>2010 ADAS 308 2010 ADAS 307.1</p>

<p>Lower the AED box.</p> <p>Unit Cost: \$50 ea.</p> <p>Quantity: 1</p> <p>Provide a complaint candy rack.</p> <p>Unit Cost: \$150 ea.</p> <p>Quantity: 1</p> <p>Relocate the table.</p> <p>Unit Cost: \$50 ea.</p> <p>Quantity: 1</p>	\$250

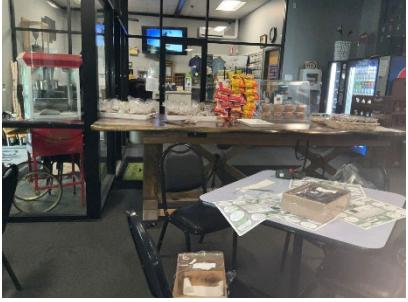
7.	<p>Restaurant/Bar</p> <p>The height of the bar counter measured >34".</p> <p>There are no accessible tables due to their pedestal base.</p>	2010 ADAS 902

<p>Lower a 36" wide portion of the counter to 36" max. AFF.</p> <p>Unit Cost: \$750 ea.</p> <p>Quantity: 1</p> <p>Provide at least one accessible table.</p> <p>Unit Cost: \$250 ea.</p> <p>Est. Quantity: 1</p>	\$1,000
----	---	---------------	---	--	---------

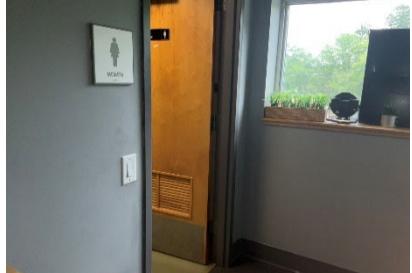
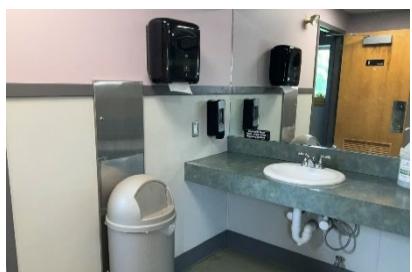
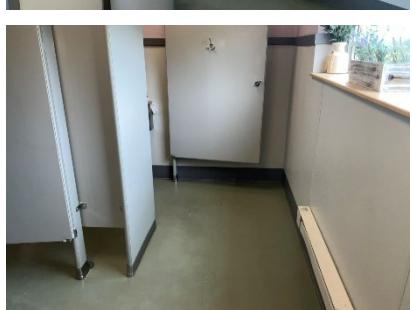
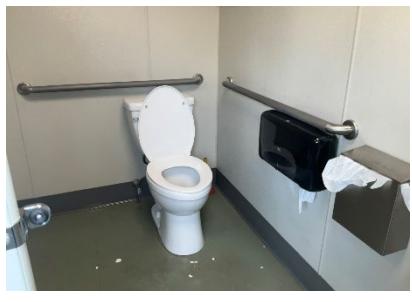
8.	<p>Toilet Rooms (Men's & Women's)</p> <p>The entry door requires more than 5lbs of force to operate.</p> <p>The lavatory is mounted >34" AFF, @ up to 34 3/4".</p> <p>The paper towel dispenser is mounted >48" AFF, @ 56".</p> <p>The self-closing hinge on the accessible stall door is faulty.</p> <p>The side grab bar extends <54", @ up to 50" measured from the rear wall.</p> <p>The toilet paper dispenser is mounted < 1 1/2" below the side wall grab bar.</p> <p>The coat hook is mounted >48" AFF, @ up to 53".</p> <p>The accessible stall door maneuvering clearance on the latch pull side for a side approach measured <42" @ 40 1/2" measured to the face of the heater. In addition, the door is not located maximum 4" from the side partition farthest from the toilet (Women's only).</p> <p>The entry door provides <32" of clear width due to the door being unable to open 90 degrees (Men's only).</p> <p>The toilet centerline measured >16"-18", @ 18 1/2" measured from the sidewall (Men's only).</p>	<p>2010 ADAS 404 2010 ADAS 606 2010 ADAS 307 2010 ADAS 604 2010 ADAS 609</p>

The flush valve is not located on the open side of the toilet (Men's only).			
TOTAL FOR GOLF COURSE:				\$38,200

<p>Adjust the door closer. Unit Cost: \$50 ea. Quantity: 2</p> <p>Lower the lavatory. Unit Cost: \$750 ea. Quantity: 2</p> <p>Relocate the dispenser. Unit Cost: \$50 ea. Quantity: 2</p> <p>Fix the self-closing hinge on the accessible stall door. Unit Cost: \$100 ea. Quantity: 2</p> <p>Relocate the side wall grab bar. Unit Cost: \$50 ea. Quantity: 2</p> <p>Lower the toilet paper dispenser. Unit Cost: \$50 ea. Quantity: 2</p> <p>Lower the coat hook. Unit Cost: \$50 ea. Quantity: 2</p> <p>Reposition the stall partition. Unit Cost: \$500 ea. Quantity: 1</p> <p>Fix the swing of the door to allow for an opening of 90 degrees. Unit Cost: \$500 ea. Quantity: 1</p> <p>Reposition the flush valve or install an automatic flush control. Unit Cost: \$1,500 ea. Quantity: 1</p>	<p>\$4,700</p>

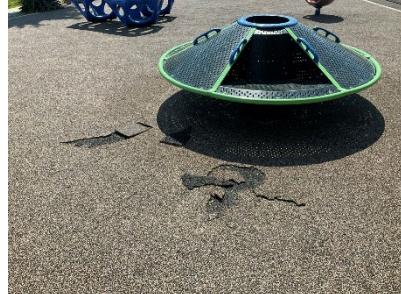
LEVITZ PLAYGROUND					
#	<i>Barrier Statement</i>	<i>Code References</i>	<i>Photo</i>	<i>Proposed Mitigation</i>	<i>Cost</i>
1.	Play Surface There is a change in level $> \frac{1}{4}$ " AFF where the playground surface is deteriorated, @ 1".	2010 ADAS 403.4

Resurface the deteriorated section of playground. Unit Cost: \$500 Quantity: 1	\$500
TOTAL FOR LEVITZ PLAYGROUND:					\$500

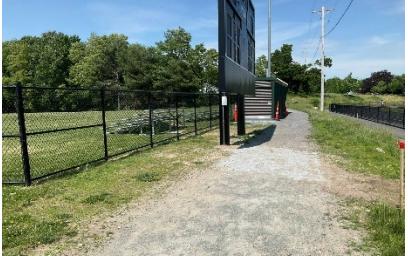
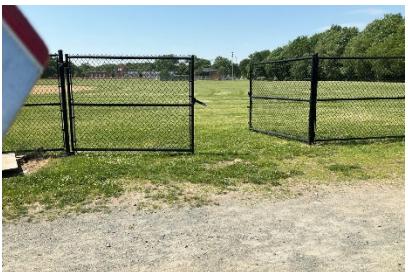
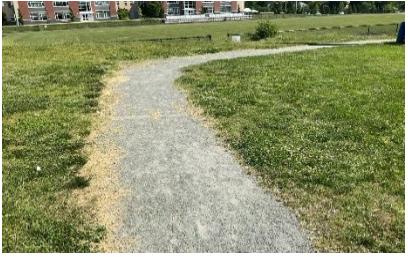
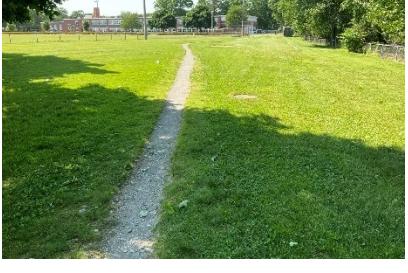
1.	<p>Walkways</p> <p>The walkway that loops around the complex and along Levitz Playground is not accessible due to the gravel and stone dust surface.</p> <p>Further, the walkway is <36" wide in certain areas along the East side of the complex.</p>	2010 ADAS 206.1

<p>Provide an accessible route throughout the complex.</p> <p>Unit Cost: \$25/SF</p> <p>Est. Quantity: 2,800 SF</p>	\$70,000
----	--	-----------------	--	---	----------

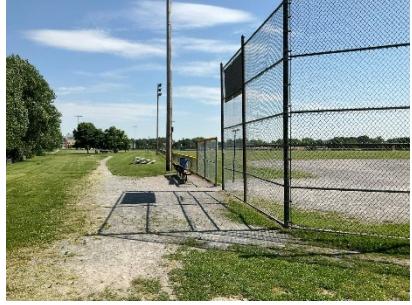
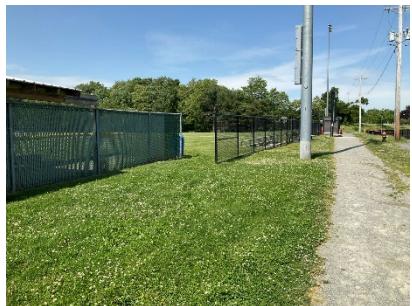
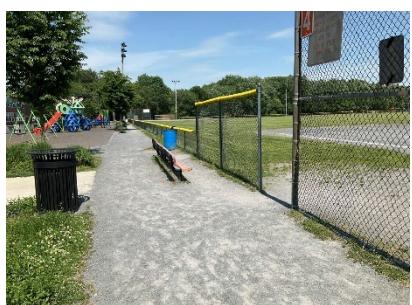
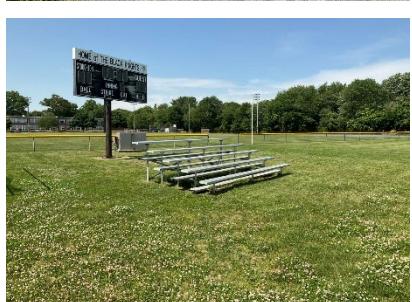
2.	<p>Sports Fields</p> <p>None of sports fields provide an accessible route connecting elements and spaces within areas of sports activities, including an:</p> <ul style="list-style-type: none"> • Accessible route from the looping walkway to the field. • Accessible route to team player seating areas (i.e., dugouts on baseball fields and team benches along the sidelines of the soccer field). • Accessible route to spectator seating (i.e., benches and bleachers), when provided. 	2010 ADAS 206.1

<p>Provide at least one of each type of sports fields along an accessible route, including an accessible route to all of the field's elements and spaces within areas of sports activities. For bleachers, provide the required number of wheelchair spaces and at least one companion seat per wheelchair space.</p> <p>Unit Cost: \$25/SF</p> <p>Est. Quantity: 600 SF</p>	\$15,000
----	---	-----------------	--	--	----------

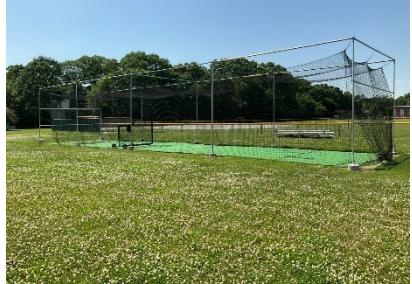
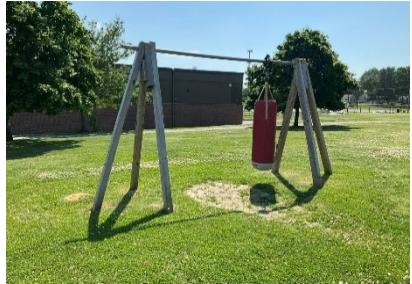
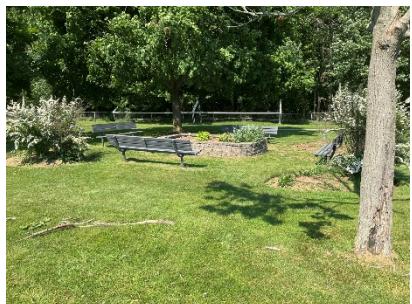
3.	<p>Site Amenities</p> <p>Some site amenities (i.e., batting cages, punching bag, and benches) are not located along an accessible route due to the grass surface.</p>	2010 ADAS 206.2.1

<p>Provide at least one of each type of amenity along an accessible route.</p> <p>Unit Cost: \$25/SF Est. Quantity: 700 SF</p>	\$17,500
----	--	----------------------	--	--	----------

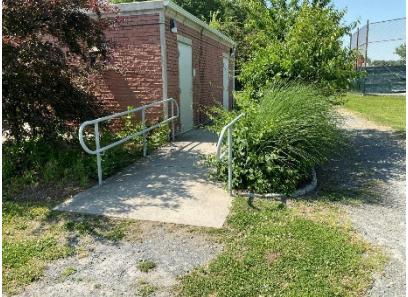
4.	<p>Exterior Ramps</p> <p>Both ramps leading to the toilet rooms lack a level landing and have handrails that do not extend the length on their run. Further, the ramps are not located on an accessible route due to the gravel surface.</p> <p>Further, the ramp handrails are obstructed by the vegetation.</p>	2010 ADAS 405

<p>Rebuild the ramps. Unit Cost: \$5,000 ea. Quantity: 2</p> <p>Provide an accessible route to the ramp. Unit Cost: \$25/SF Est. Quantity: 40 SF</p>	\$11,000
----	--	---------------	---	--	----------

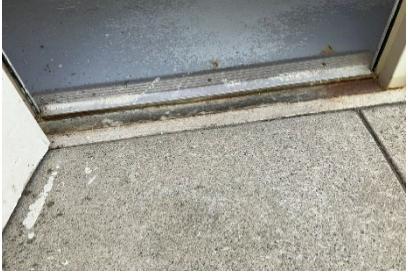
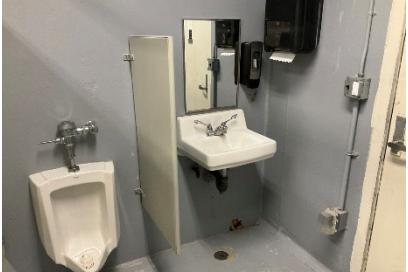
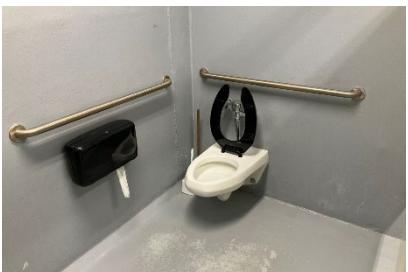
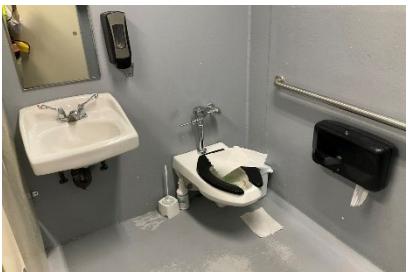
5.	<p>Toilet Rooms (Men's & Women's)</p> <p>The threshold is $> \frac{1}{2}$", @ $\frac{3}{4}$" and is not beveled.</p> <p>The bottom of the reflective surface of the mirror is >40" AFF, @ 48" (Women's only).</p> <p>The pipes underneath the lavatory are not insulated (Men's only).</p> <p>The paper towel dispenser is mounted >48" AFF, @ 54" (Men's only).</p> <p>The coat hook is >54" AFF, @ 57" (Men's only).</p> <p>The grab bars are not mounted 33"-36" AFF, @ 37", measured to the top of the gripping surface.</p> <p>The toilet lacks the required clearance around it due to the lavatory and soap dispenser inside the accessible toilet stall (Women's only).</p> <p>The self-closing hinge on the accessible stall door is faulty.</p>	<p>2010 ADAS 404 2010 ADAS 606 2010 ADAS 308 2010 ADAS 603 2010 ADAS 604 2010 ADAS 609</p>

<p>Replace the threshold. Unit Cost: \$250 Quantity: 2</p> <p>Lower the mirror. Unit cost: \$50 ea. Quantity: 2</p> <p>Insulate the pipes underneath the sink. Unit Cost: \$50 ea. Quantity: 1</p> <p>Relocate the paper towel dispenser. Unit Cost: \$50 ea. Quantity: 1</p> <p>Relocate the grab bars. Unit cost: \$50 ea. Quantity: 4</p> <p>Remove the lavatory and soap dispenser inside the accessible toilet stall. Unit cost: \$500 ea. Quantity: 1</p> <p>Lower the coat hook. Unit Cost: \$50 ea. Quantity: 1</p> <p>Install a self-closing door. Unit Cost: \$150 ea. Quantity: 2</p>	\$1,750
