Town of Stoughton

Annual Inflow & Infiltration (I/I) Program

February 9, 2025

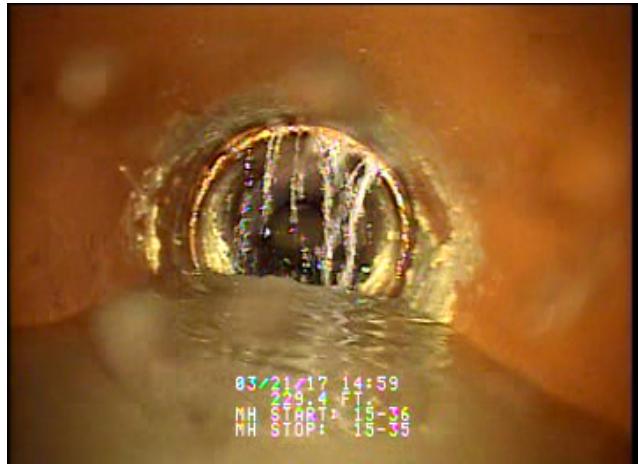
Greenwood Avenue

← Before: Open Joint

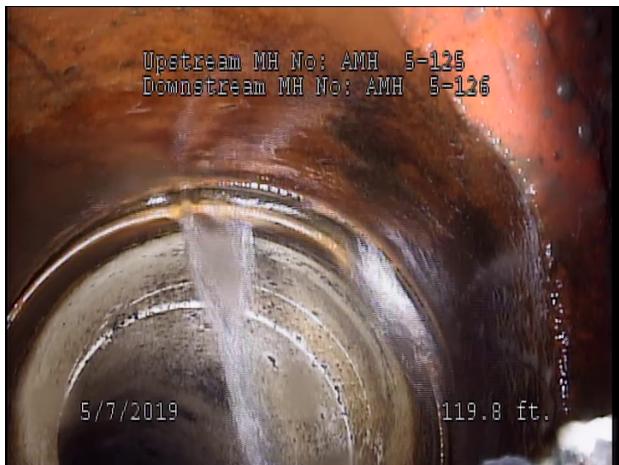
Clapp Street

← Before: Service Defect

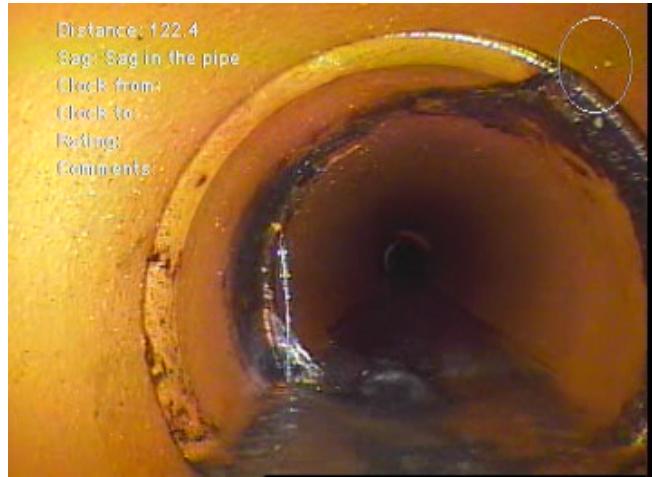
Greenbrook Drive

← Before: Defective Pipe

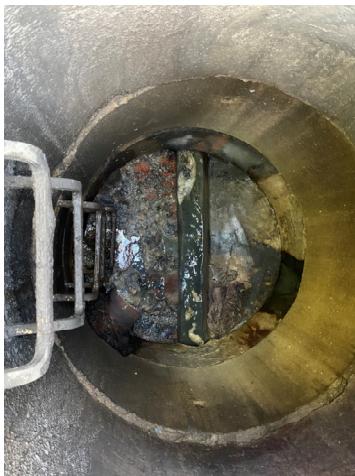
Central Street

← Before: Leaking Manhole

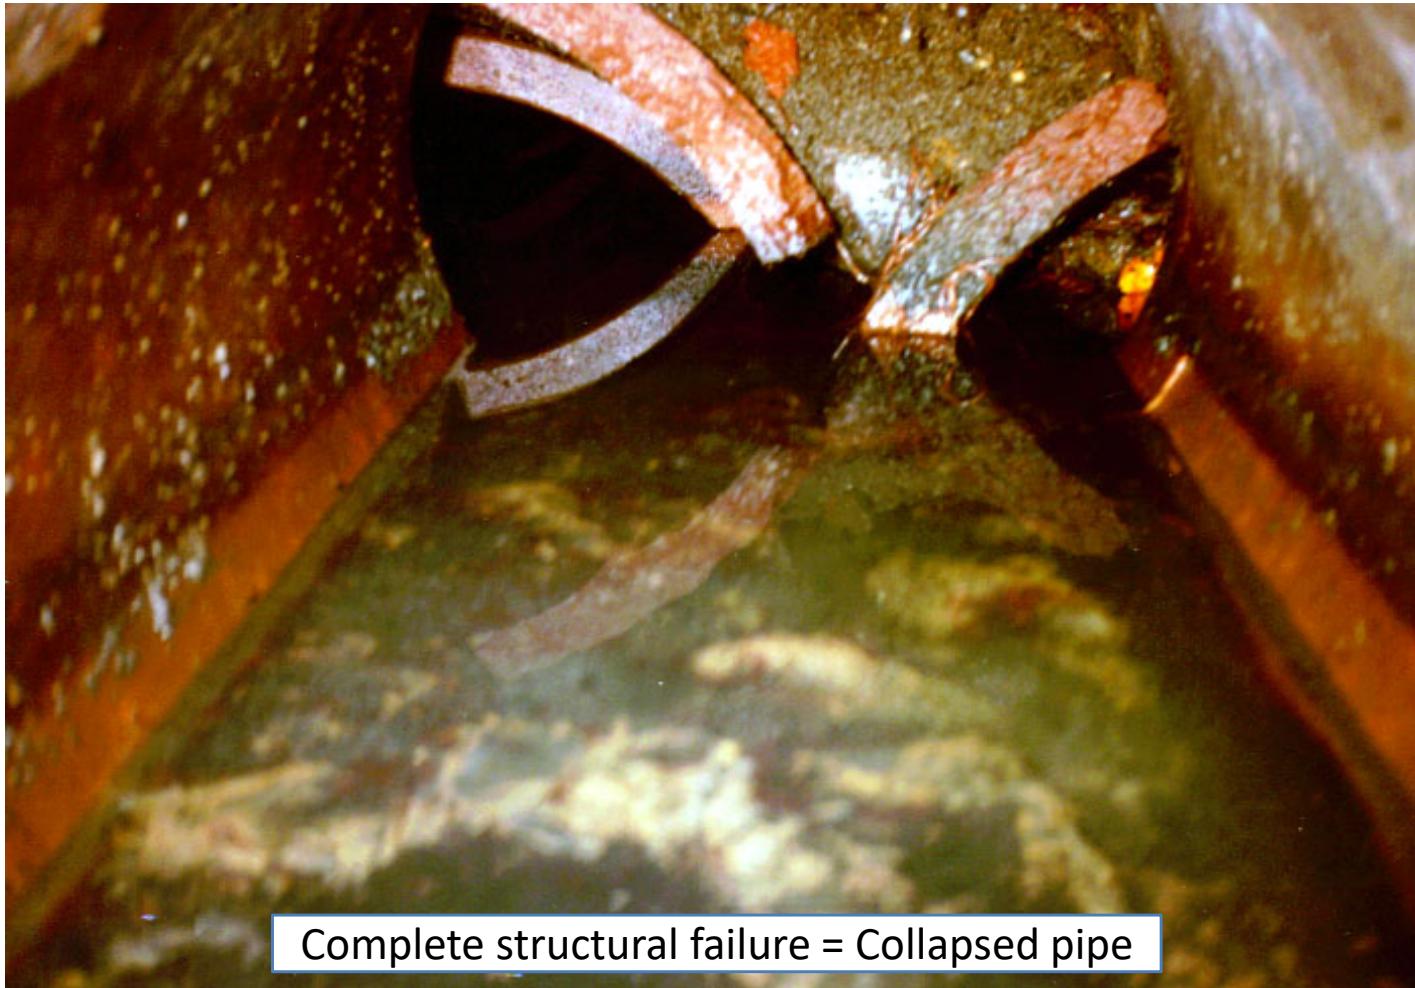
Complete structural failure = Collapsed pipe

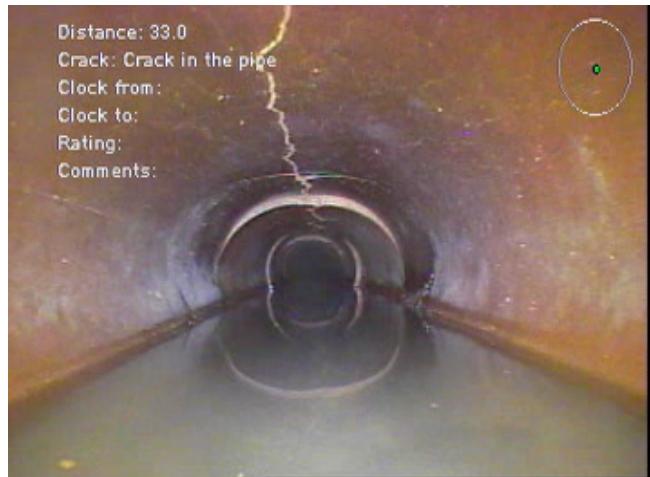
Kinsley Street
← Before: Defective Pipe
After: CIPP →

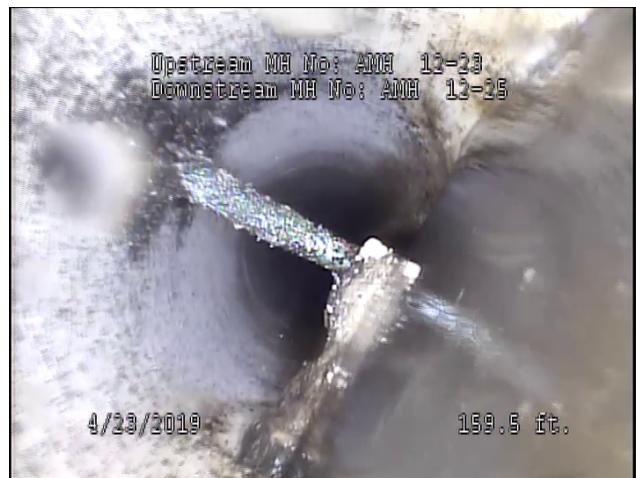
Central Street
← Before: Cross Bore
After: Removed →

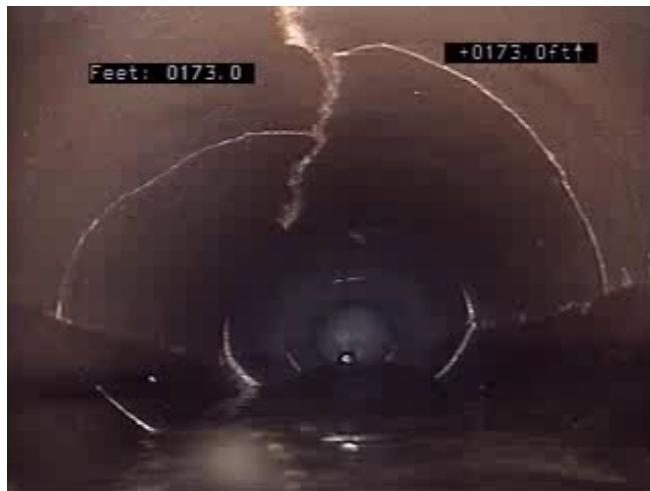
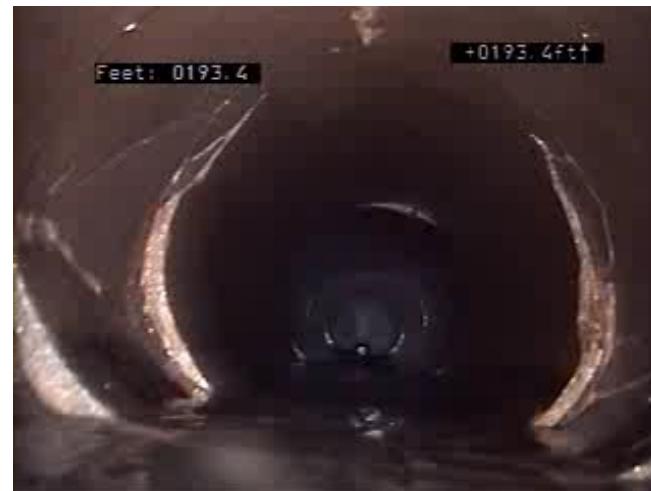
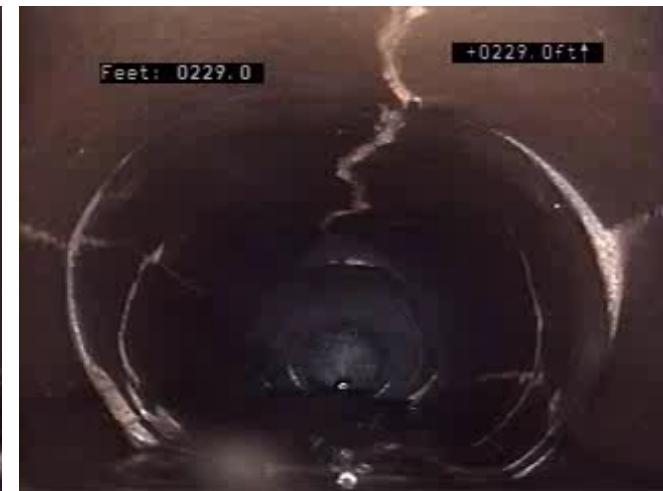
Morton Street CIPP

↑ Severely damaged pipe = reduced cross-sectional area and potential structural failure ↑
