NAME OF SLUM & BLIGHT AREA:

45 Stoughton Downtown Redevelopment Area

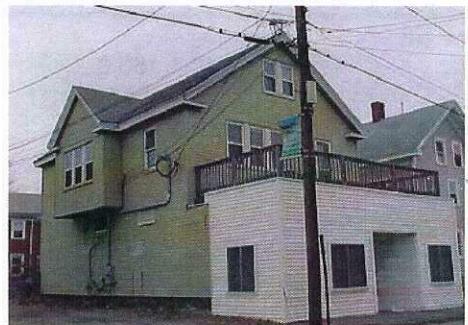
Roofing	
Windows and Doors	
Exterior Walls	New siding on front of building; some paint required
Porch/Stairs/Deck	
Foundation	
Storefront & Signage	
Parking Lots	
Environmental	Probable lead paint based on age of building
Other:

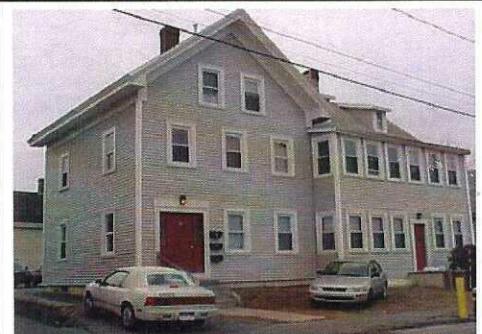
<u>Component</u>	<u>Condition</u>
Roofing	
Windows and Doors	
Exterior Walls	Some paint needed
Porch/Stairs/Deck	
Foundation	
Storefront & Signage	
Parking Lots	
Environmental	Probable lead paint based on age of building
Other:	
Overall Property Rating: (Excellent / Good / Fair / Poor) briefly state why.

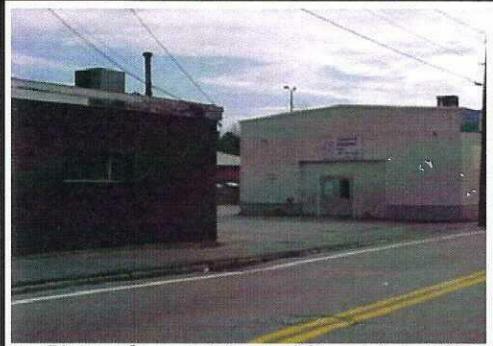
<u>Component</u>	<u>Condition</u>
Roofing	
Windows and Doors	
Exterior Walls	Brick - good; Steel - poor
Porch/Stairs/Deck	
Foundation	
Storefront & Signage	
Parking Lots	
Environmental	Probable lead paint based on age of building
Other:	Check parcel for number of buildings - one brick, one steel. Steel may be T
Overall Property Rating: (Excellent / Good / Fair / Poor)	
briefly state why.
