# SOUTH ELEMENTARY SCHOOL

Photo Tour for Town Meeting  
May 3, 2021

## SOUTH ELEMENTARY SCHOOL

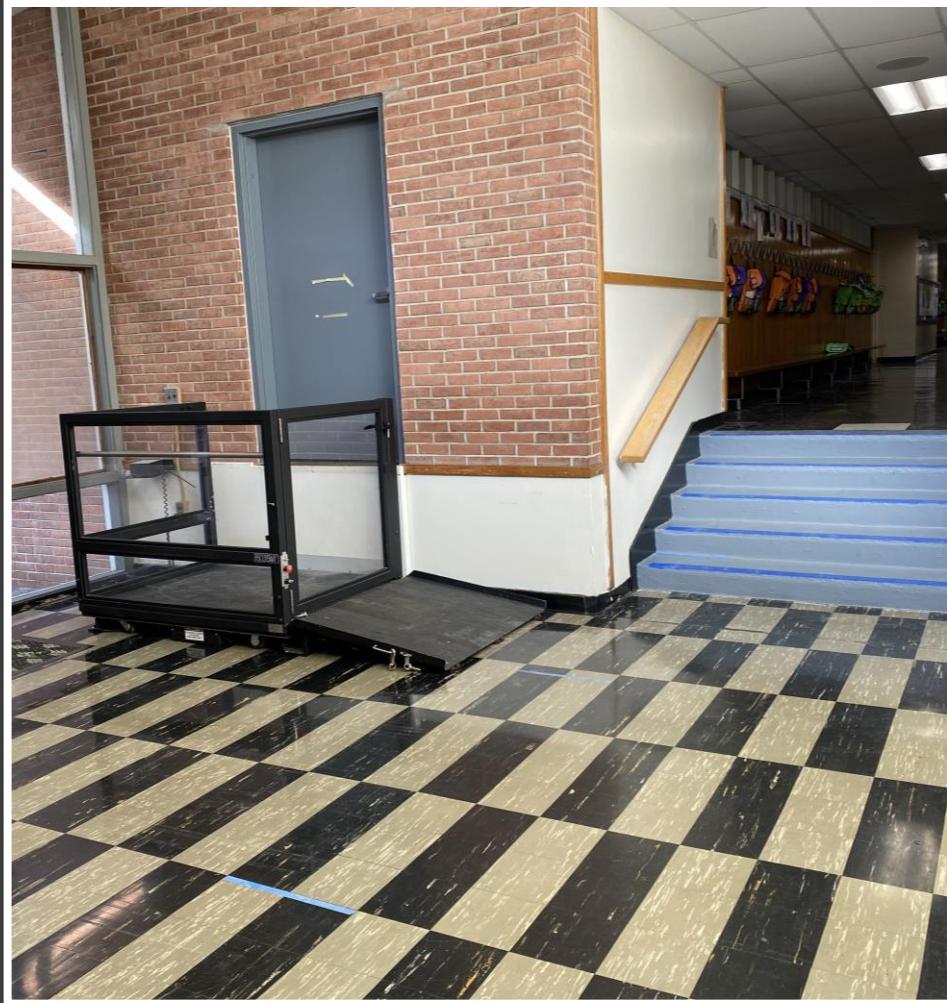
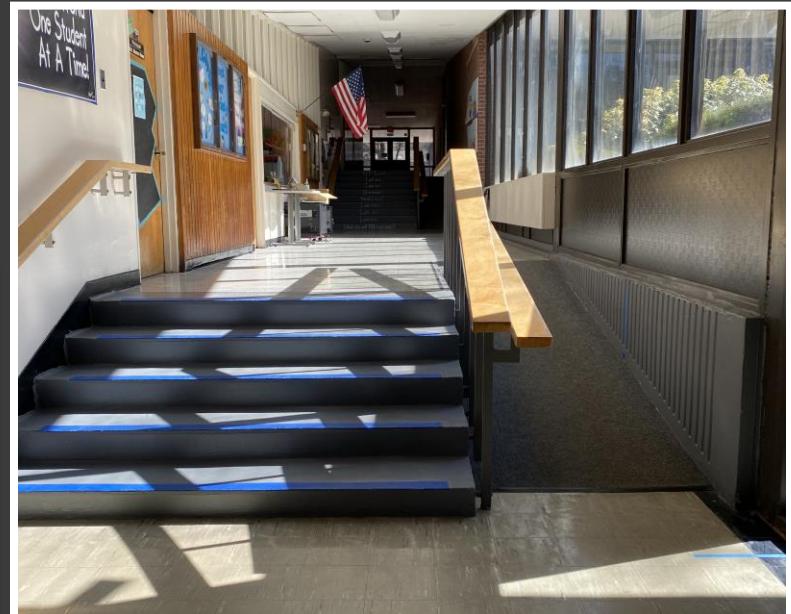
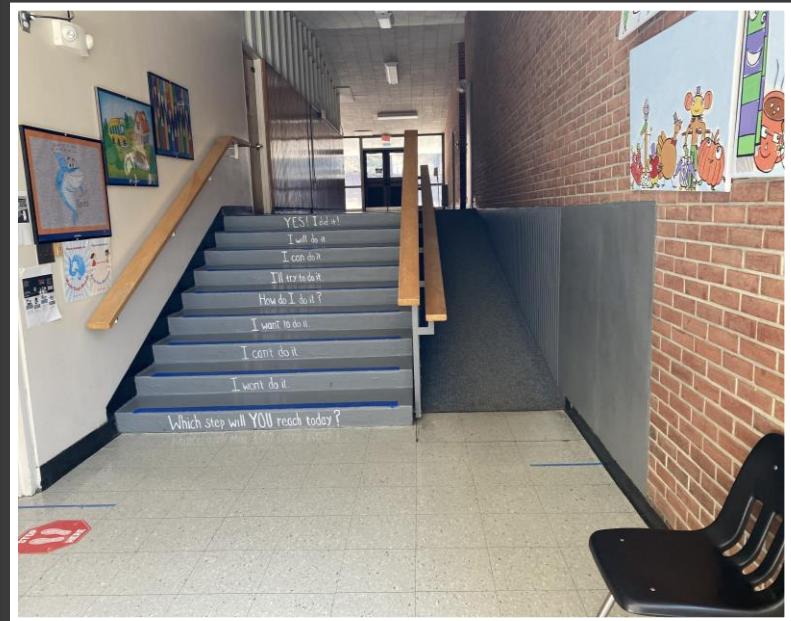
There are four ramps and one lift that serve the five levels of the school. The ramps range from 23% to 26%. The maximum allowable standard is 8.3%.

The ramps are original to the building – 32 years before ADA (Americans with Disabilities Act) was the law.

It was determined in the 1990's ADA studies that there was no solution that could fix the accessibility problems at this school.

# NON-COMPLIANT ADA RAMPS AND LIFT. LIFT OPENS INTO CLASSROOM

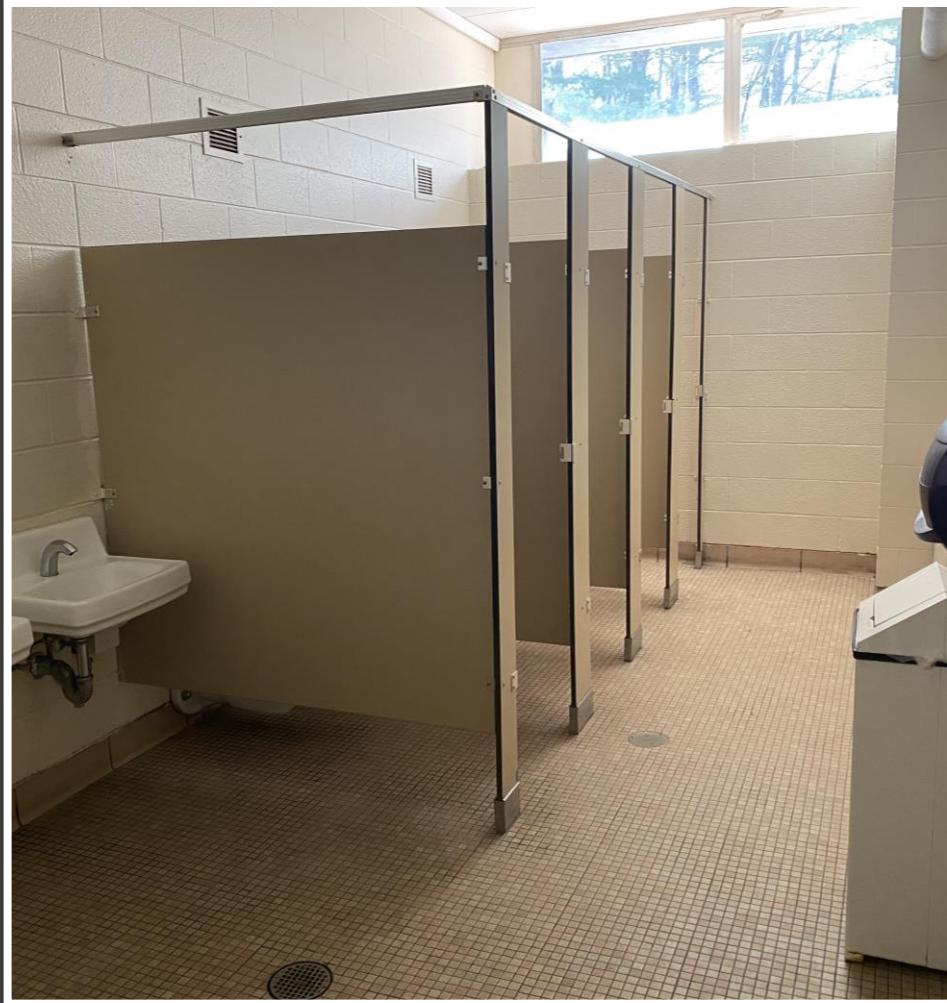
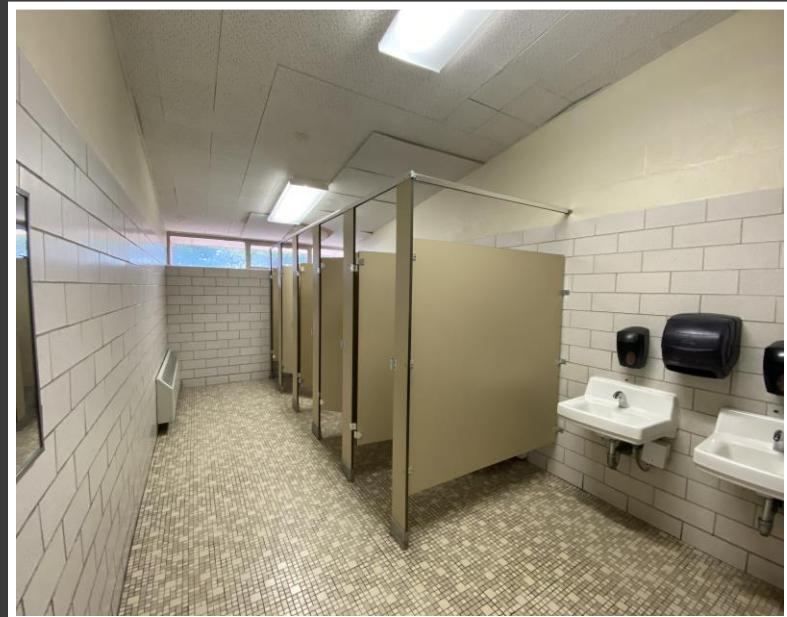
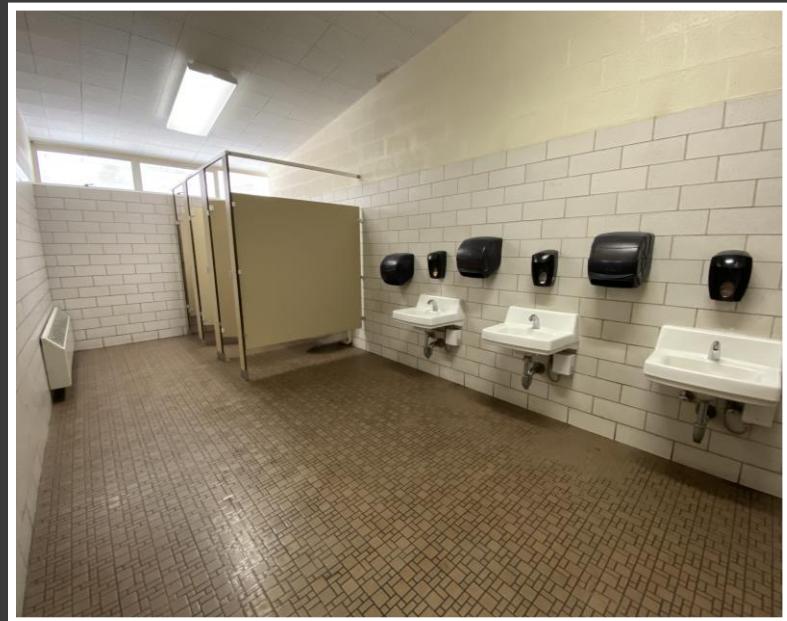
# NON-ADA STUDENT RESTROOMS

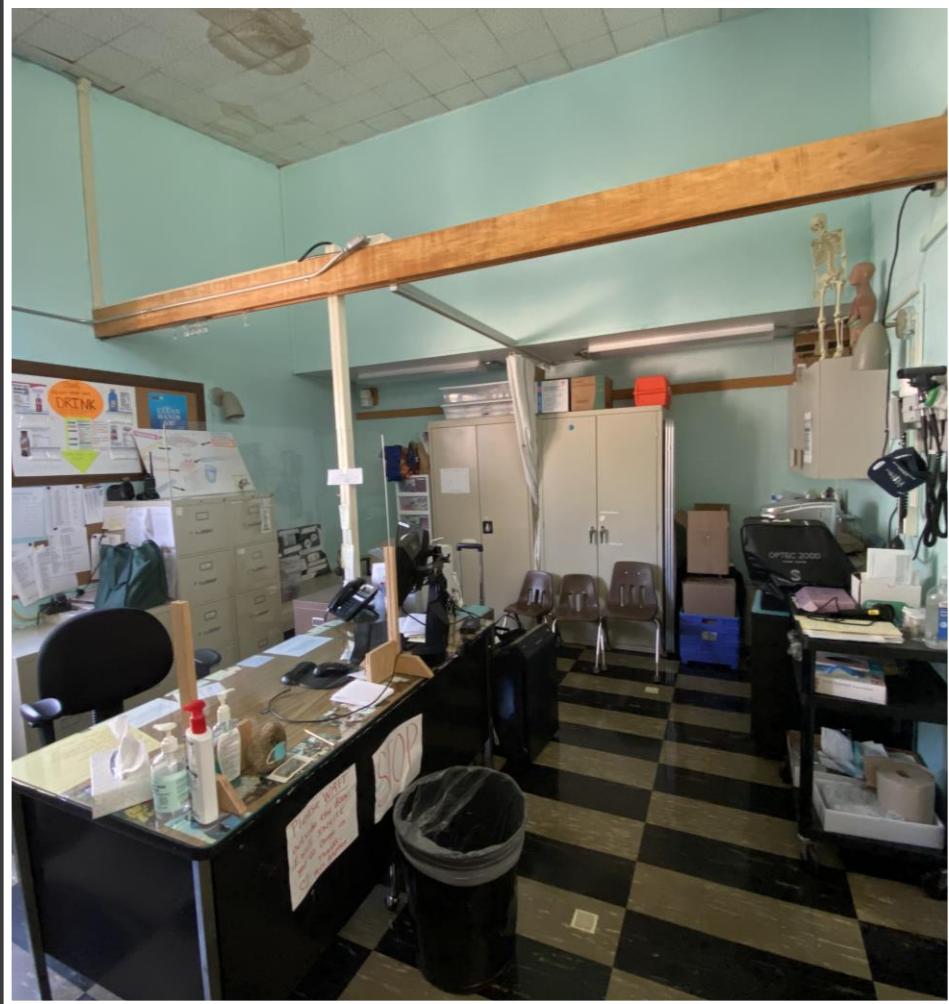
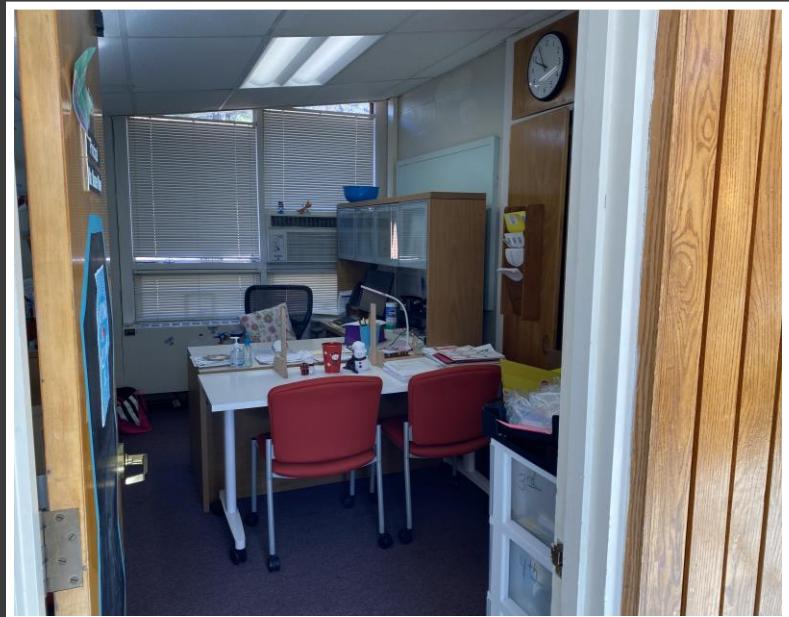
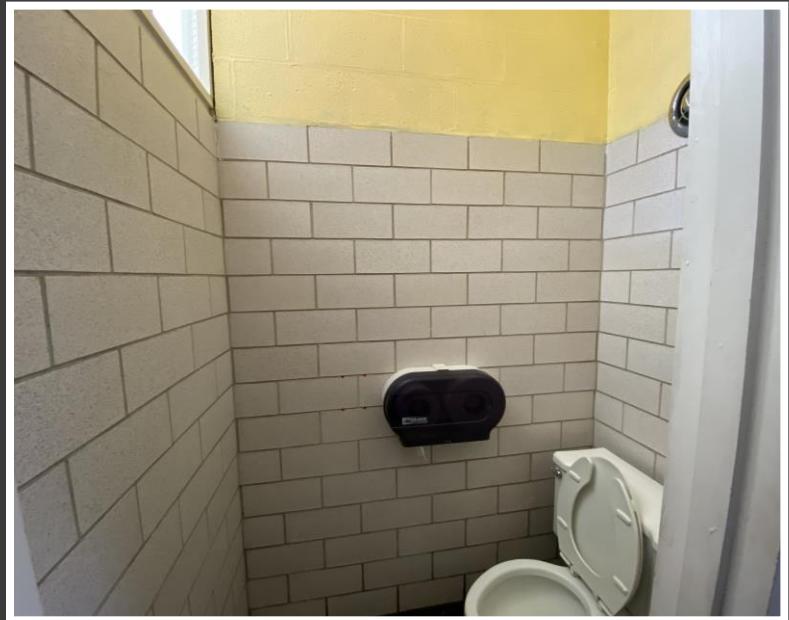
# UNDERSIZED PRINCIPAL'S OFFICE, CLINIC, AND CLINIC RESTROOM

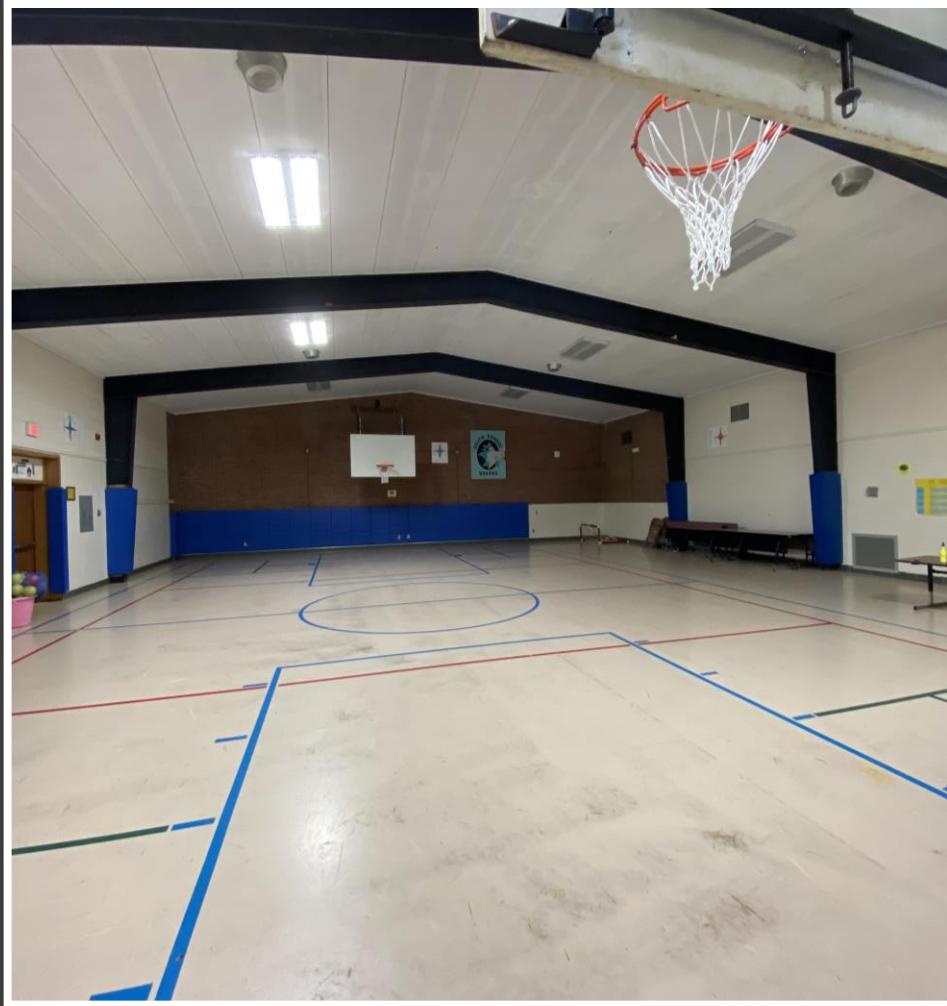
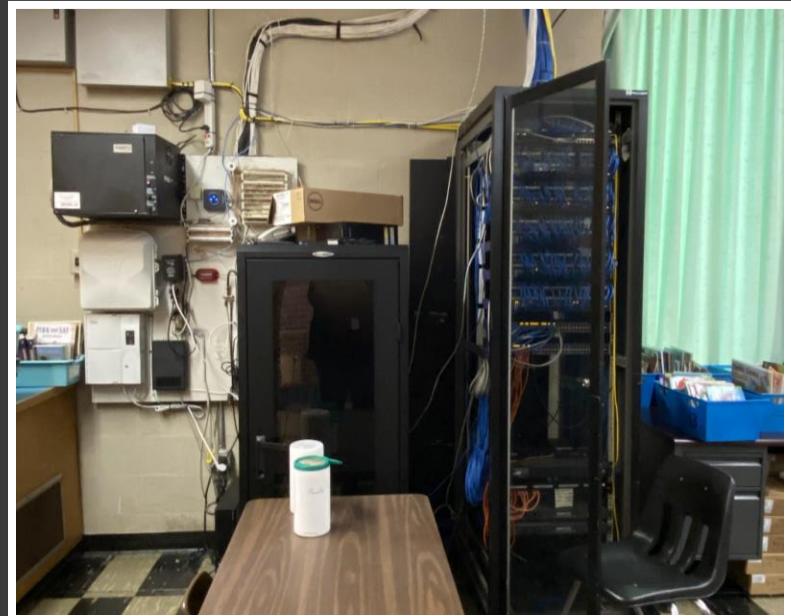
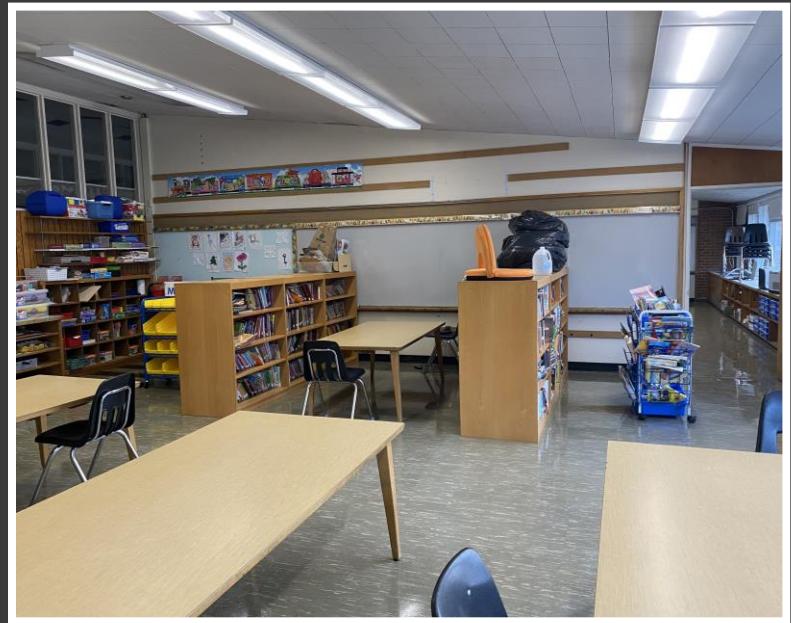
# SMALL GYM, SERVER IN CONFERENCE ROOM, AND LIBRARY IN SMALL CLASSROOM

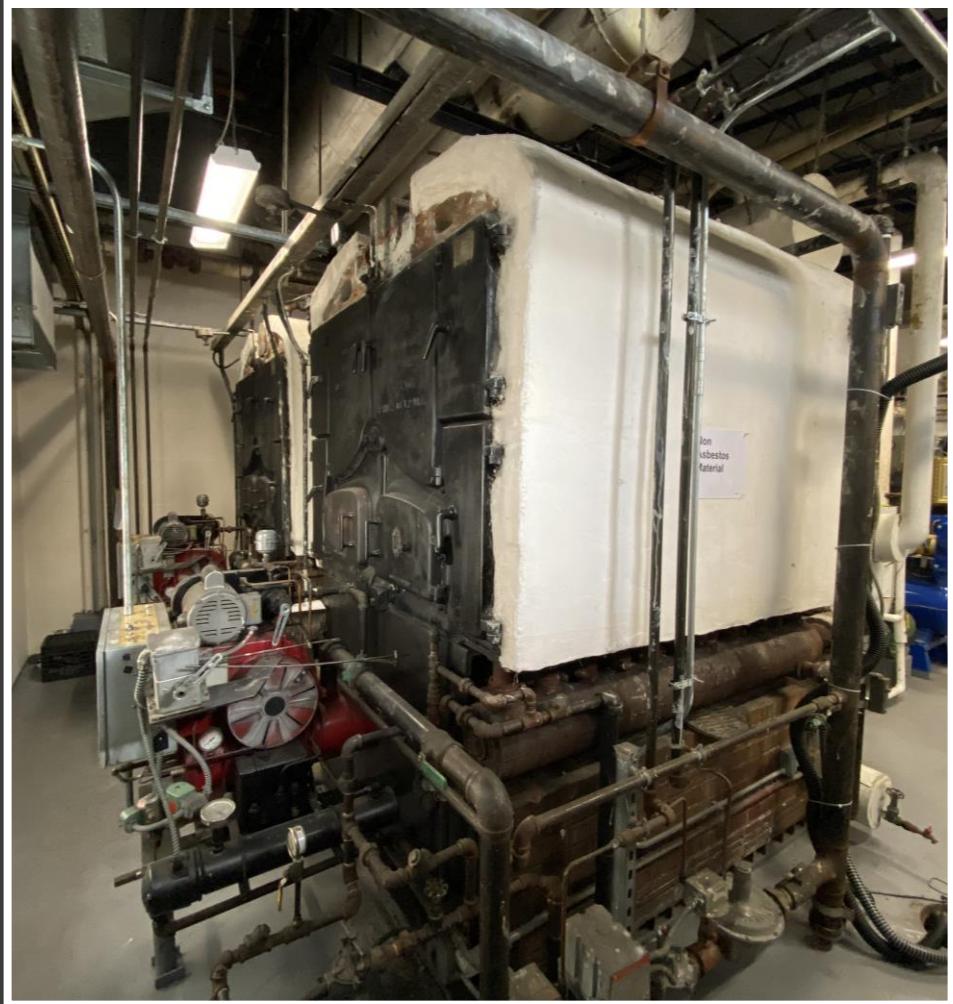
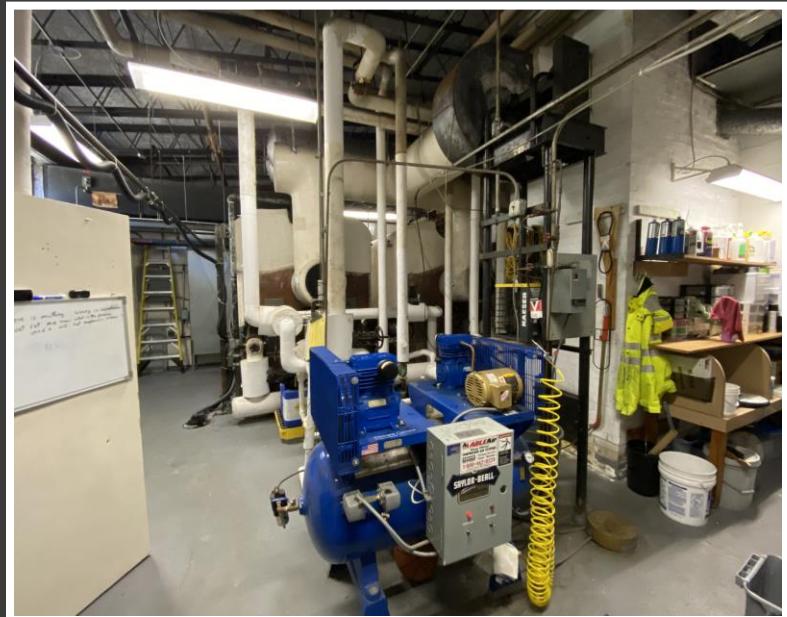
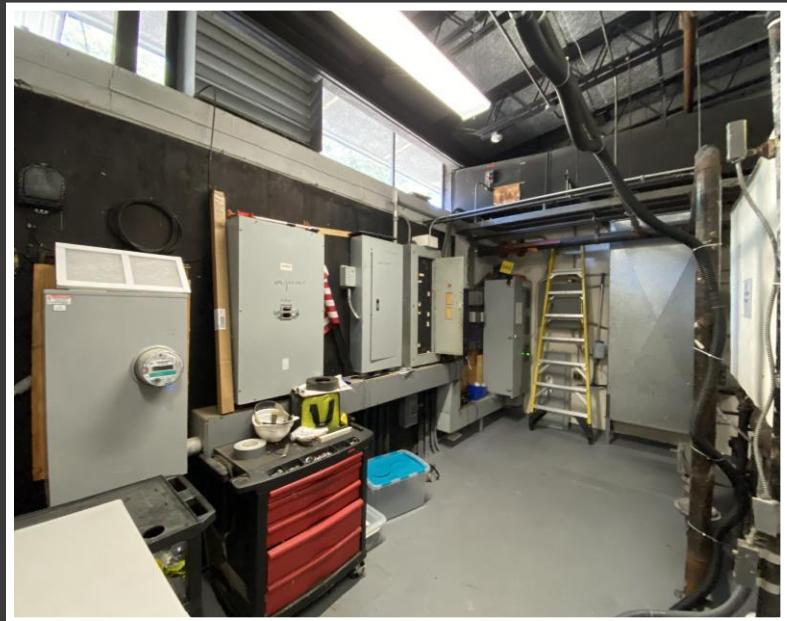
# ORIGINAL 1958 BOILERS

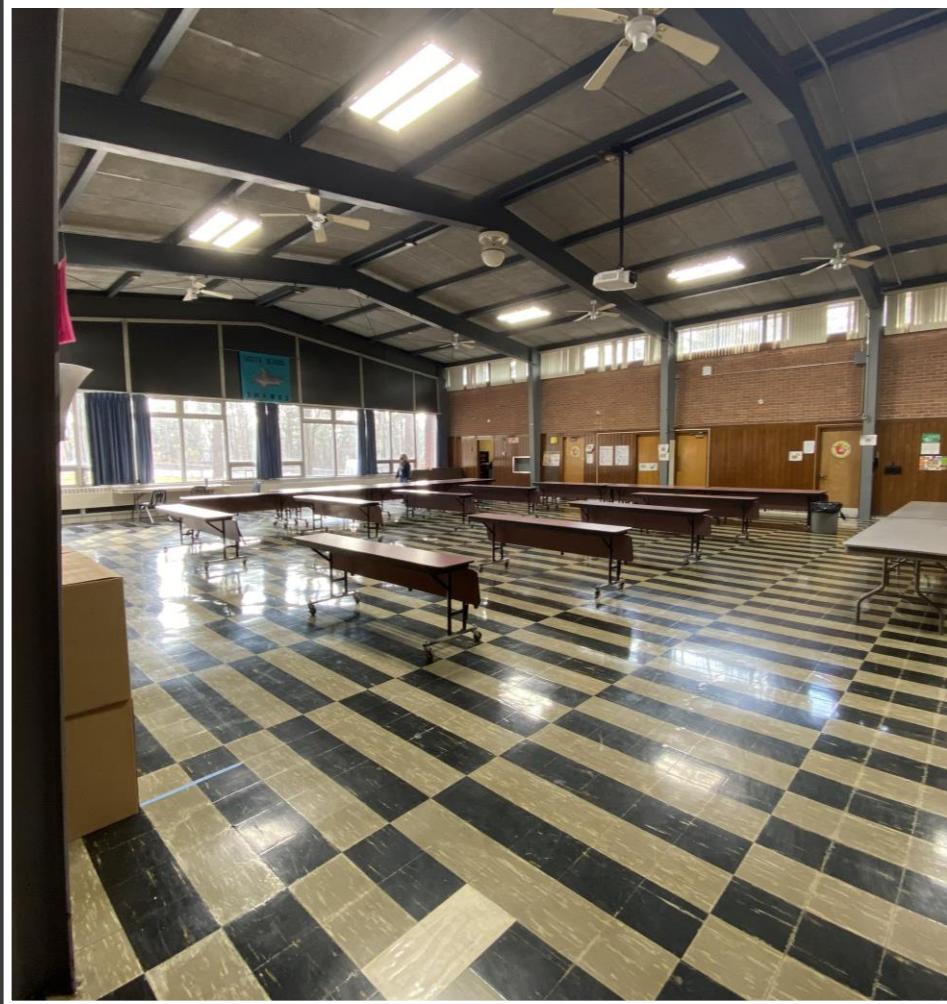
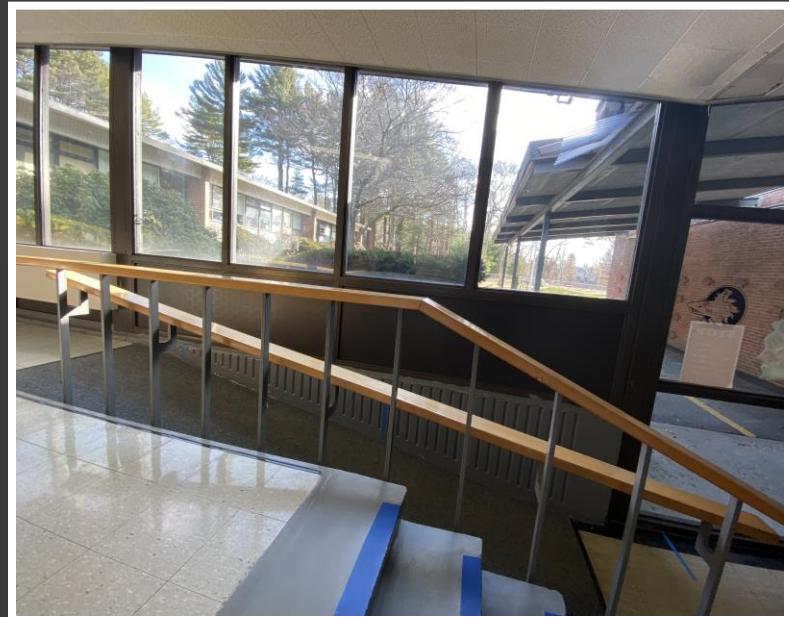
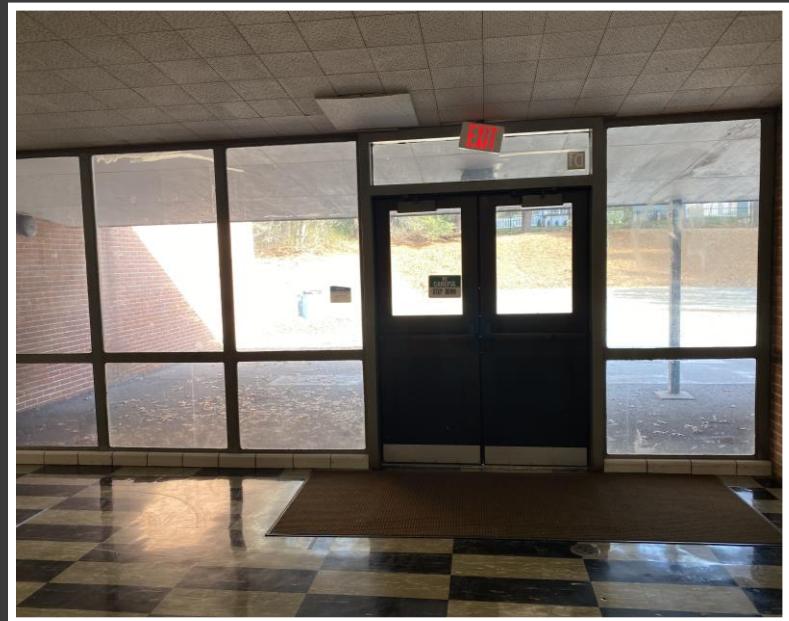
# LARGE EXPANSES OF SINGLE GLAZED GLASS – ENERGY INEFFICIENT

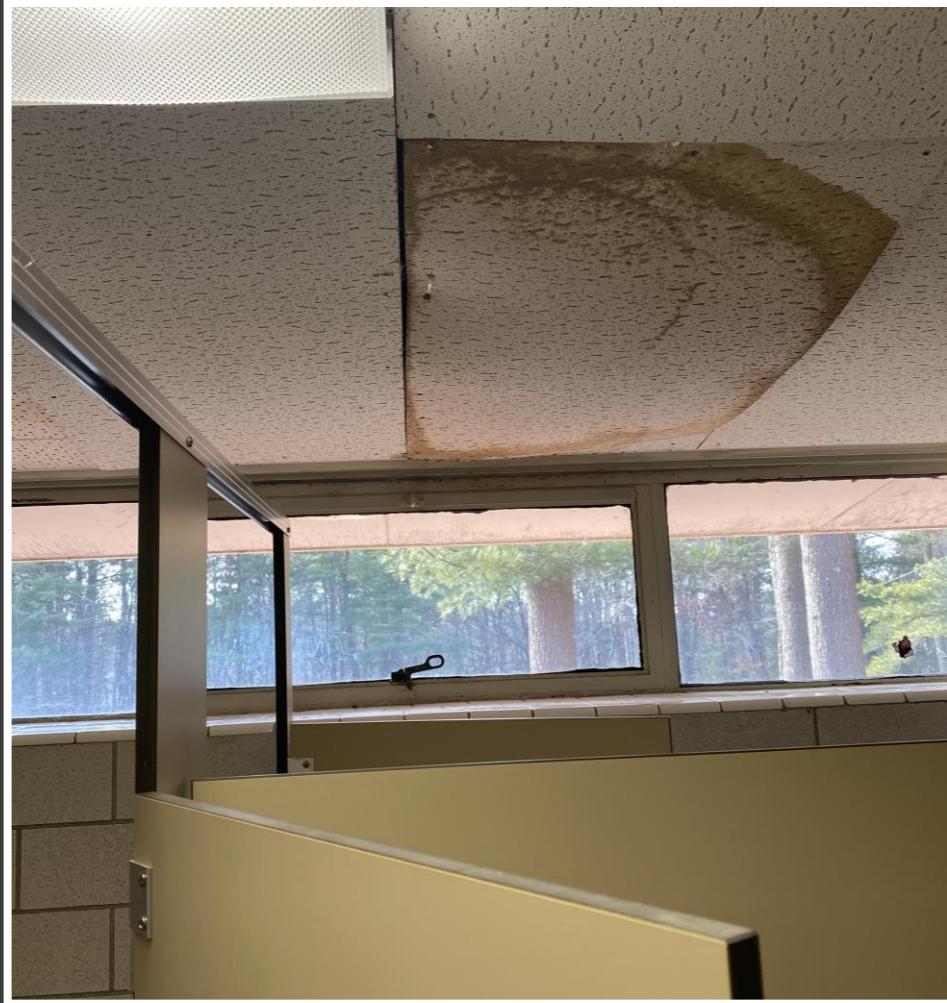
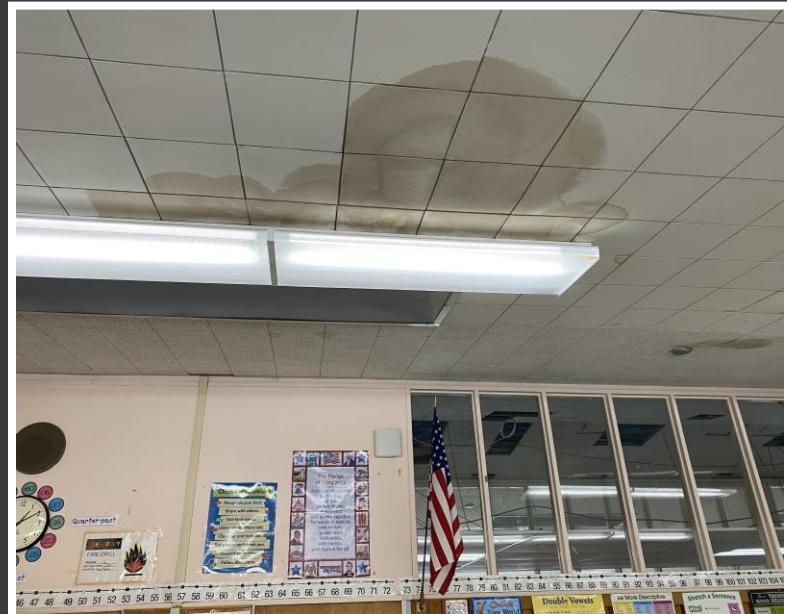
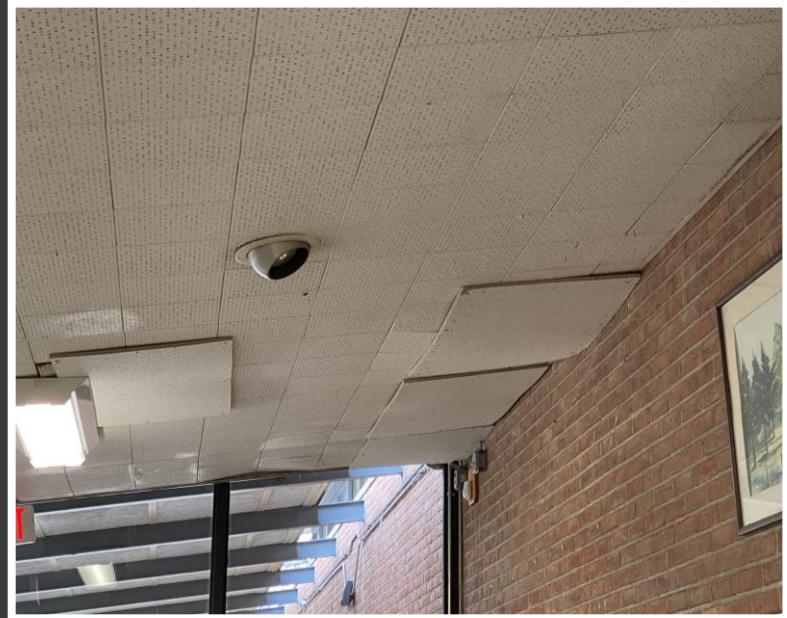
# CEILING DAMAGE

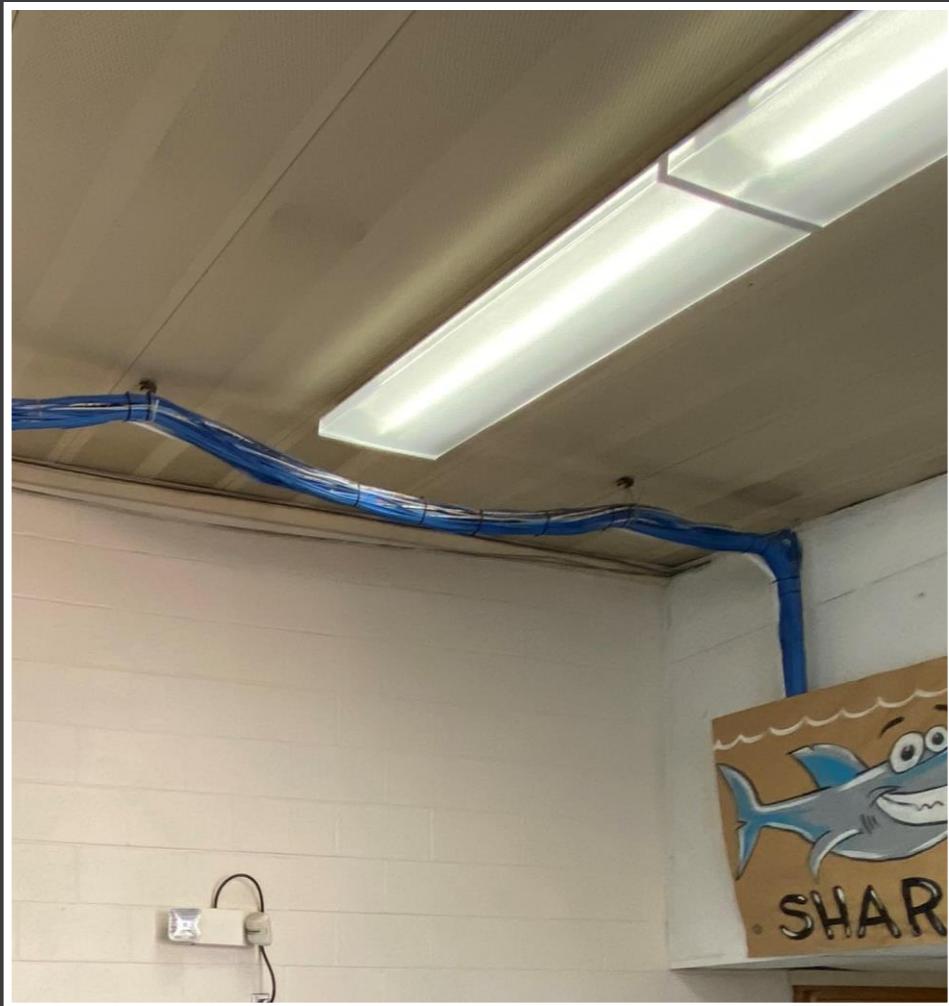
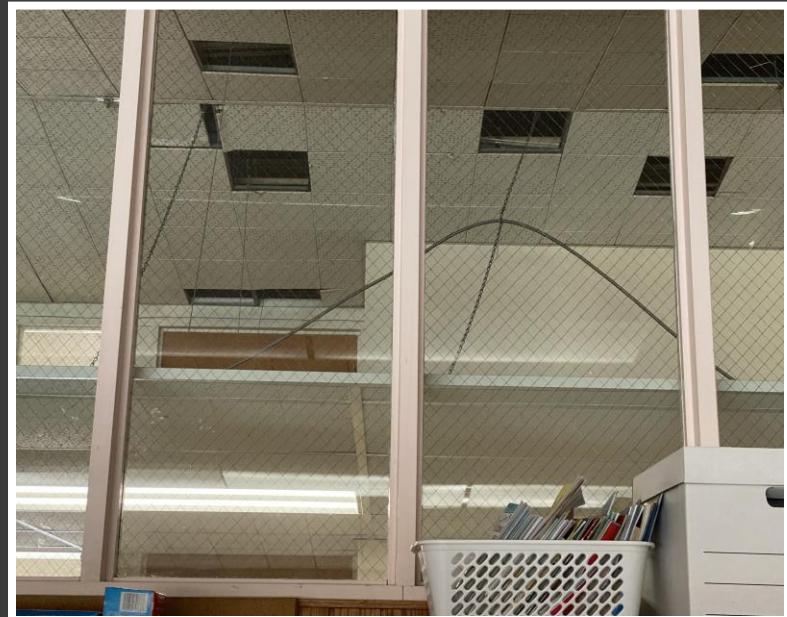
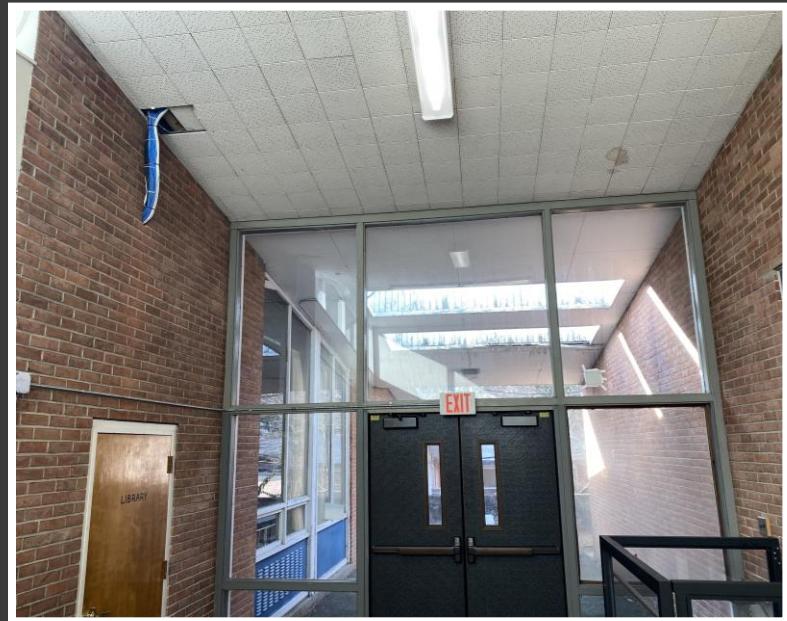
# CABLES RUN ALONG SURFACE DUE TO ROOF/CEILING DESIGN

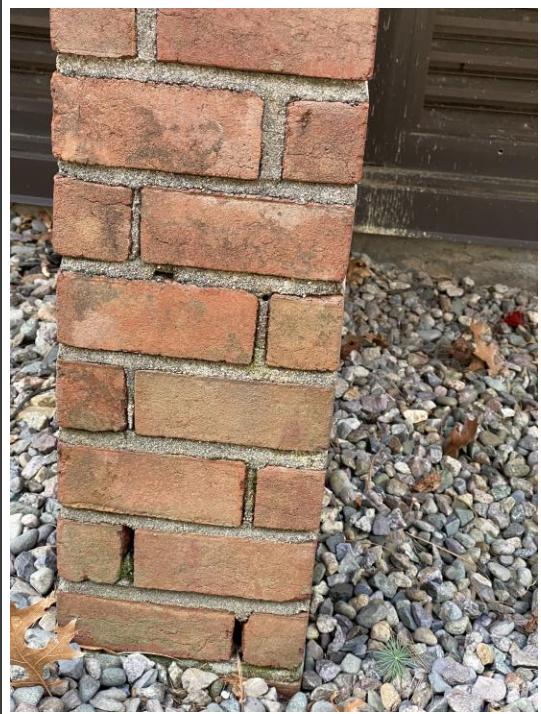
# BRICK DETERIORATION

Brick Pointing

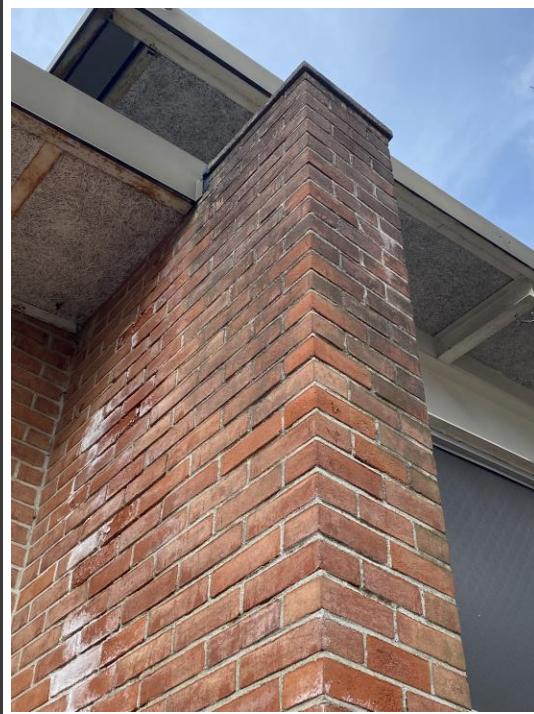
Brick Staining

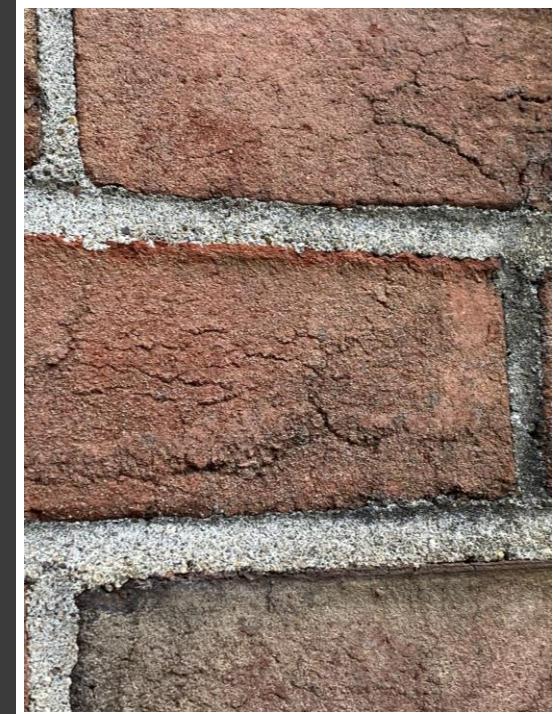
Brick Cracking

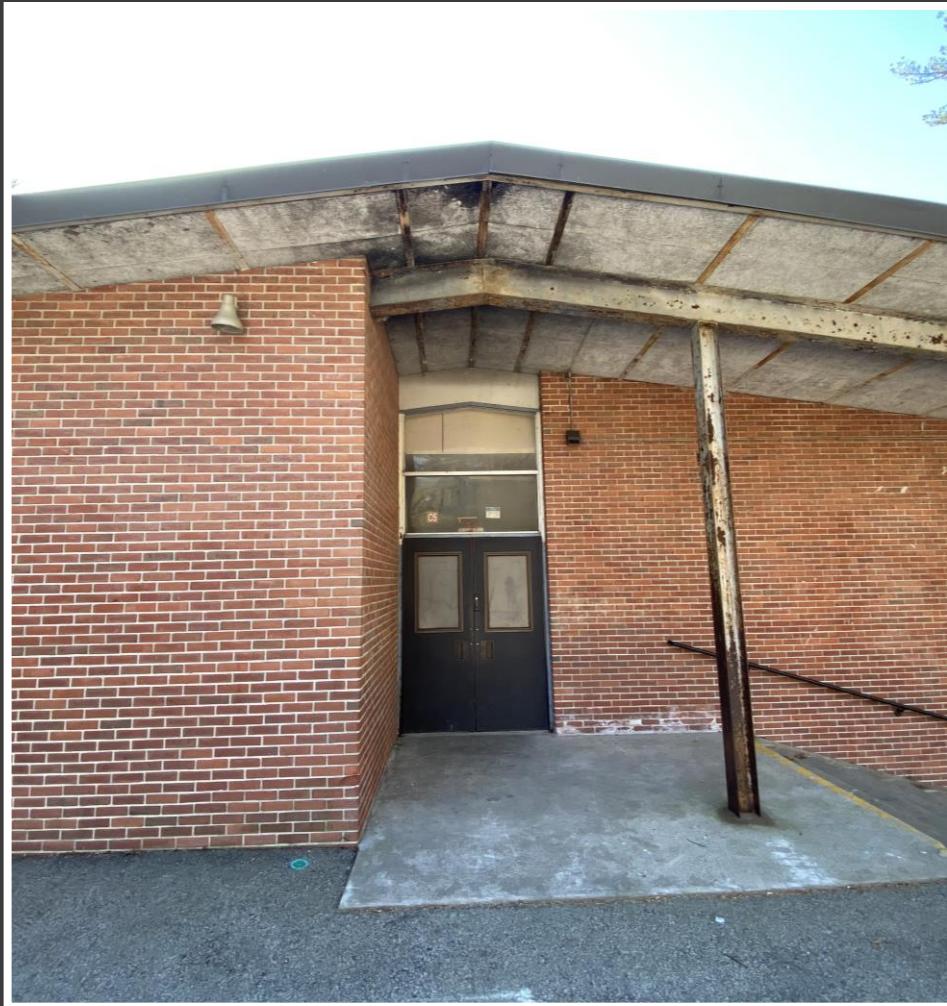
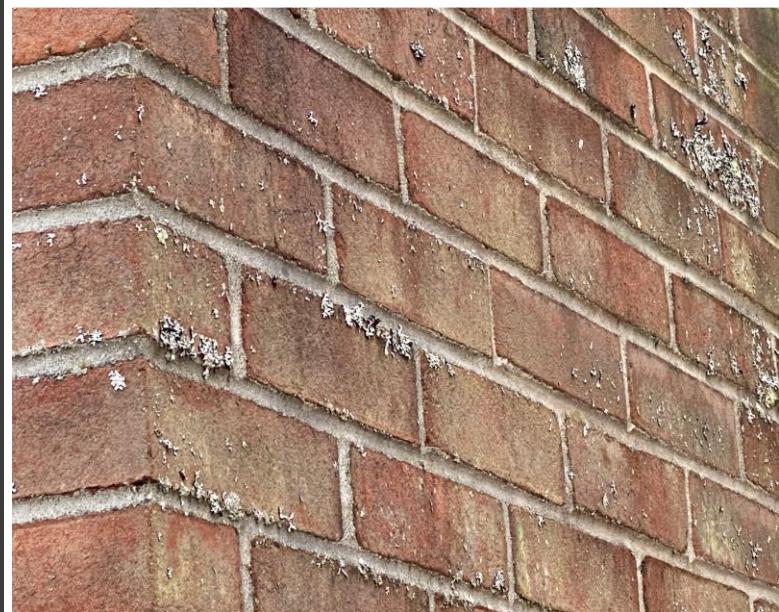
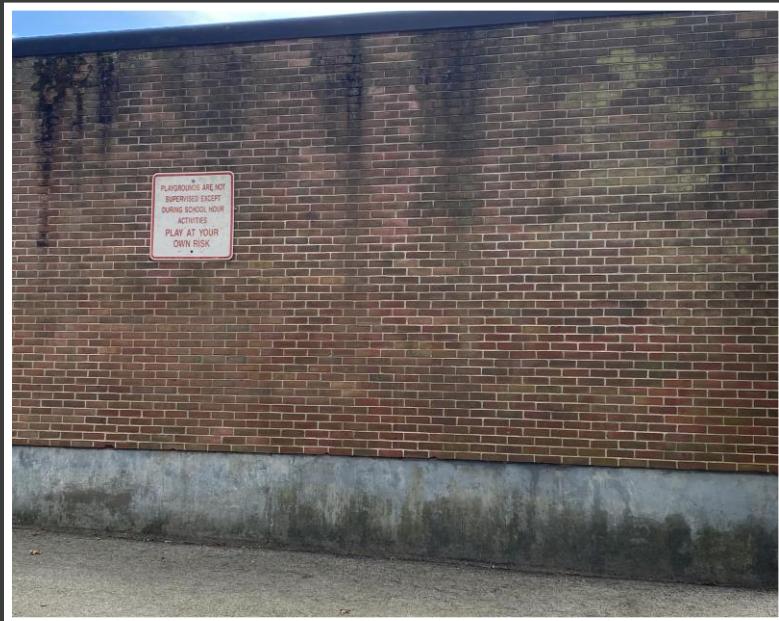
# NORTH FAÇADE DETERIORATION

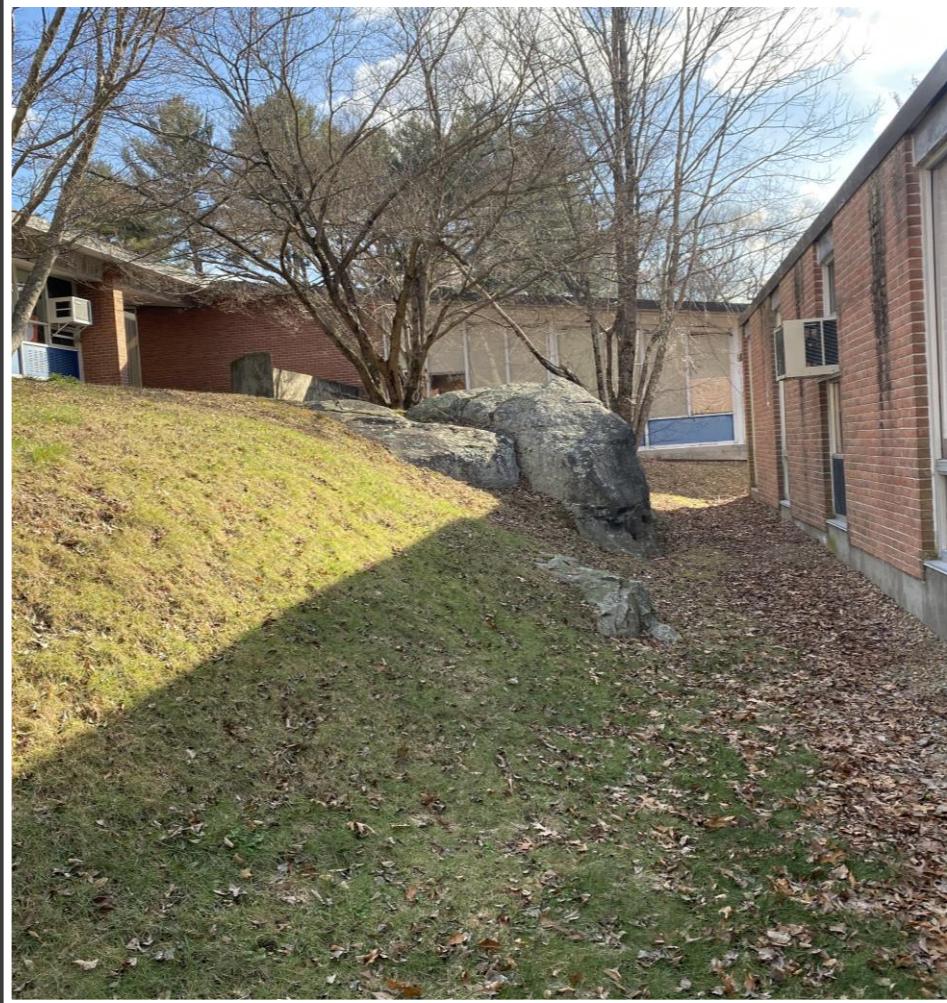
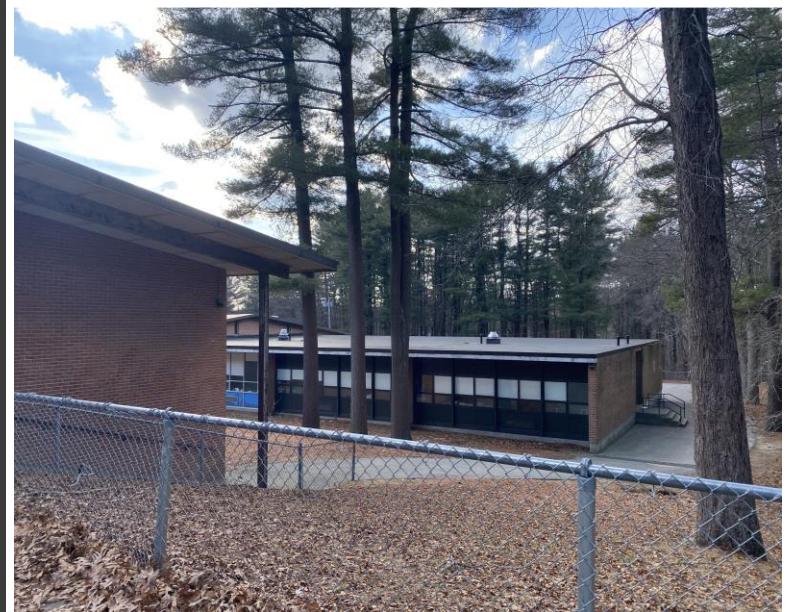
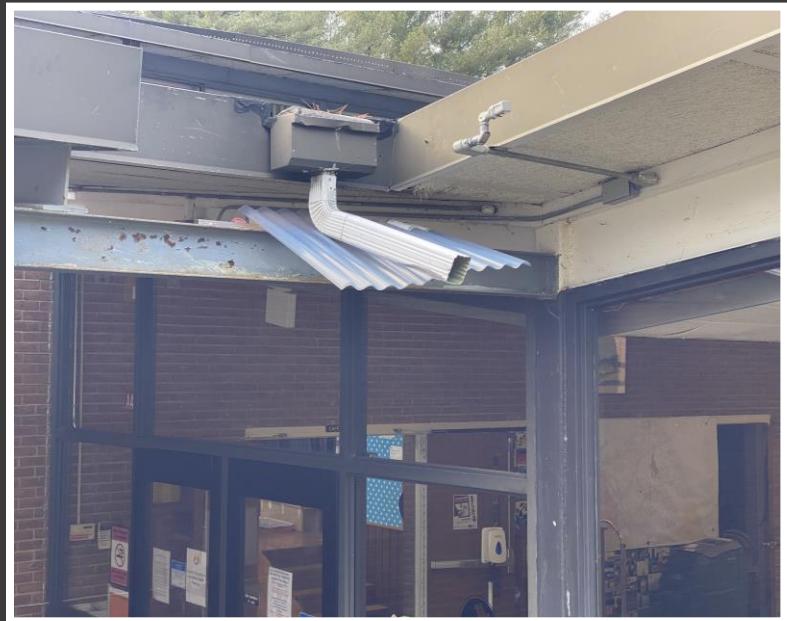
# SITE DRAINAGE

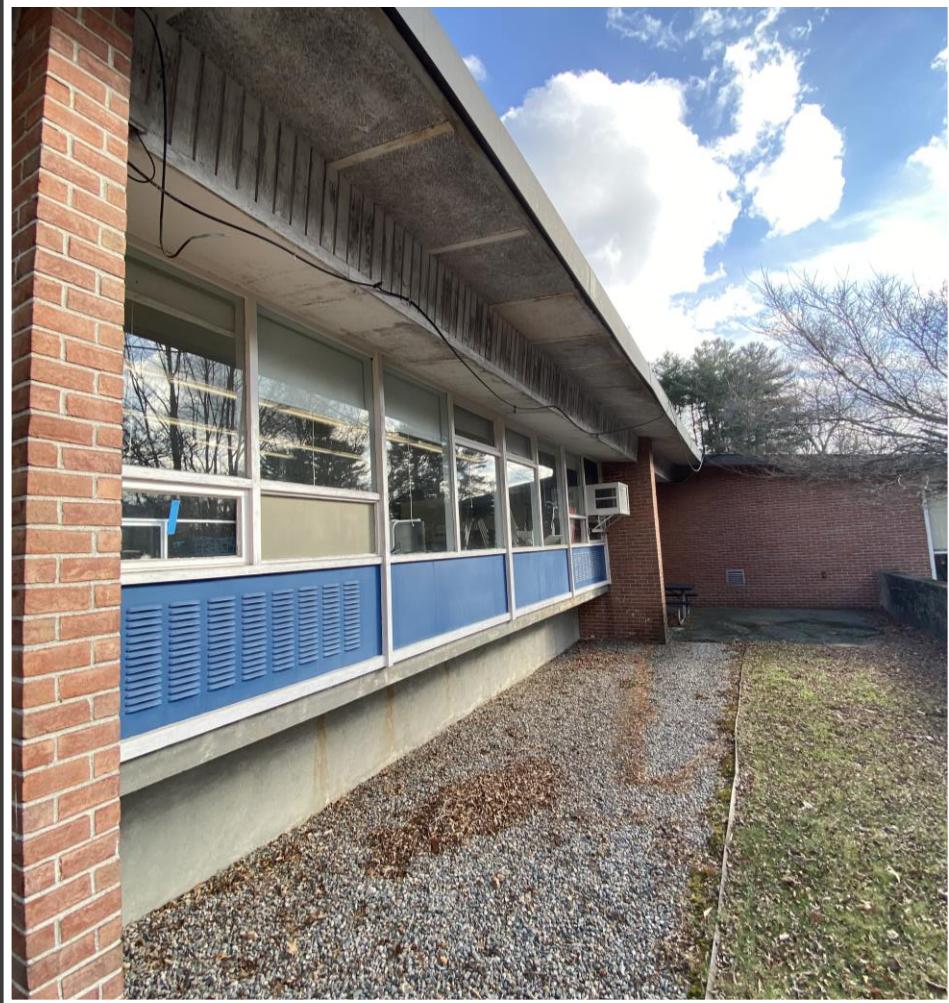
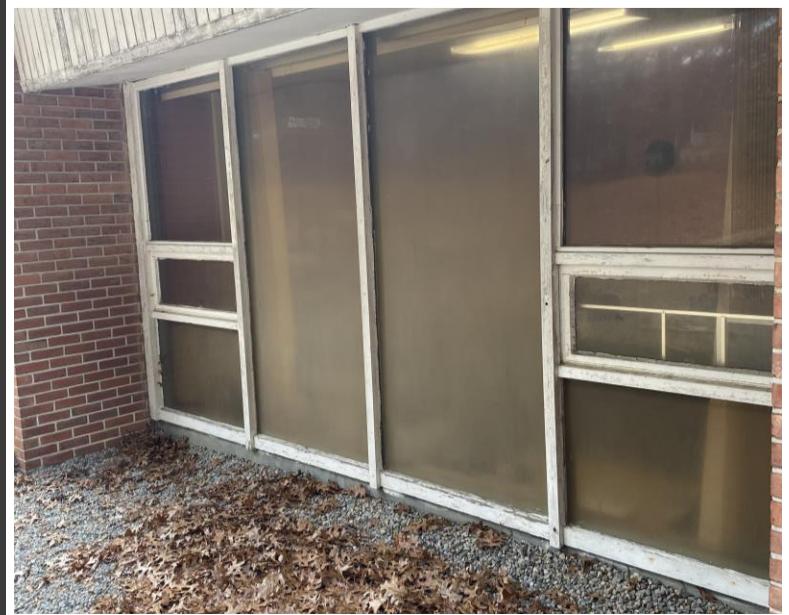
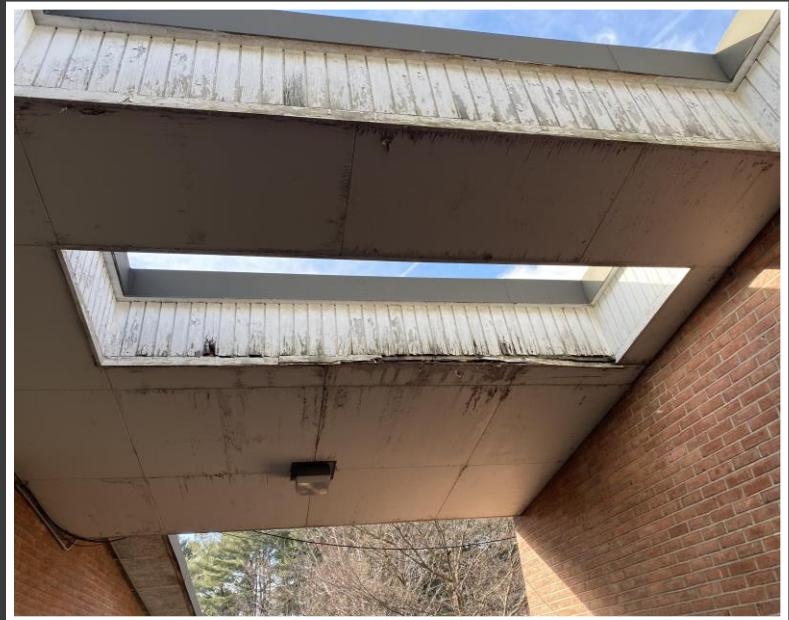
# WOOD FRAMING ON WINDOWS AND STRUCTURE DECAYING
