# SOUTH ELEMENTARY SCHOOL

Photo Tour for Town Meeting  
May 3, 2021

## SOUTH ELEMENTARY SCHOOL

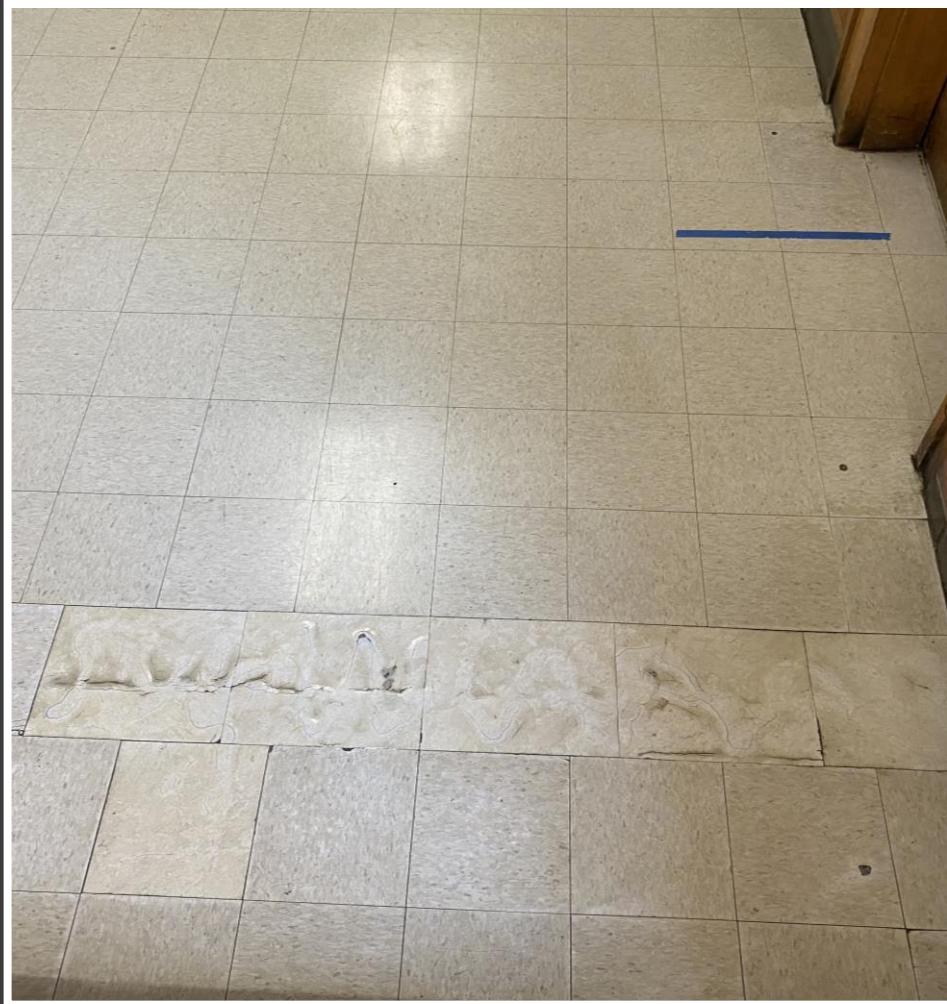
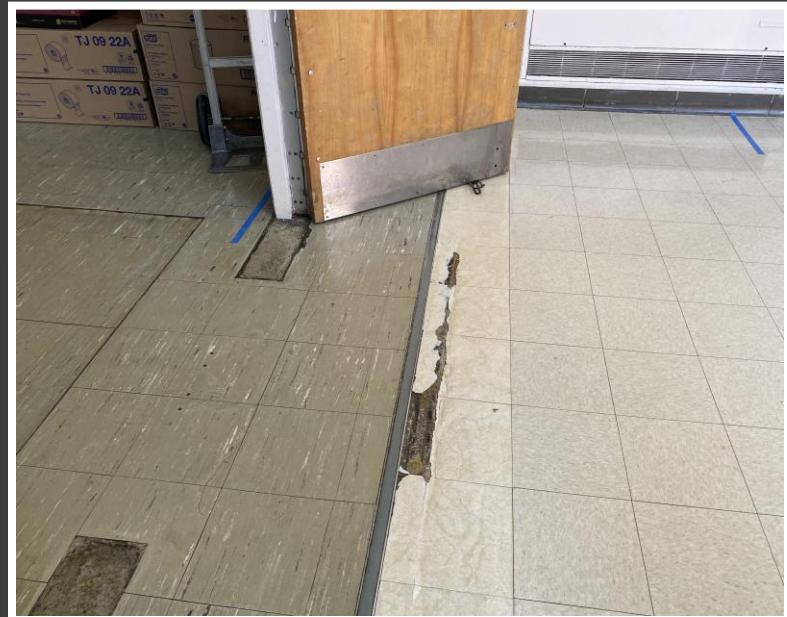
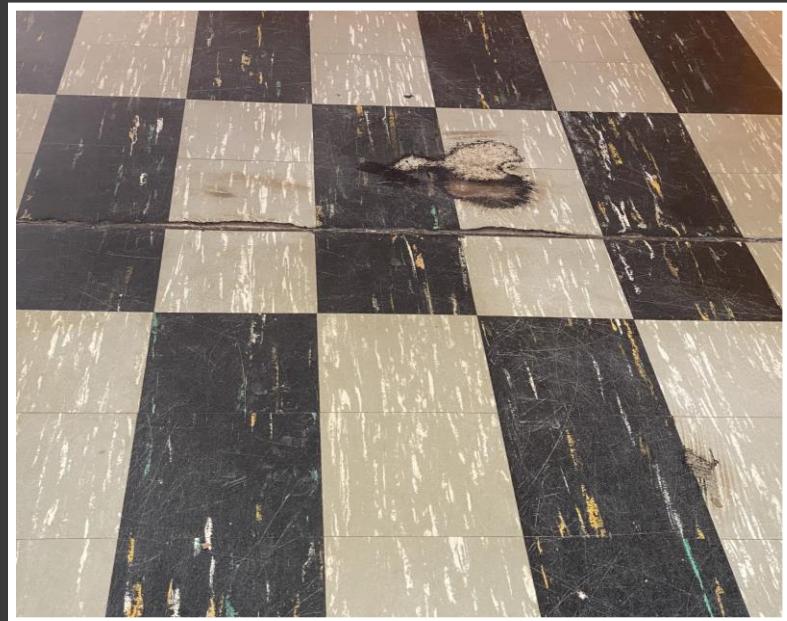
# FLOORING DETERIORATION
