# STOUGHTON DOWNTOWN REDEVELOPMENT PLAN

## Volume III: Existing Conditions Memorandum

## Appendices

Stoughton, Massachusetts April 2015

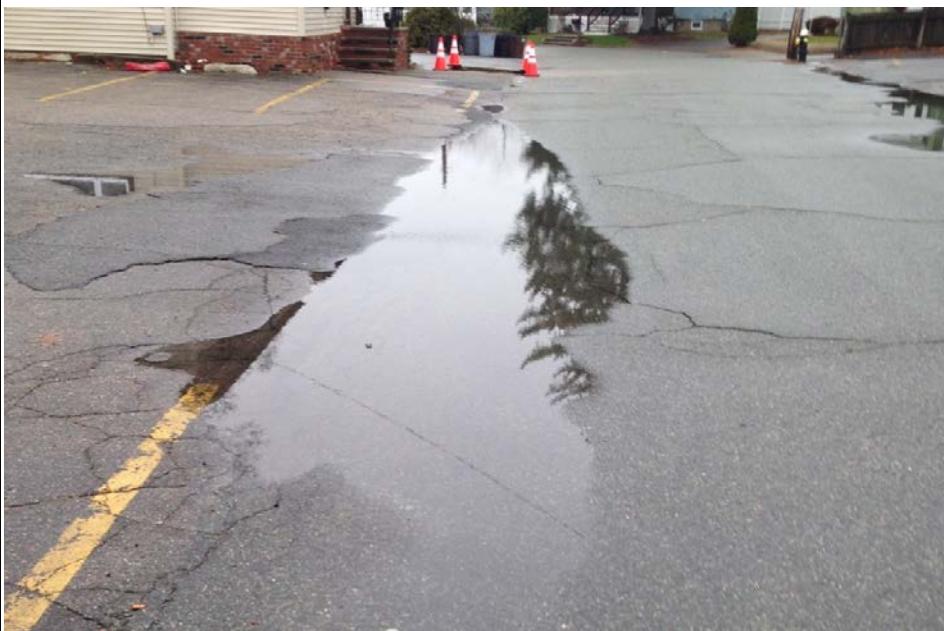
<b><u>Component</u></b>	<b><u>Condition</u></b>	<b><u>Comments</u></b>
Road Surface	Poor	Moderate/severe Cracking on road surface. Alligator cracking
Water Lines	Poor	6" line, no material listed
Sewer Lines	Poor	Unknown material and diameter
Existing Sidewalk	Poor	Rollover sidewalk on North side of street, none on south side
Curbing	Poor	No curbing on either side of street
Drainage	Poor	Severe ponding on both sides of street
Gas Lines	Good	2" CS-HP Installed 1982
Parking Lot:		
Lighting:		
Trees/Landscaping:		
Park/Playground:		
Other:		
<b>Overall Rating:</b>	Poor

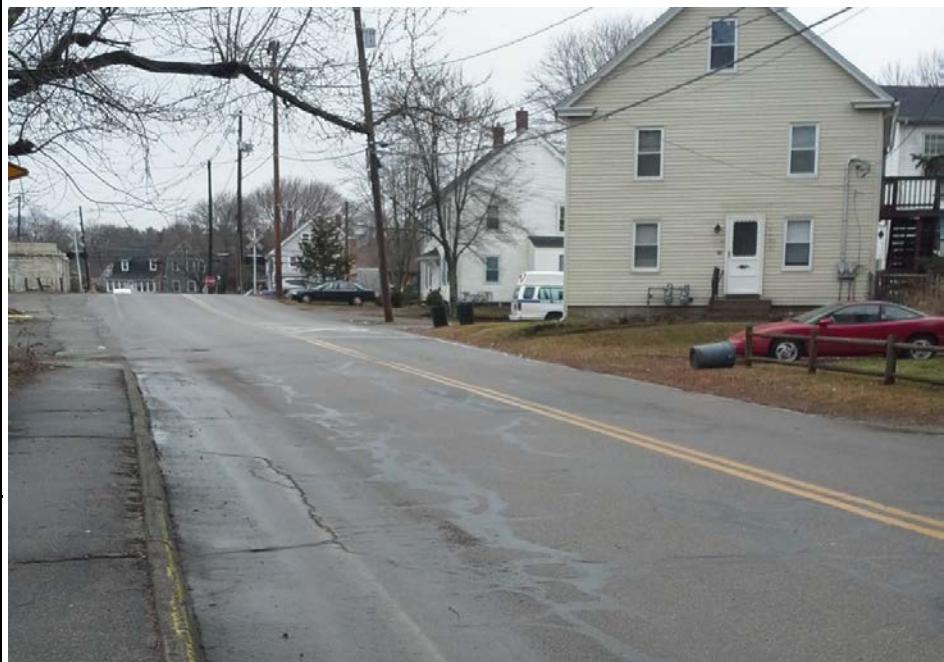
<b>Component</b>	<b>Condition</b>	<b>Comments</b>
Road Surface	Fair	Moderate to heavy cracking in roadway. Edge of roadway broken up in several locations along southerly (uncurbed) side. Some crack sealing has been done.
Water Lines	Poor	6" CI, installed 1922
Sewer Lines	Fair	(only small portion of sewer layer on GIS covers brock street) 8" VC gravity line, installed 1961
Existing Sidewalk	Fair	No sidewalk on northerly side from Washington St to about 200' west of tracks. Then HMA sidewalk along northerly side extending to the west. No sidewalk on the southerly side.
Curbing	Fair	Type II HMA curb adjacent to sidewalk on the northerly side. No curbing on the southerly side.
Drainage	Fair	No ponding observed in the gutter on the sidewalk side. Several areas of ponding observed in the shoulder along the southerly (uncurbed) side. Catch basins have older castings.
Gas Lines	Good	6" P-HP Installed 2004

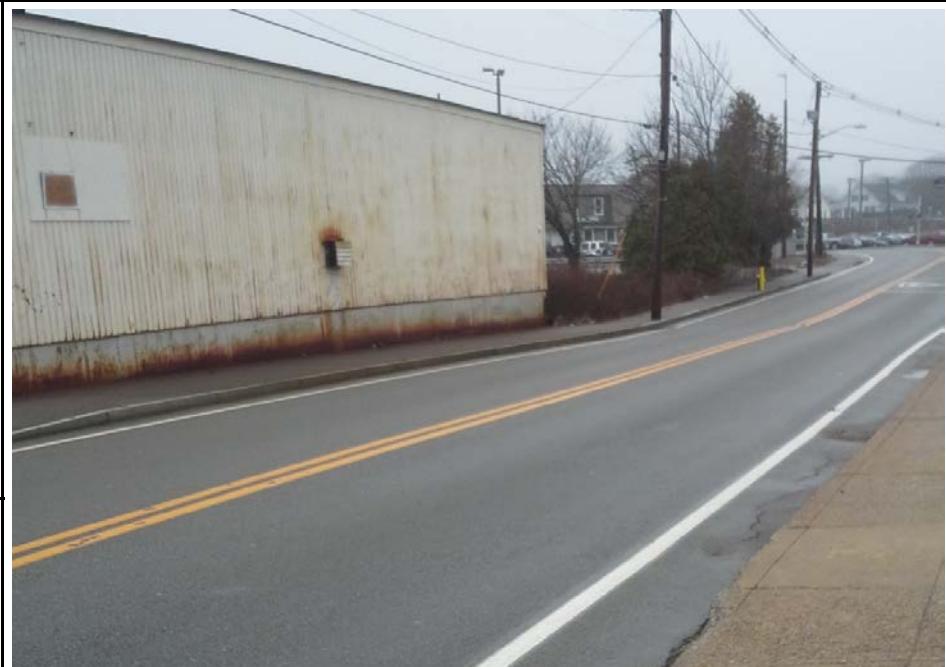
<b>Component</b>	<b>Condition</b>	<b>Comments</b>
Road Surface	Good	Light cracking in lane. Light to moderate cracking in shoulder. No crack sealing has been done.
Water Lines	Good	12" CICL, installed 2001
Sewer Lines	Poor	8" VC gravity line, installed 1937
Existing Sidewalk	Fair	Monolithic concrete sidewalk on the southerly side. Drives and WCRs do not comply with current accessibility standards. HMA on northerly side in generally good condition.
Curbing	Good	Monolithic concrete on southerly side with relatively low (4" +/-) reveal. Granite curb, type VB, in good condition on northerly side.
Drainage	Fair	Some low spots in the gutter. Most catch basins have older castings. Observed one catch basin full of water to the rim.
Gas Lines	Good	6" P-HP installed 2006
Parking Lot:		
Lighting:		
Trees/Landscaping:		
Park/Playground:		
Other:		
<b>Overall Rating:</b>	Fair

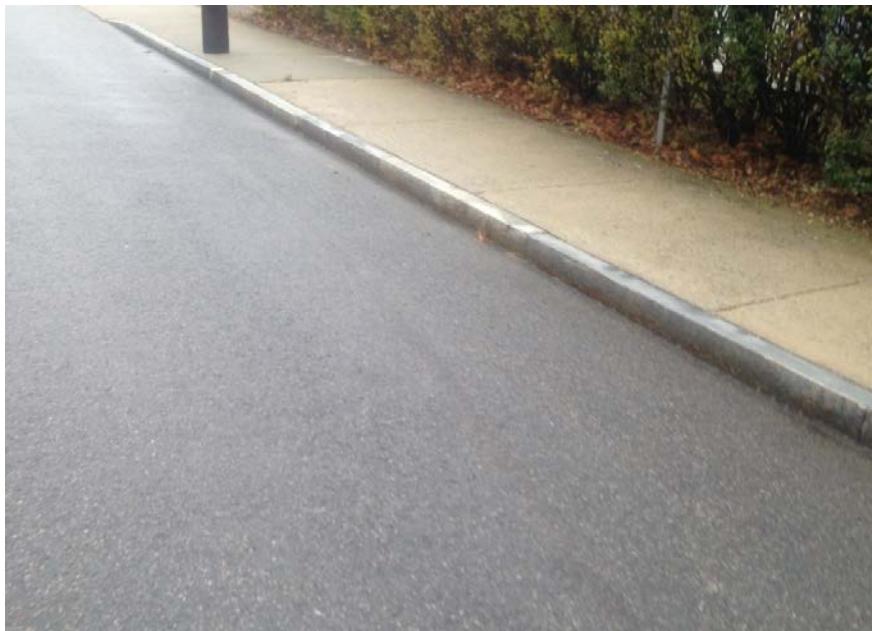
<u>Component</u>	<u>Condition</u>	<u>Comments</u>
Road Surface	Excellent	Newly paved road in excellent condition
Water Lines	Poor	6" CI, installed 1922
Sewer Lines	Poor	8" VC gravity line, installed 1937
Existing Sidewalk	Good	Both sides concrete in great condition
Curbing	Good	Granit VB curb on west side of street, monolitic curb on east side, both in good condition, maybe some accessibility issues
Drainage	Good	no ponding areas seen on street
Gas Lines	Good	3" BS-HP Installed 1916
Parking Lot:		
Lighting:		
Trees/Landscaping:		
Park/Playground:		
Other:		
<b>Overall Rating:</b>	Good

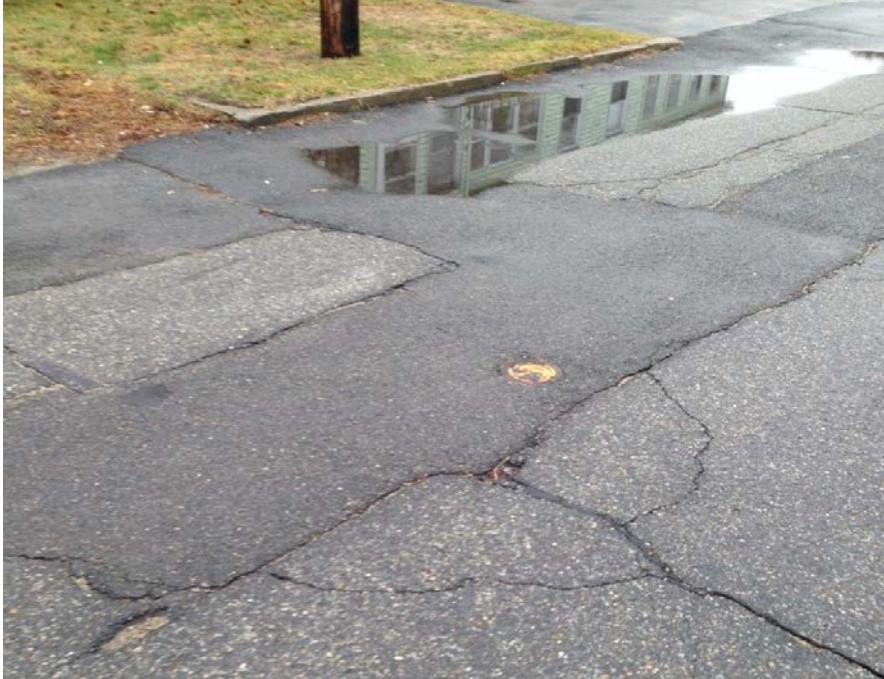
<table><tr> <th><b>Component</b></th> <th><b>Condition</b></th> <th><b>Comments</b></th> </tr><tr> <td>Road Surface</td> <td>Poor</td> <td>Severe cracking and patching along road surface</td> </tr></table>

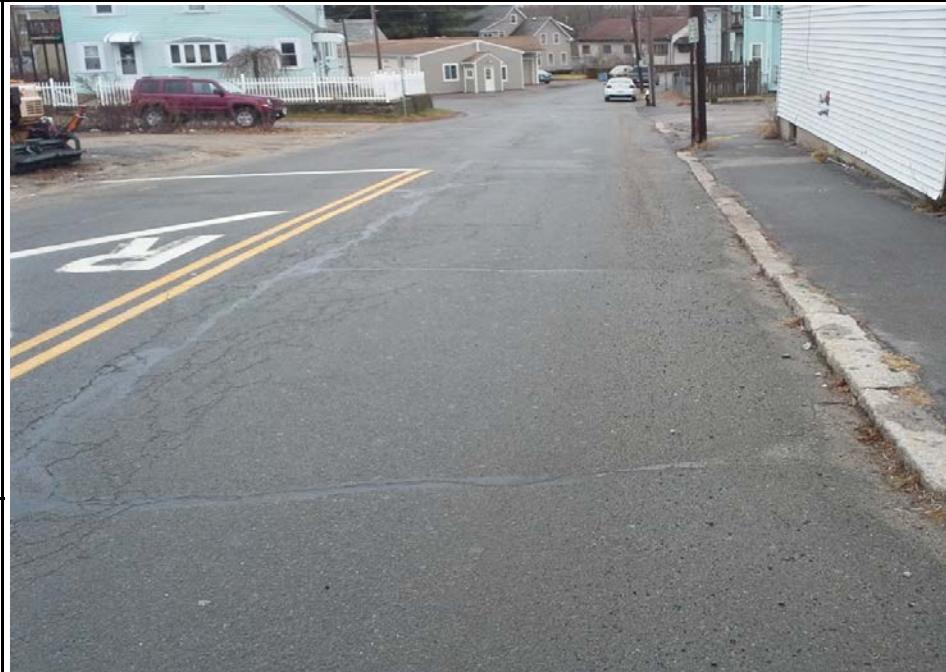
<b>Component</b>	<b>Condition</b>	<b>Comments</b>
Road Surface	Poor	Moderate alligator cracking with some settlement within the travel lane.
Water Lines	Poor	8" CI, installed 1922 - 16", unknown material and year
Sewer Lines	Poor	10" VC gravity line, unknown installation
Existing Sidewalk	Fair	HMA sidewalk on northerly side.
Curbing	Poor	Granite curb, type VA-1, with low reveal on northerly side. No curbing on southerly side.
Drainage	Fair	No ponding observed. Some washout of shoulder on southerly side.
Gas Lines	Good	3" BS-HP Installed 1915, 1916, 4" P-HP Installed 2013
Parking Lot:		
Lighting:		
Trees/Landscaping:		
Park/Playground:		
Other:		
<b>Overall Rating:</b>	Poor
