ILLICIT DISCHARGE DETECTION AND ELIMINATION (IDDE) PLAN

Town of Stoughton

September 2023

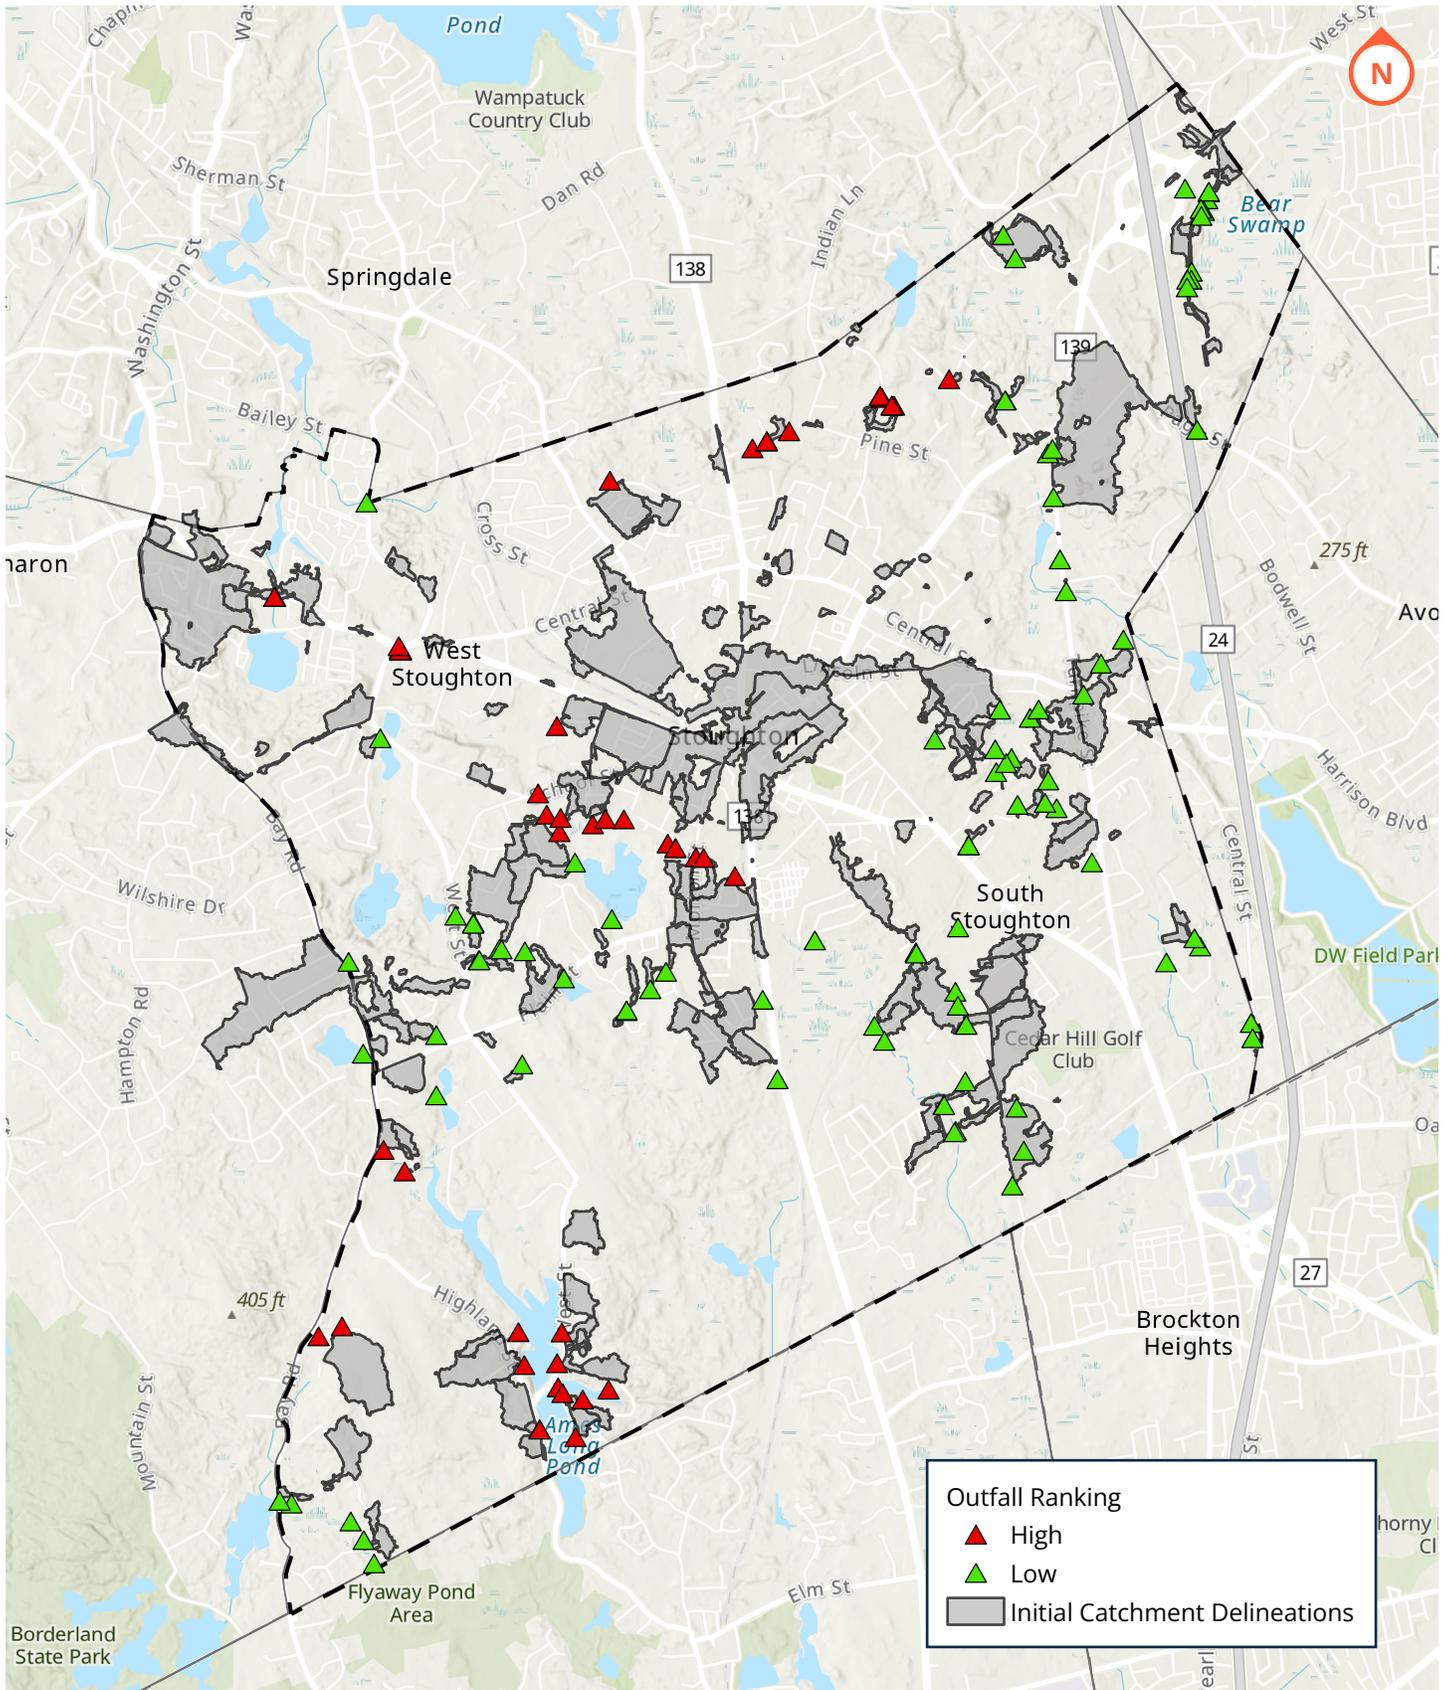
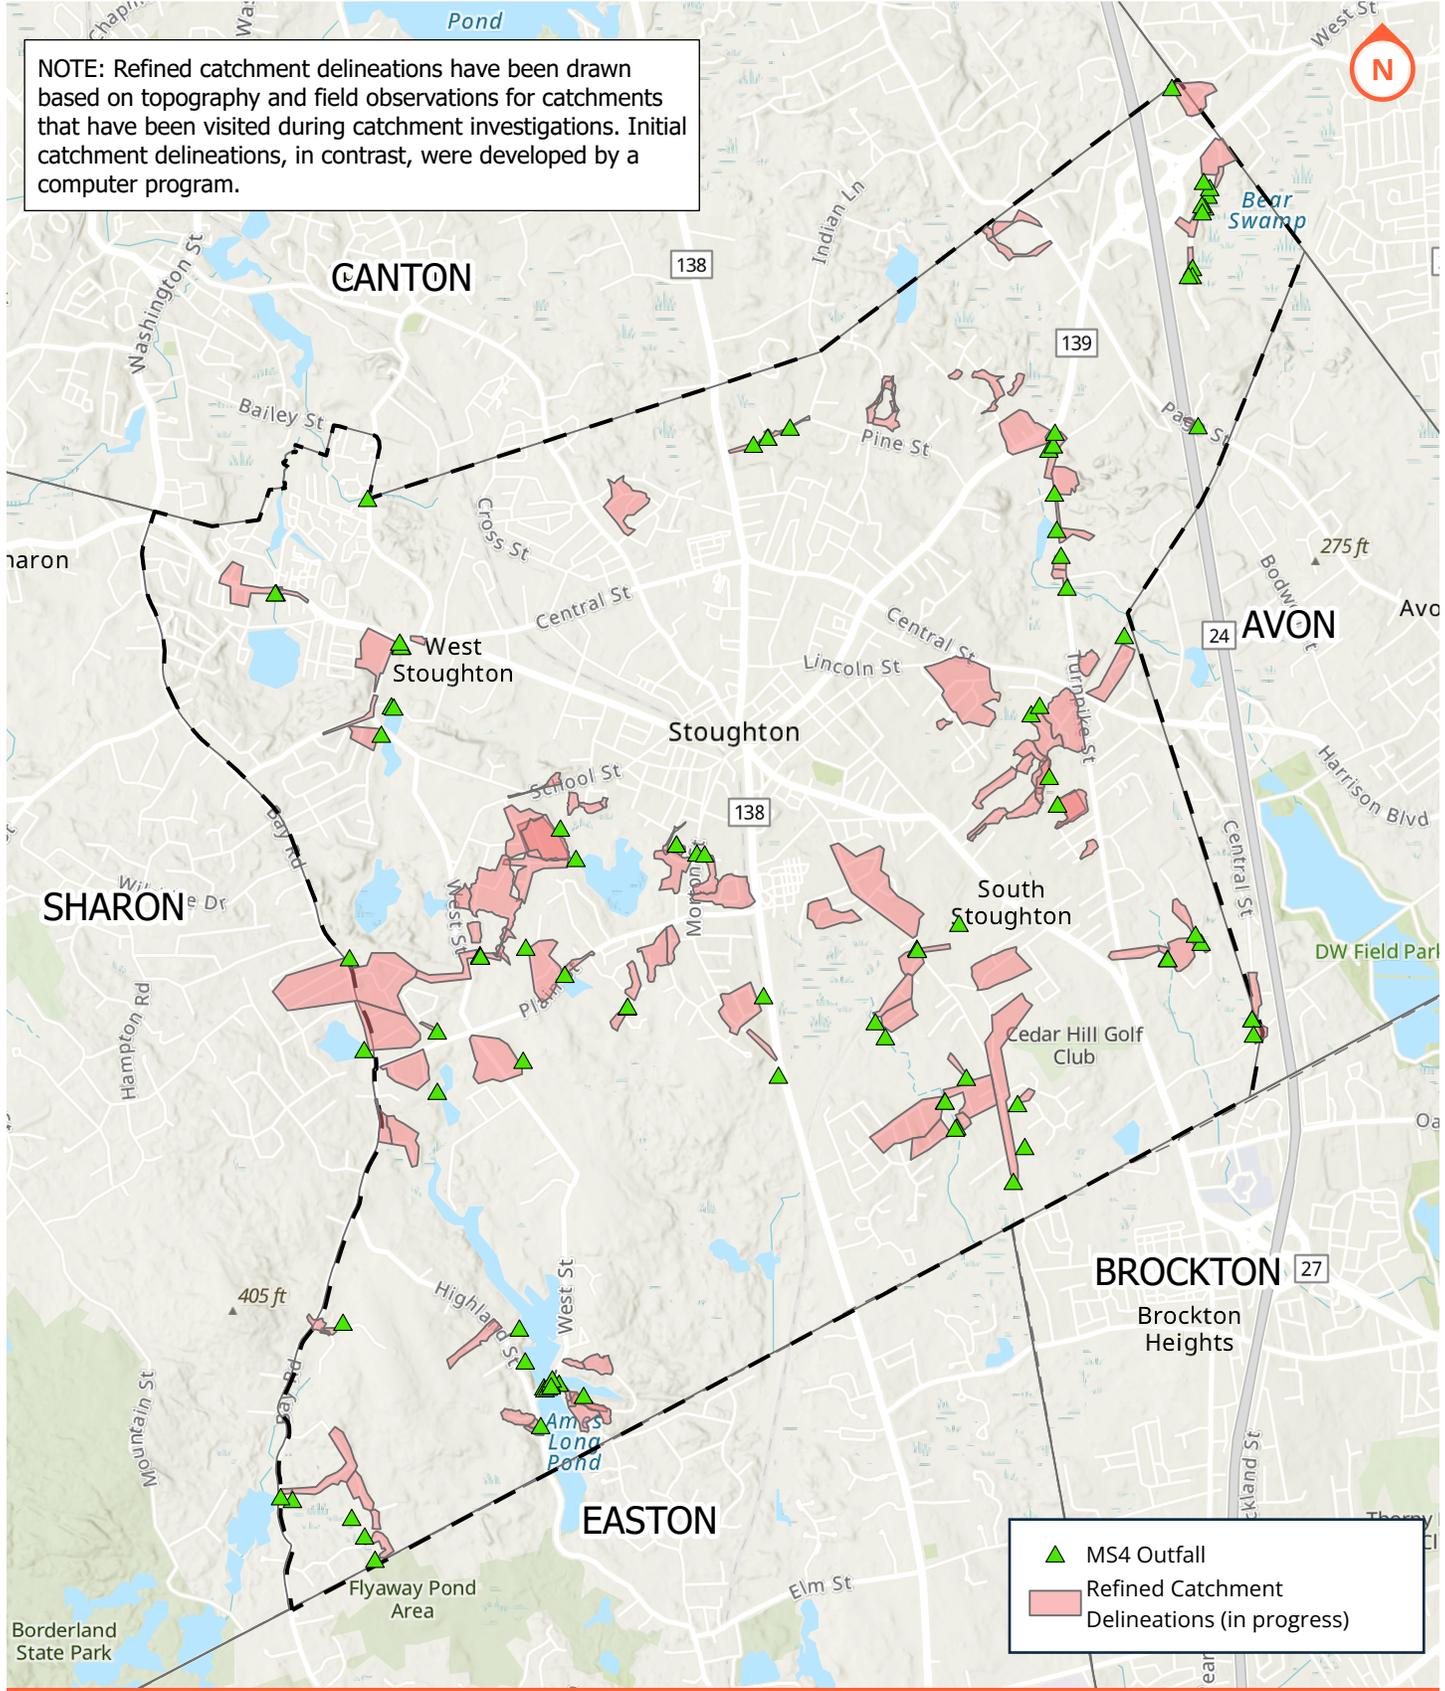
Appendix C
Catchment Ranking
 Stoughton, Massachusetts

NOTE: Refined catchment delineations have been drawn based on topography and field observations for catchments that have been visited during catchment investigations. Initial catchment delineations, in contrast, were developed by a computer program.

- ▲ MS4 Outfall
- Refined Catchment Delineations (in progress)

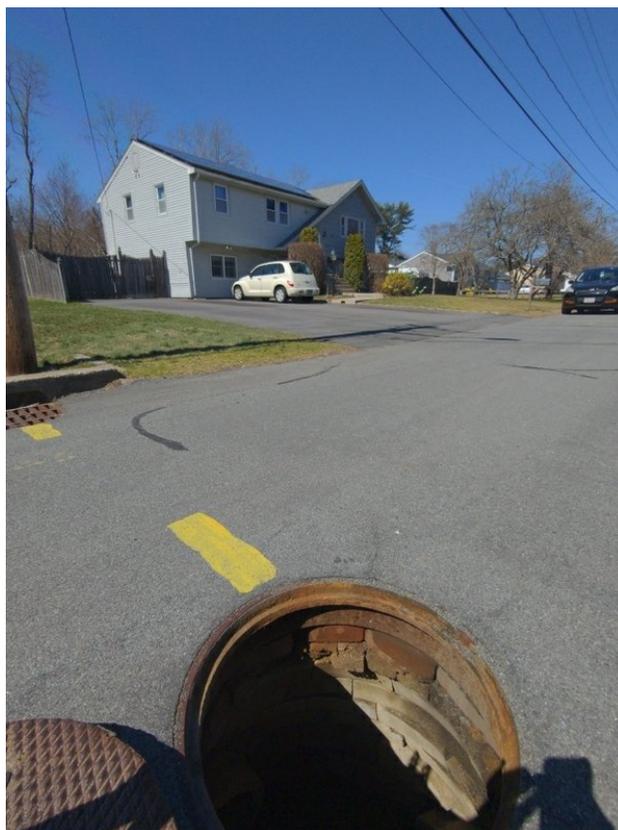
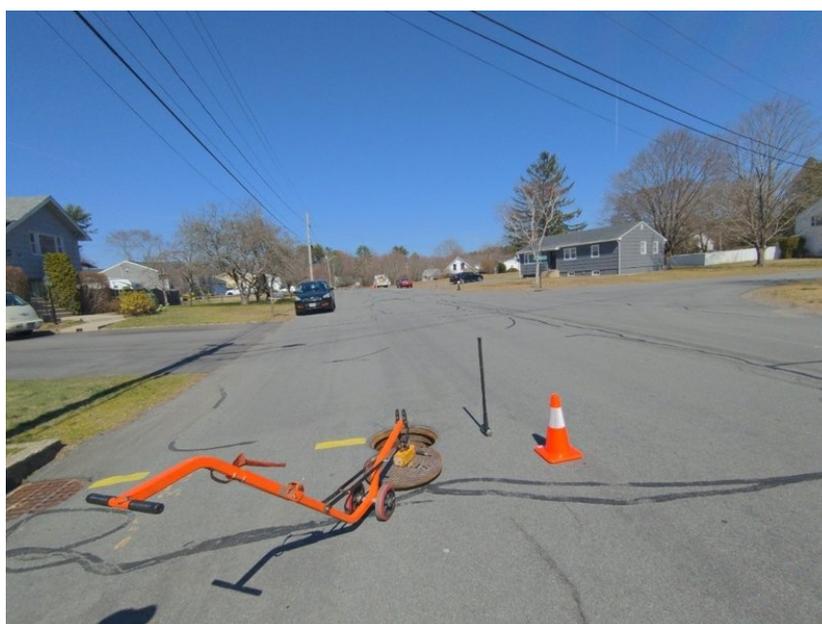
Surface Photos

Floatables	No
Odor	No
General Notes	Manhole cover says SEWER

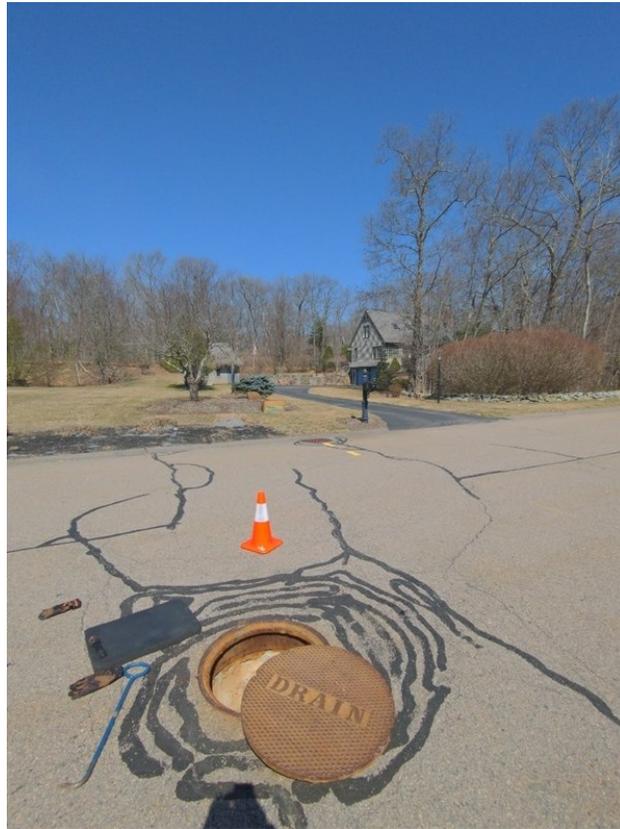
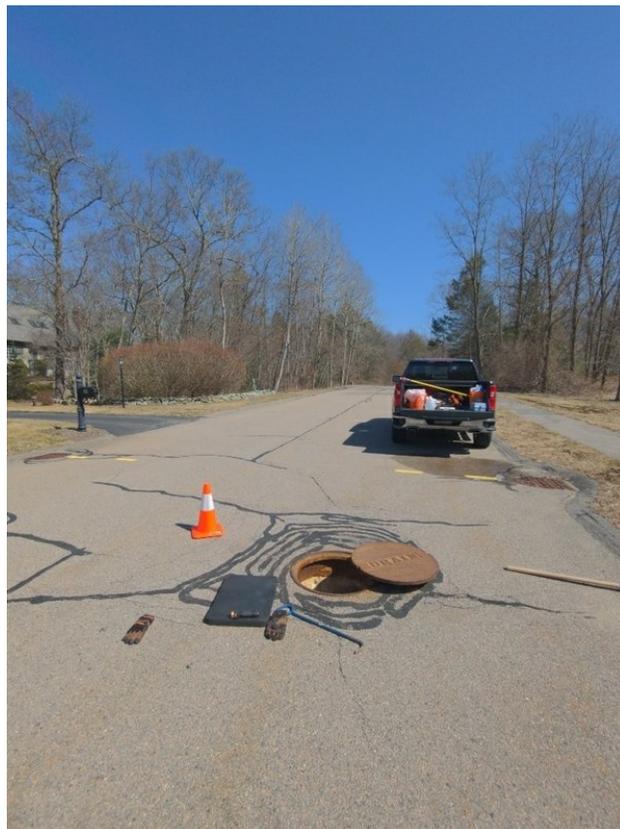
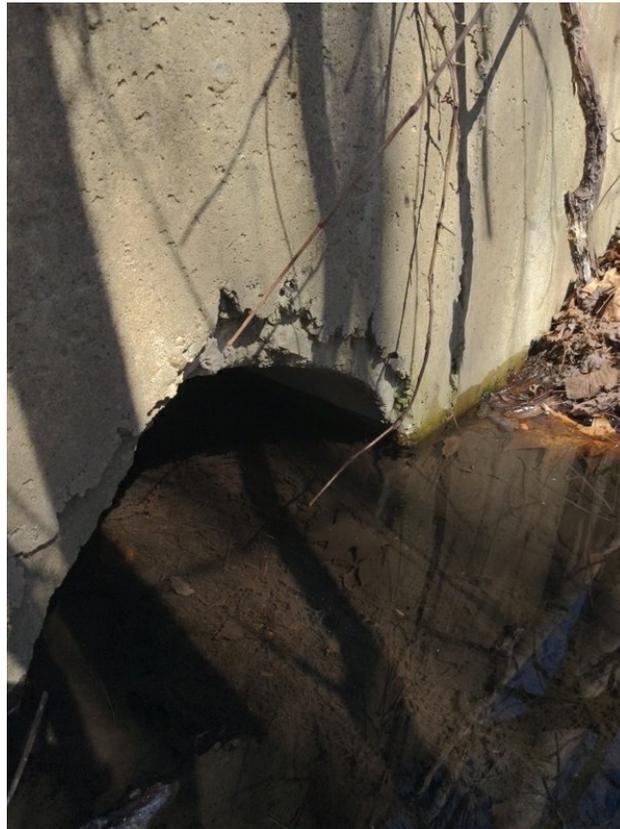
Surface Photos

Pipes Submerged	Partially
Submerged Pipes	3:00 and 6:00
Flow Present	Yes
Flow Description	Trickle
Flow Source	3:00 pipe
Structure Notes	Chimney needs repair

Temperature	53.6
pH	6.84
Specific Conductivity (SPC)	227
Surfactants	0.25
Chlorine	0.1
Ammonia	0
Sampling Notes	Sampled upstream drain manhole SWMH-547 3:00 incoming pipe

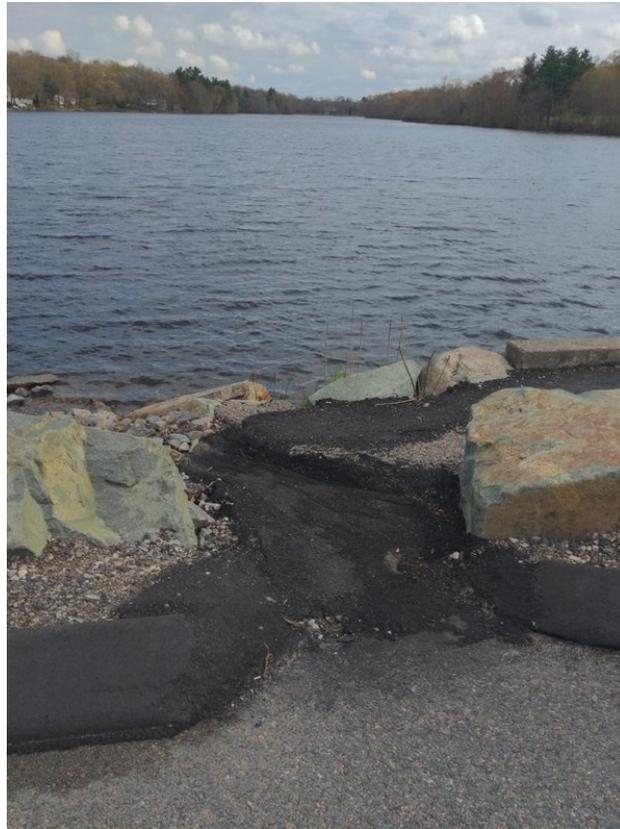
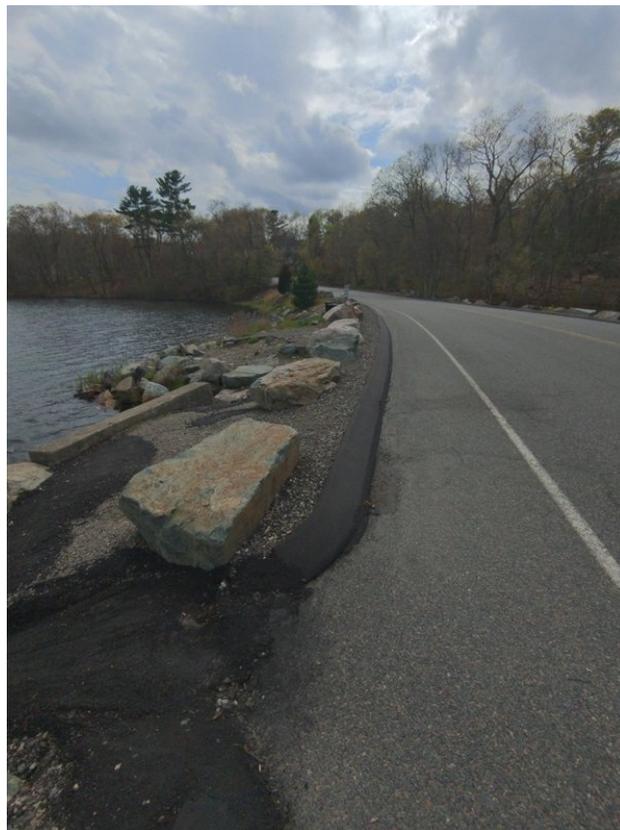
Surface Photos

Maintenance Required	No
Manhole Invert (inches)	0
Pipes Submerged	No
Flow Present	No
Structure Notes	Scupper; some debris found at the end of scupper

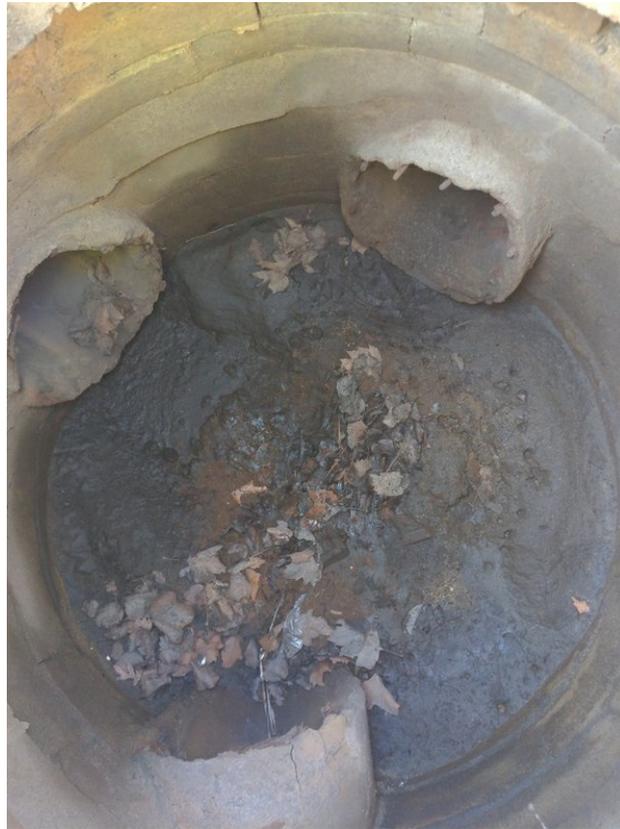
Interior Photos

Temperature	59.9
pH	6.45
Specific Conductivity (SPC)	744
Surfactants	0.5
Chlorine	0.9
Ammonia	0
General Notes	Revisited catchment that was investigated last year to re-sample and found same large chlorine hit. Also, upstream manhole was dry, indicating that flow is entering system between 2 manholes. Same results as last year

Maintenance Required	Yes
Maintenance Needs	Deposits observed, cleaning recommended.
Manhole Invert (inches)	56

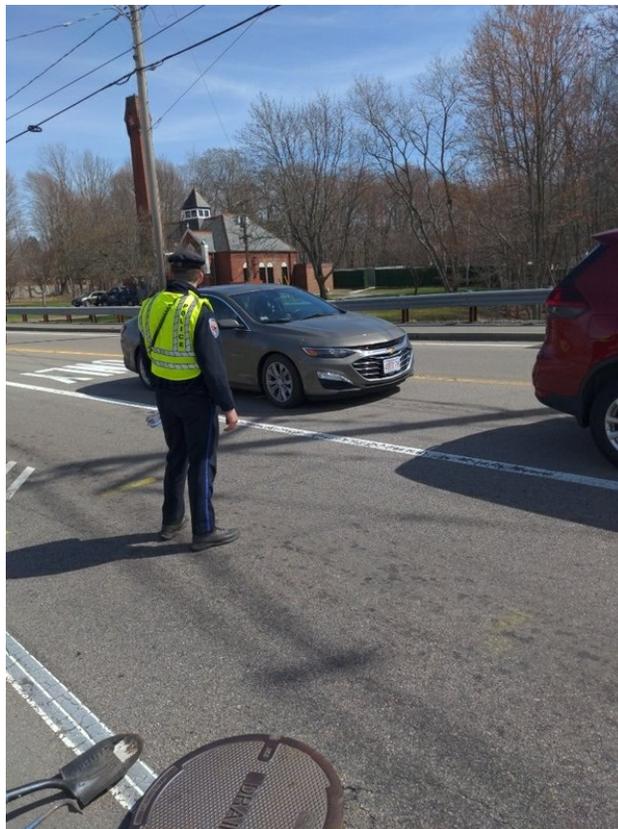
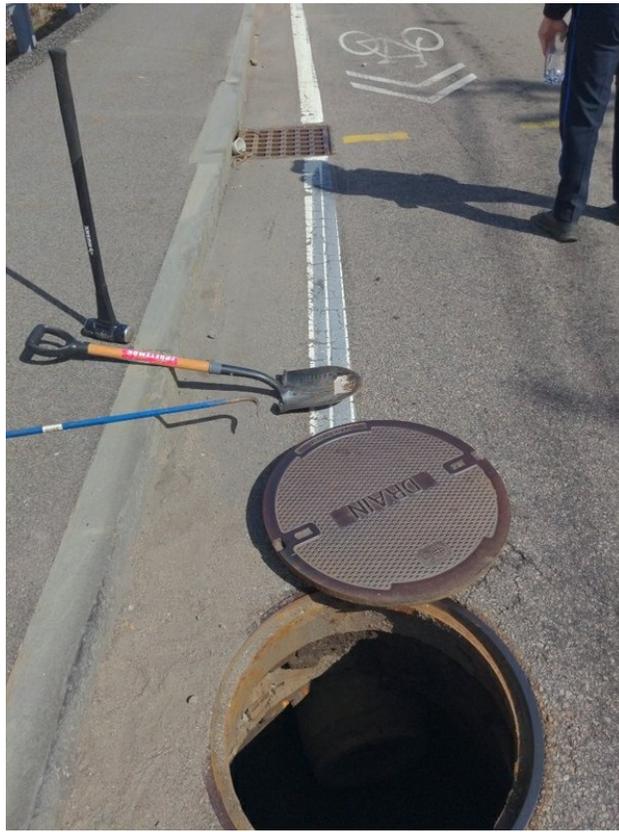
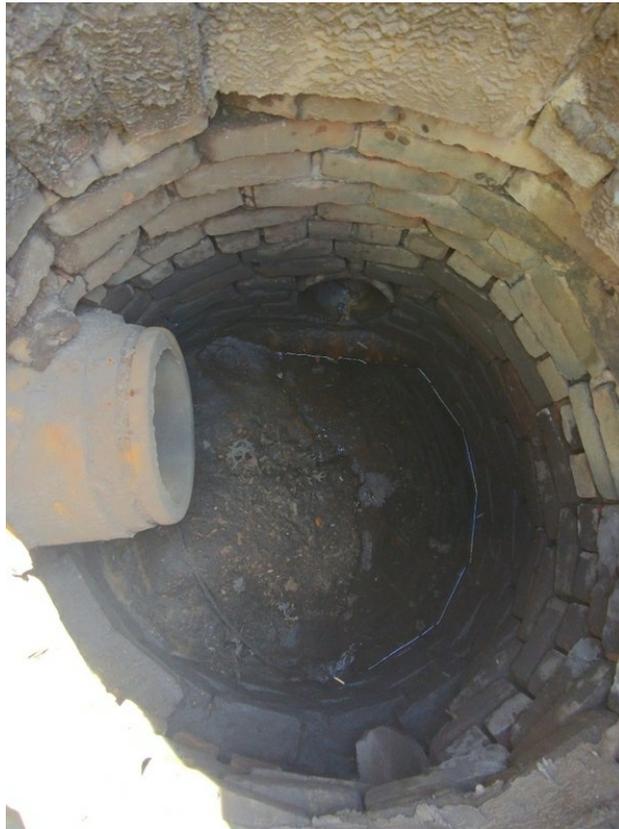
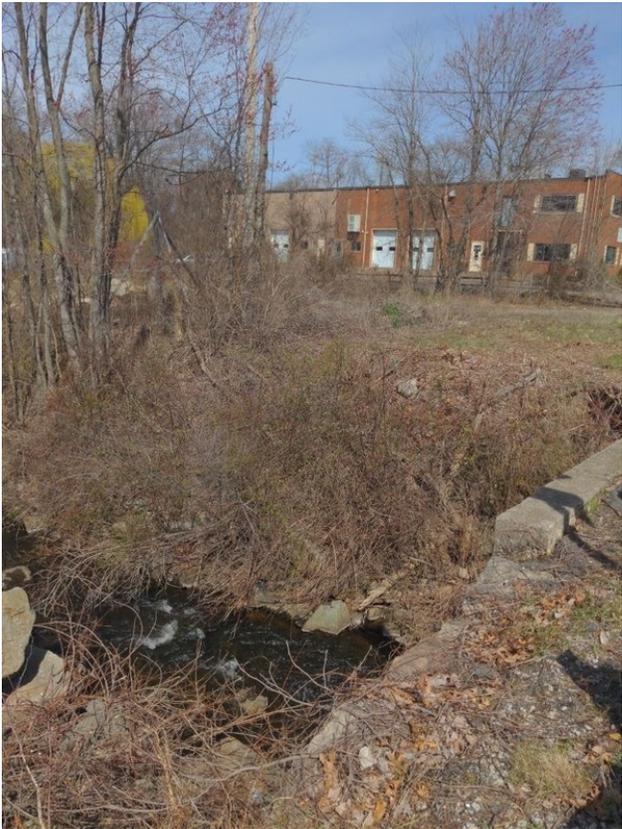
Surface Photos

Maintenance Required	Yes
Maintenance Needs	Clean sediment found at the bottom of structure
Manhole Invert (inches)	56

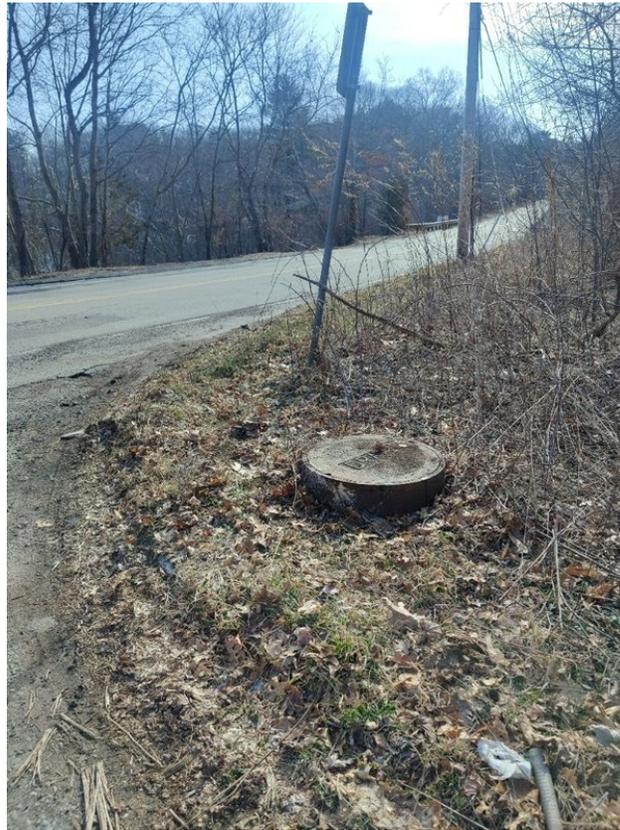
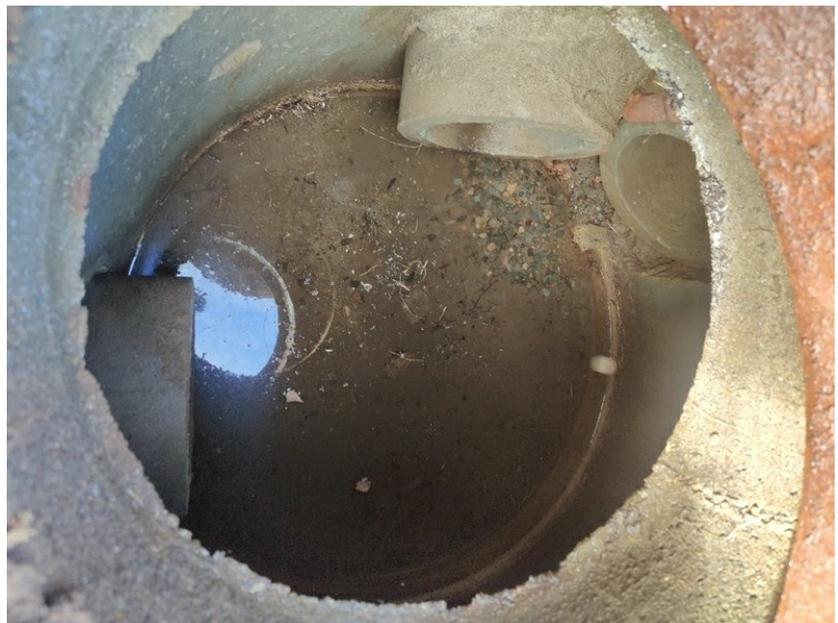
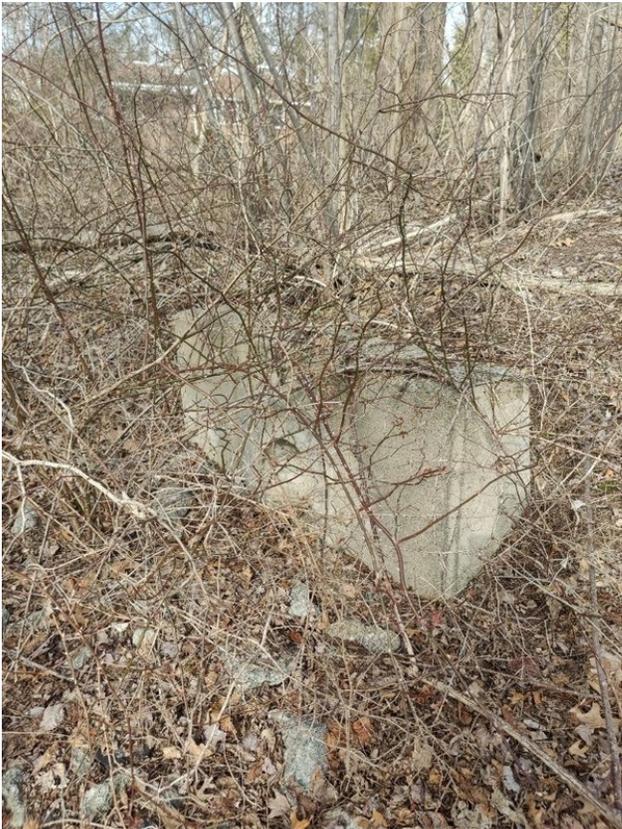
OF-478, SWMH-1061

Outfall is covered in vegetation. It appears to not receive a lot of flow. The 2 upstream catch basins were not visible and likely are clogged

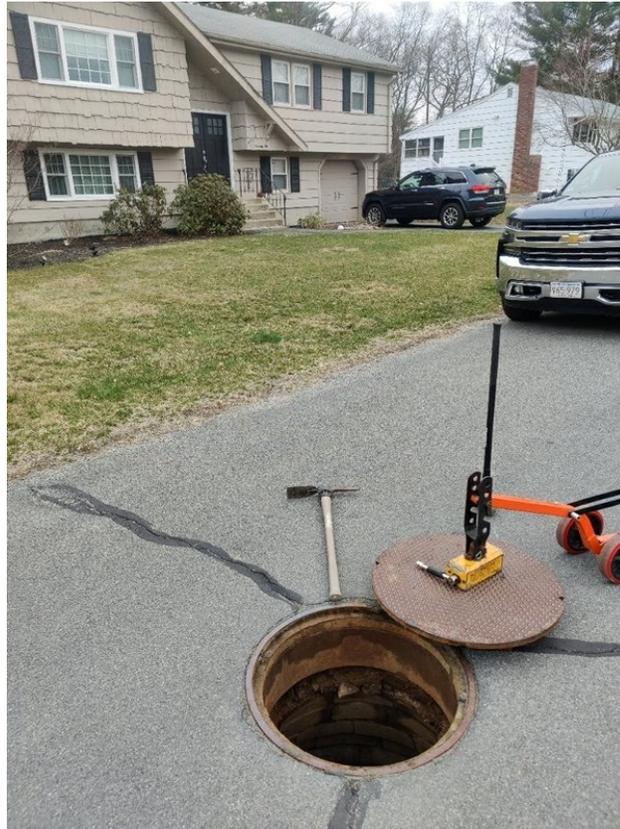
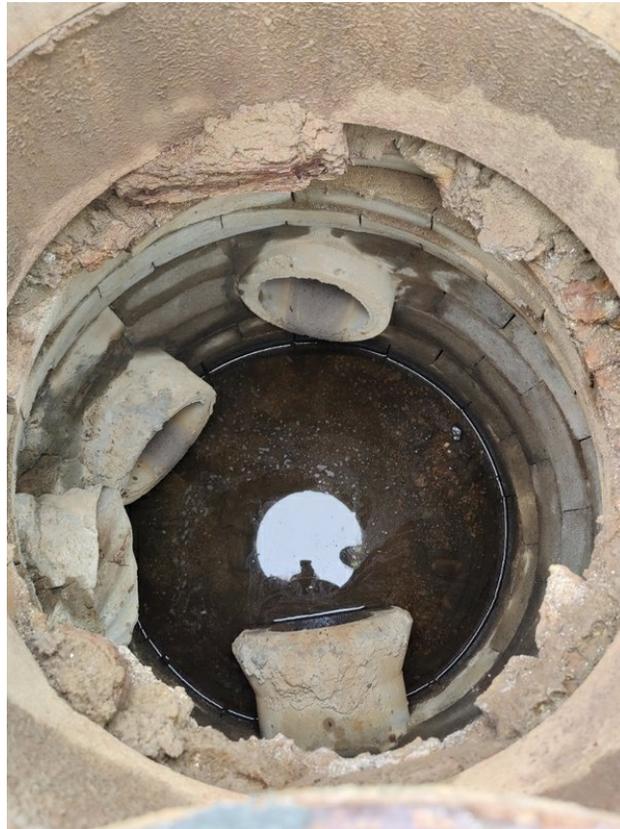
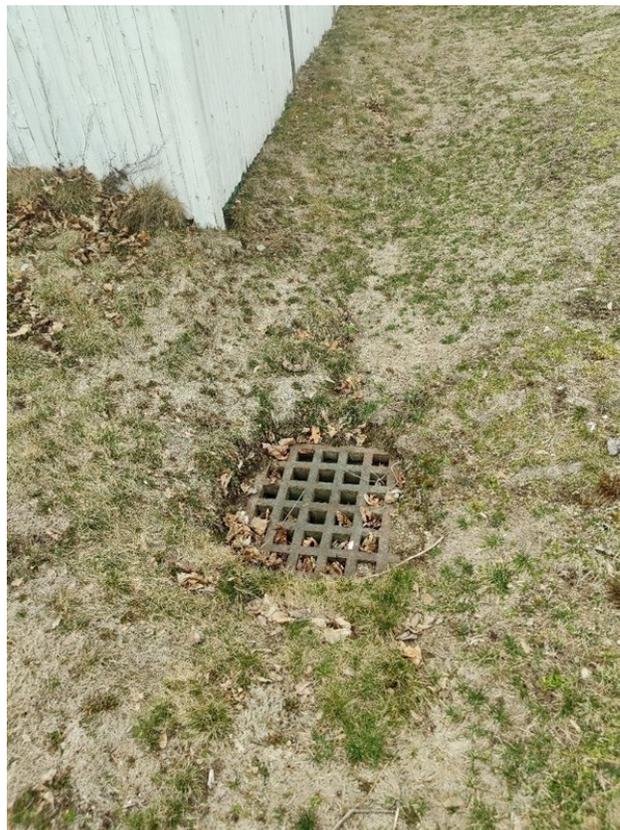
OF-464, SWMH-67

new CB on 69 Macarthur

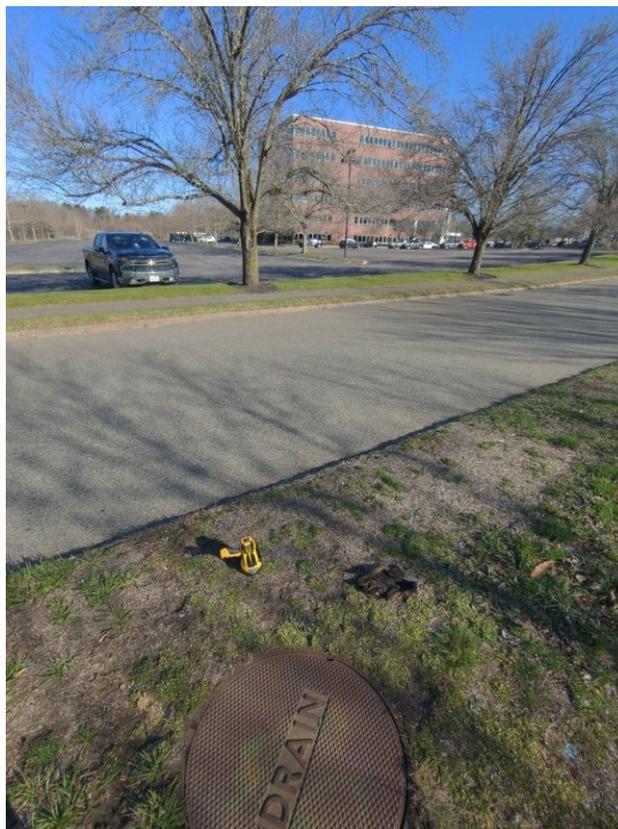
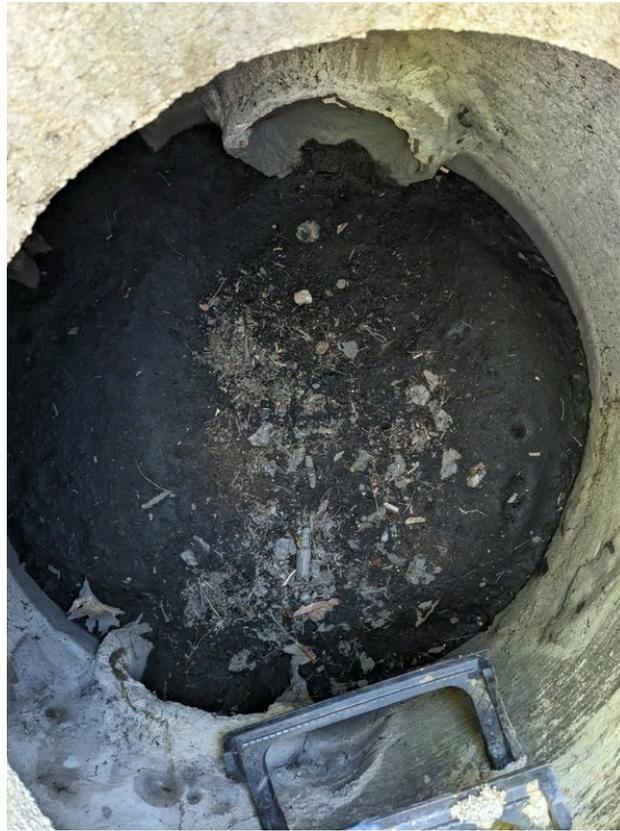
OF-331, SWMH-2033

Floatables	No
Odor	No
General Notes	Verify with Town who owns BMP in parking lot. SWMH located in island, across the street from parking lot, appears to connect to BMP.

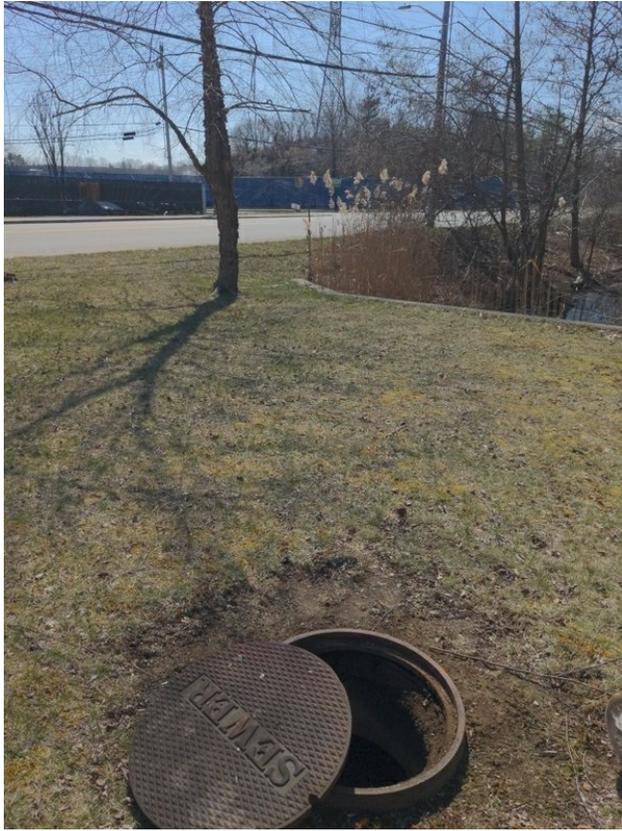
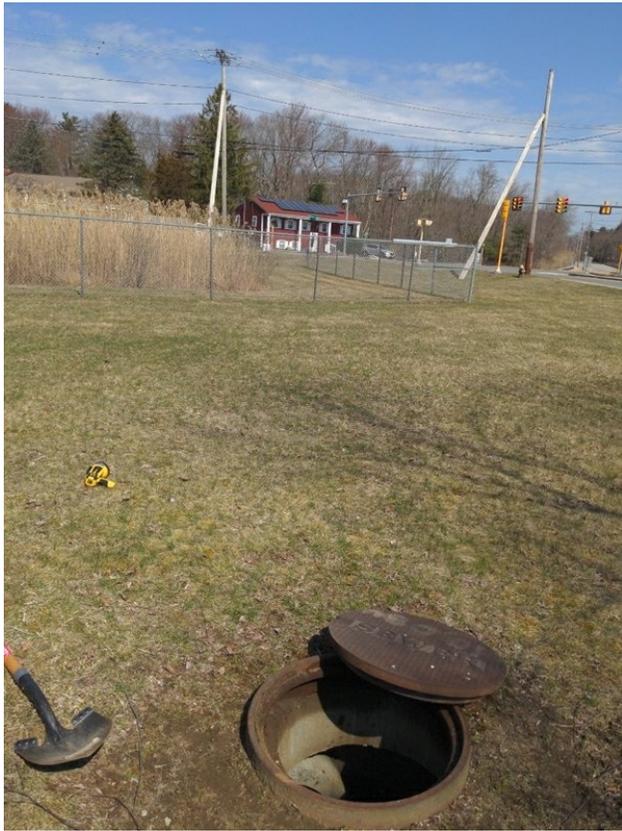
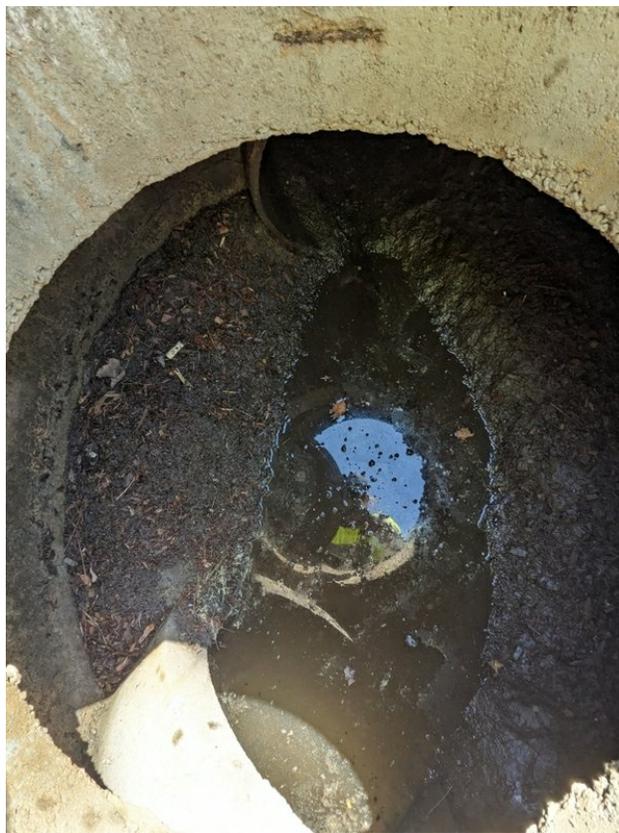
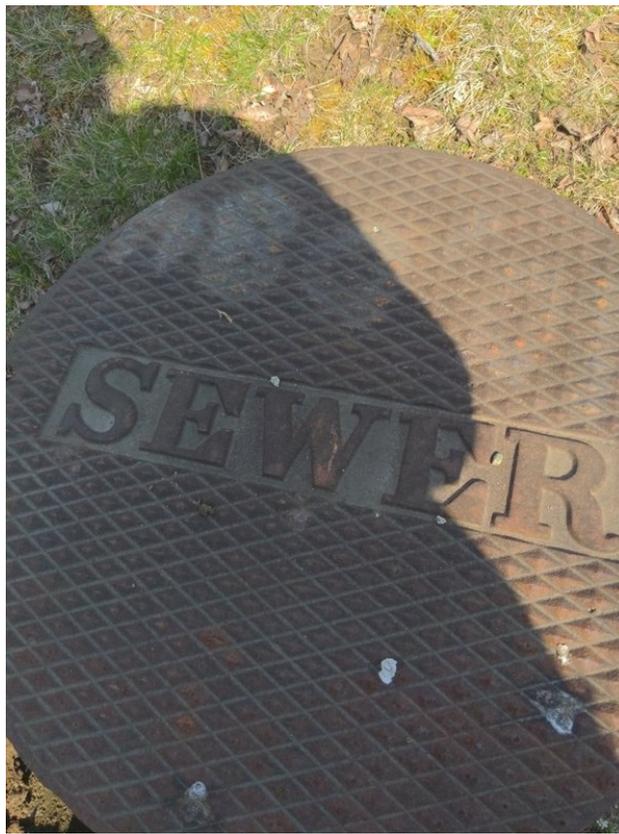
Floatables	No
Odor	No
General Notes	Manhole cover says SEWER
Surface Photos

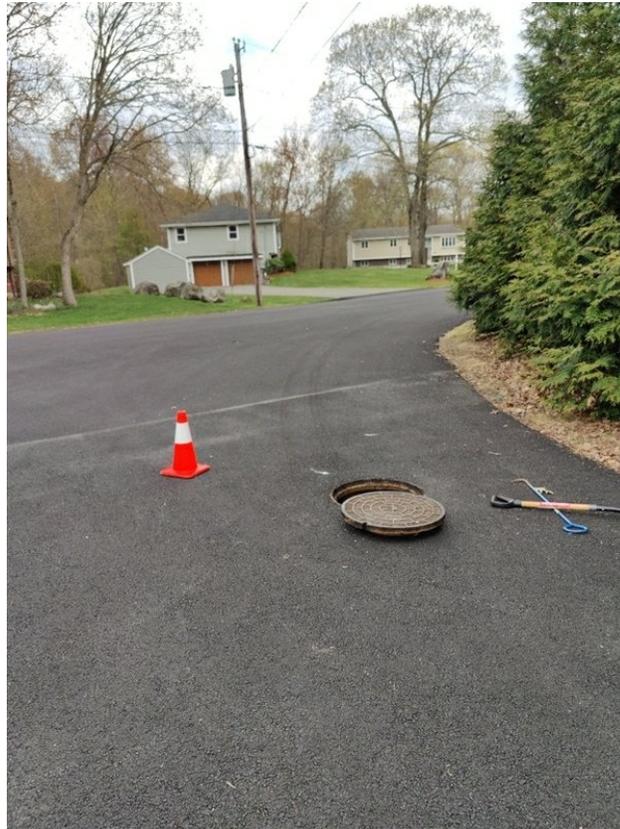
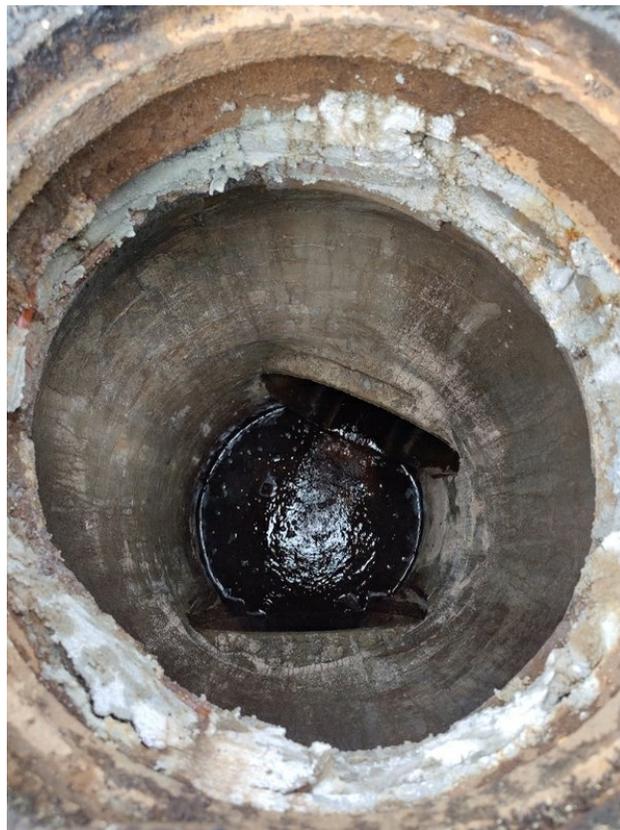
OF-458, SWMH-1721

Temperature	58.3
pH	6.28
Specific Conductivity (SPC)	319
Surfactants	0.25
Chlorine	0.07
Ammonia	0
General Notes	Revisited catchment to re-sample structure with hit last year.

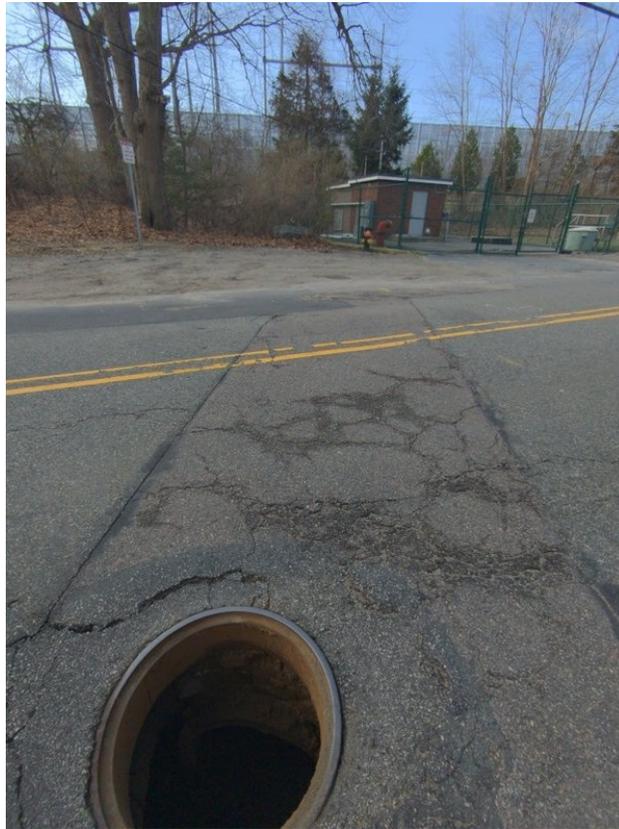
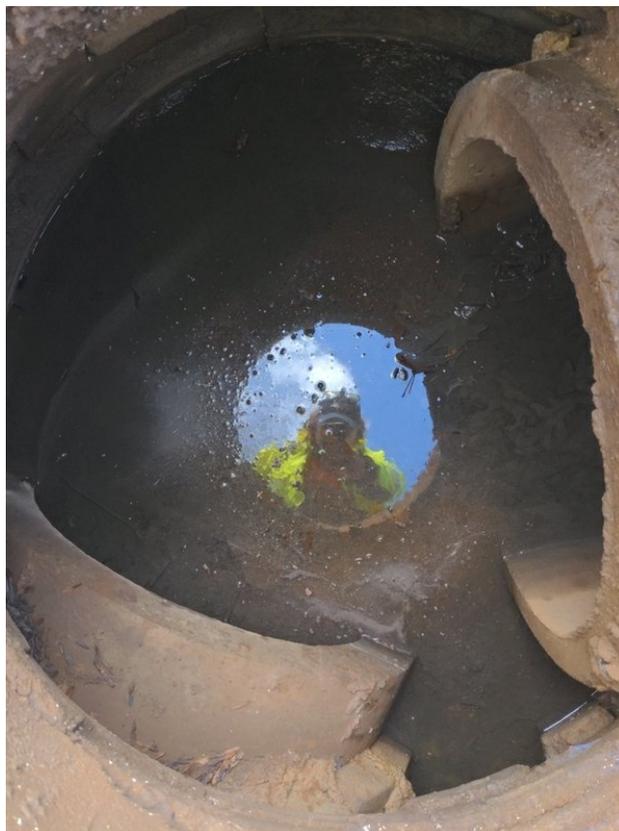
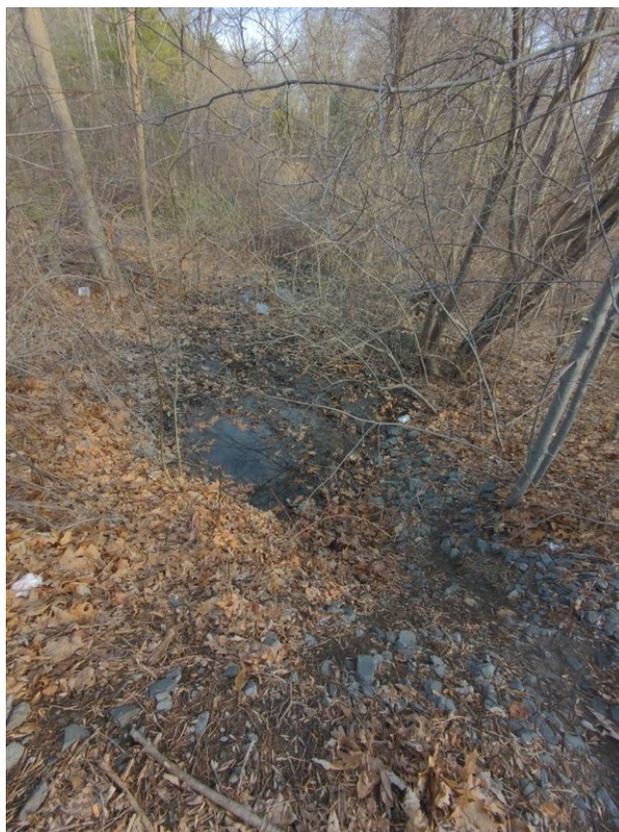
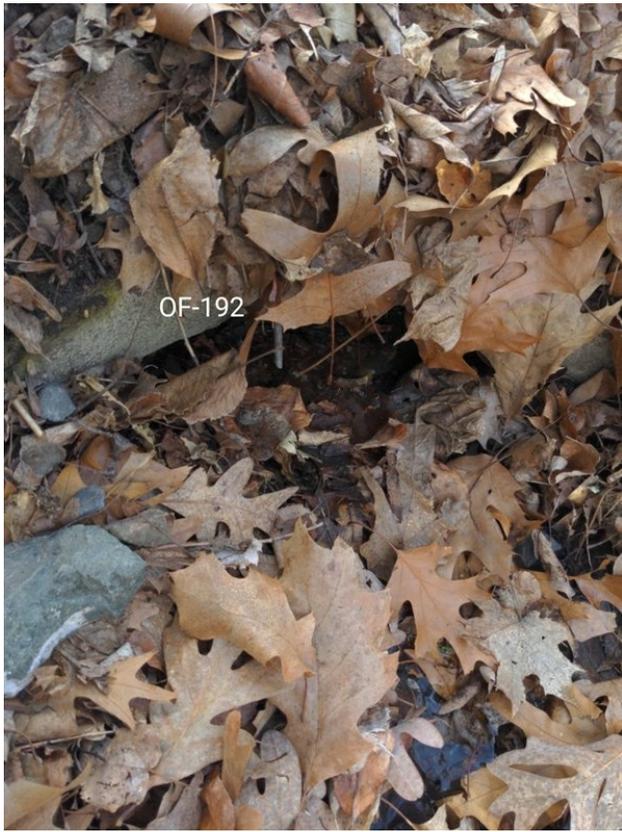
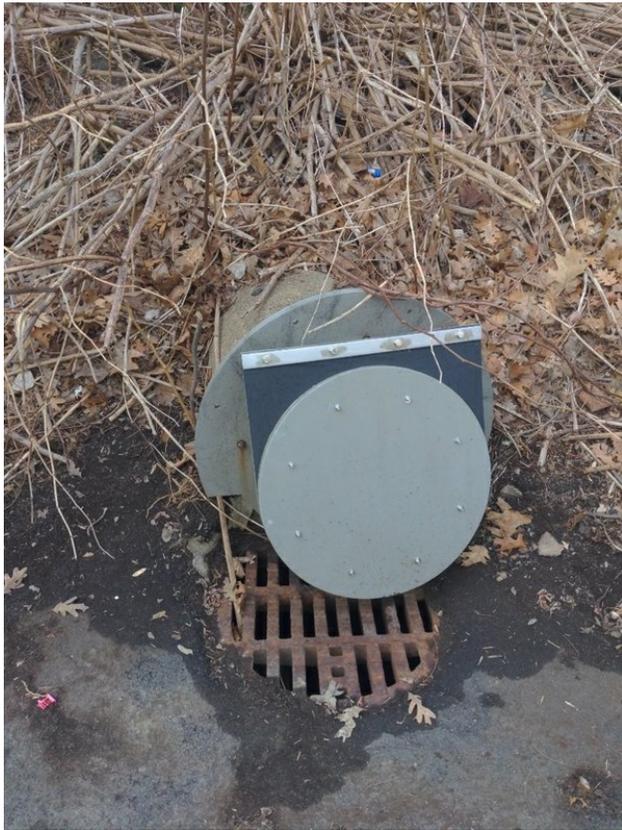
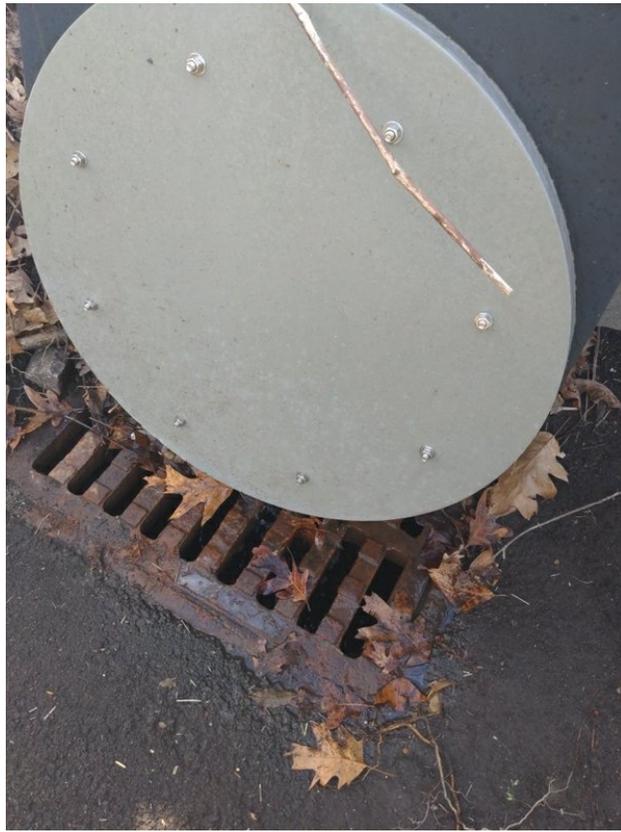
OF-192, SWMH-1832

Maintenance Required	Yes
Maintenance Needs	Cleaning is recommended due to severe debris build up
Manhole Invert (inches)	44

General Notes	Outfall is located within 100' of a wetland. To be considered as a new MS4 outfall. Outlets are located behind the pump station and are directly flowing into the catch basins and catchment.
---------------	---

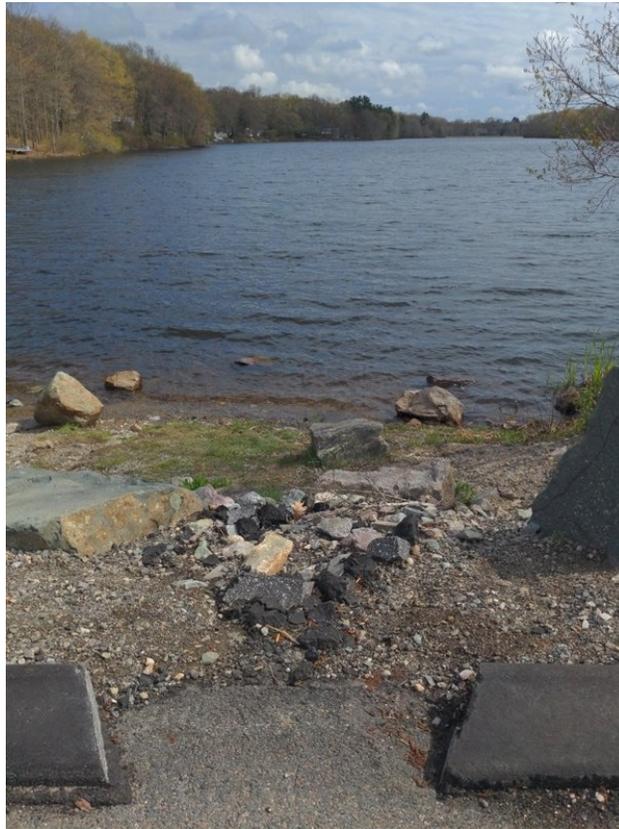
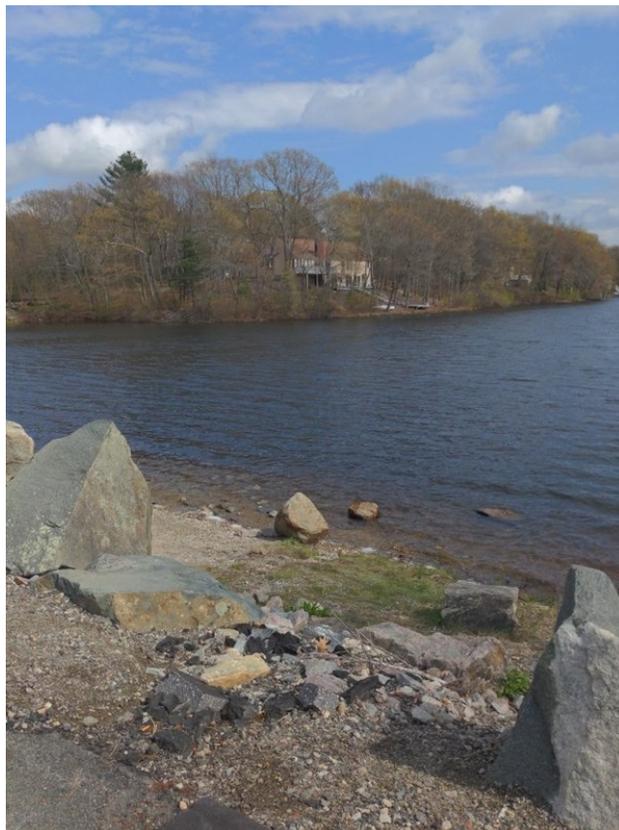
Floatables	No
Odor	No
General Notes	Some vegetation located at the end of scupper
