ILLICIT DISCHARGE DETECTION AND ELIMINATION (IDDE) PLAN

Town of Stoughton

September 2023

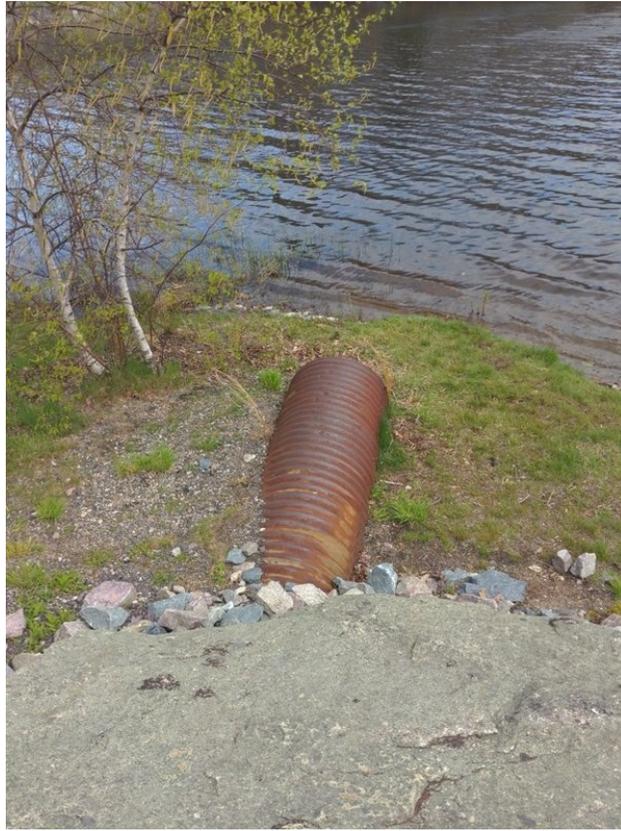
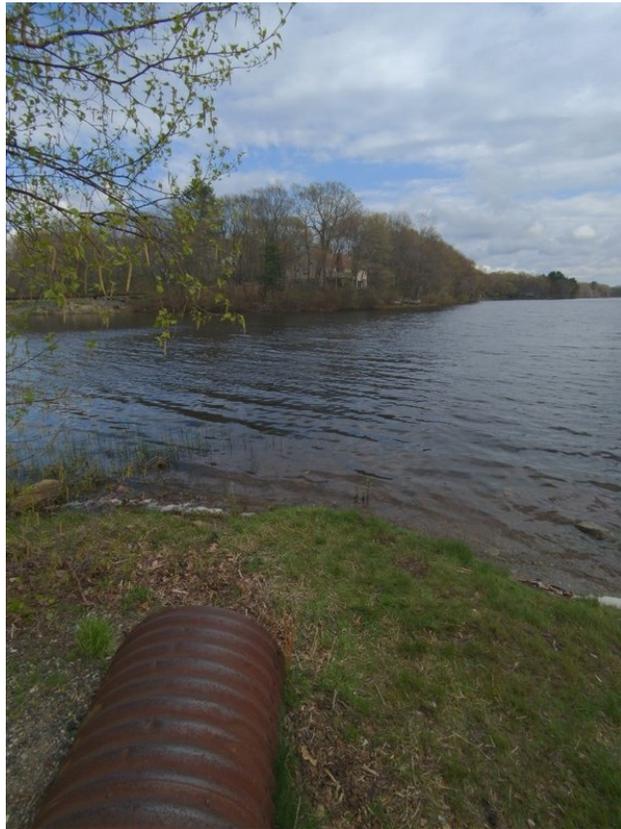
OUTLET-NEW , OUTLET-NEW

Pipe Clock Position	6
Flow Direction	Out
Pipe Material	Corrugated Metal
Pipe Diameter (inches)	18
Pipe Invert (inches)	0
Pipes Submerged	No
Flow Present	No
Structure Notes	Structure looks relatively new but does not show any signs of recent flow. Vegetation growth is observed in the pipe

Floatables	No
Odor	No
General Notes	Could not locate any upstream structures or inlet draining into outlet.
Surface Photos

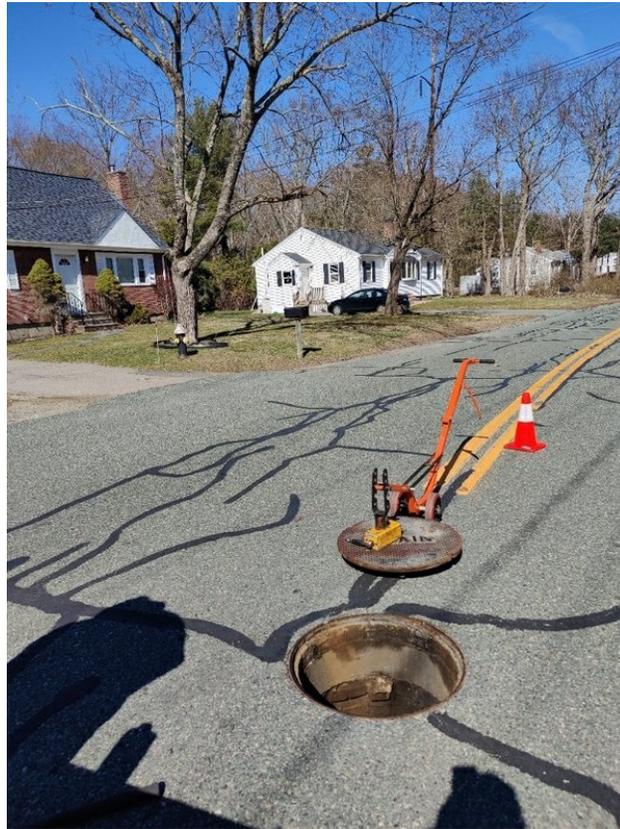
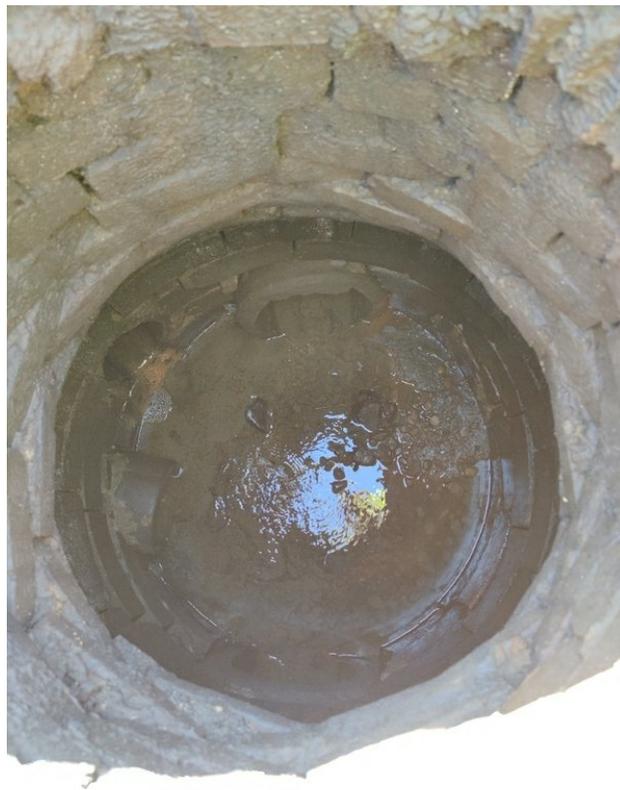
OF-54, SWMH-20

Temperature	54.7
pH	6.6
Specific Conductivity (SPC)	406
Surfactants	0.25
Chlorine	0.06
Ammonia	0

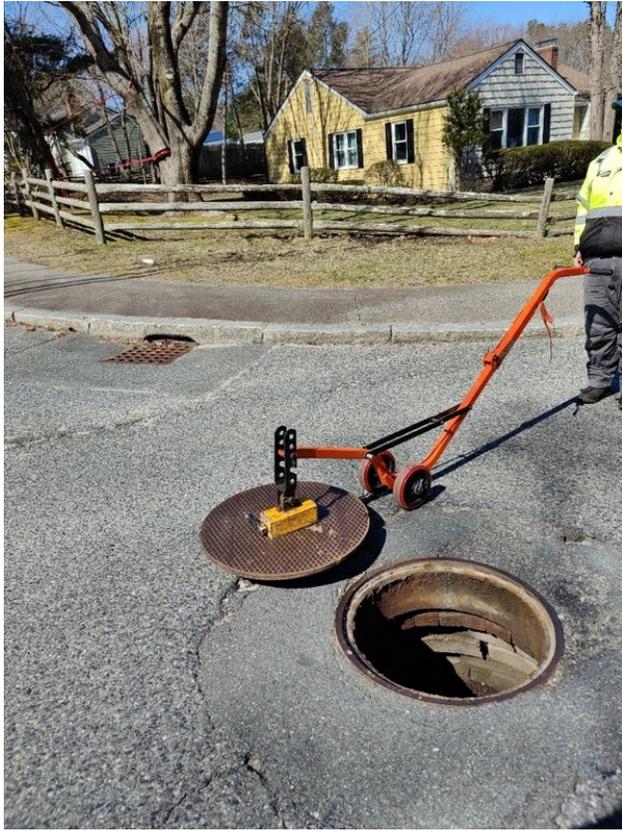
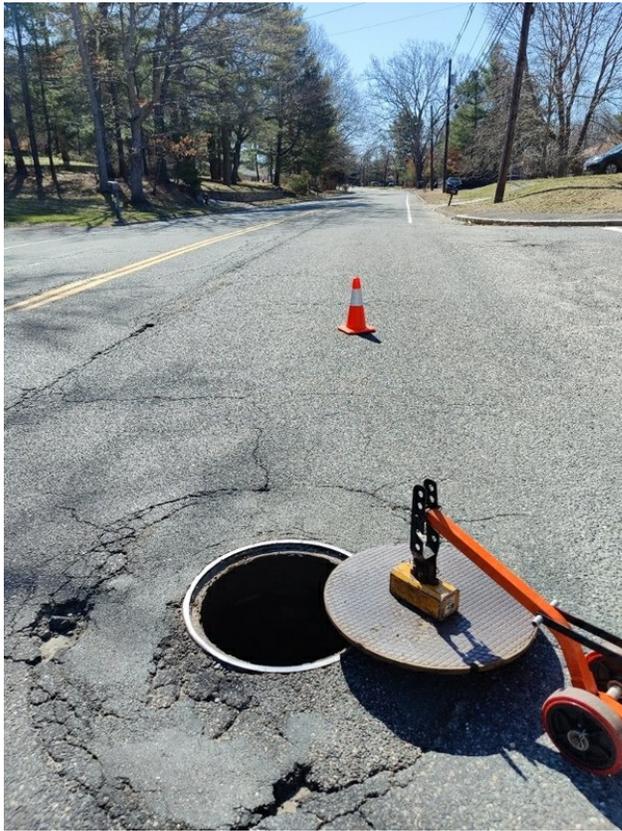
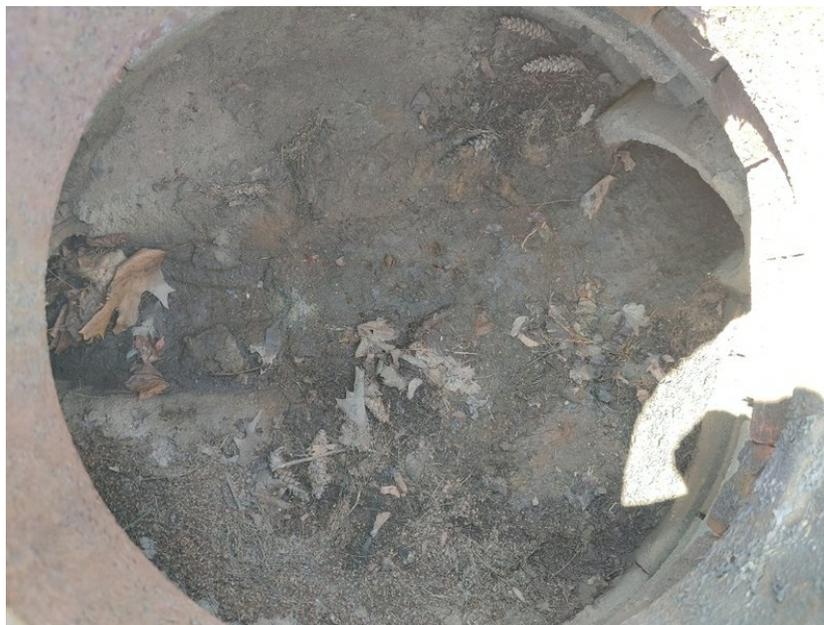
OF-769, New

Floatables	No
Odor	No
Surface Photos

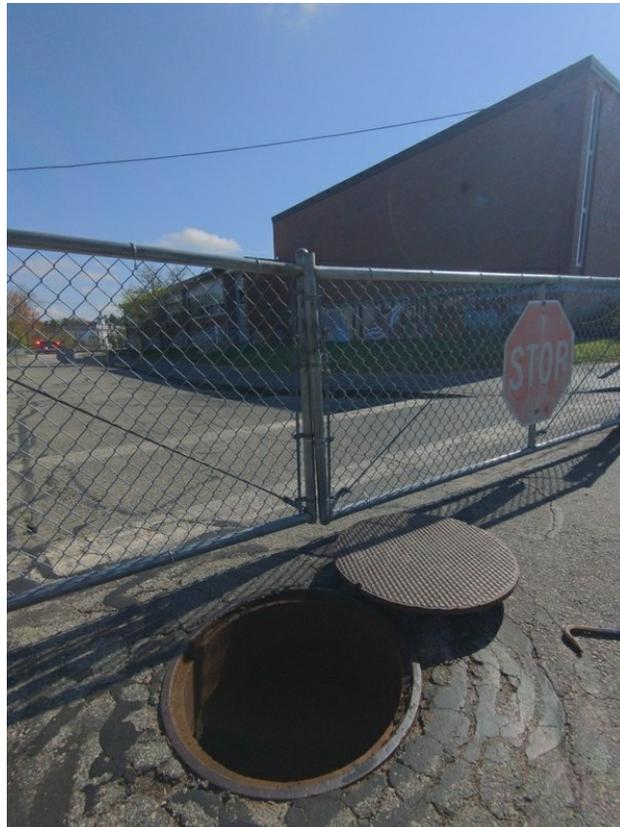
Floatables	No
Odor	No
General Notes	Confirm with Town the connectivity of cleanout located upstream of manhole. The cleanout is in line with the 9:00 pipe found in SWMH-1234.

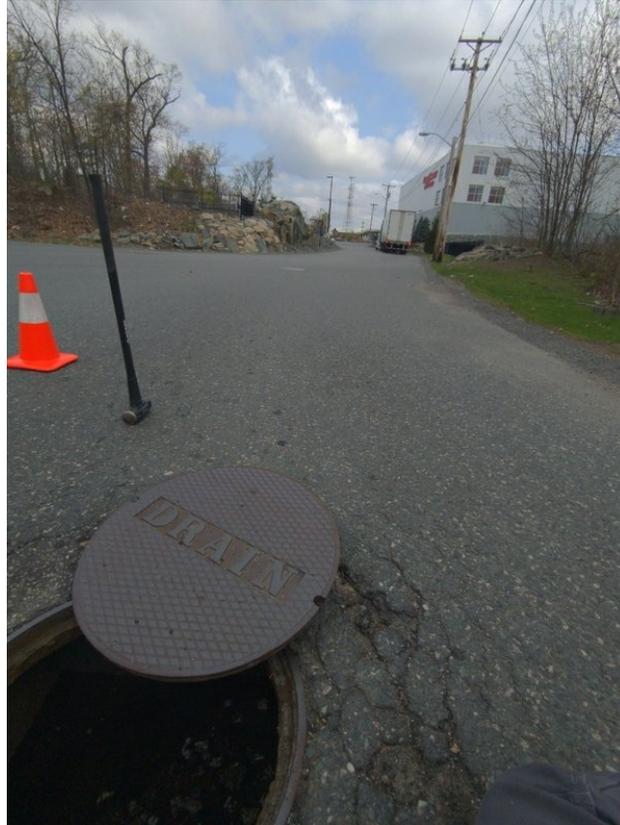
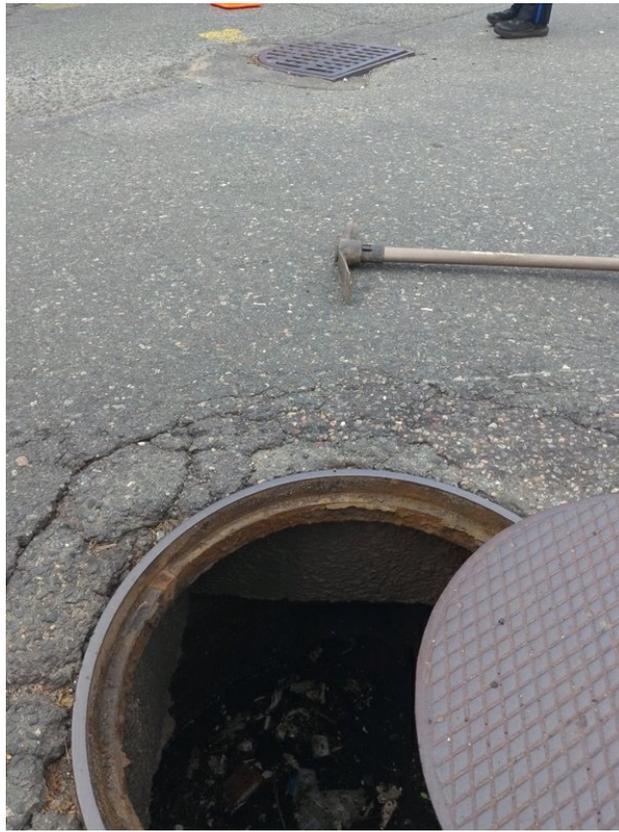
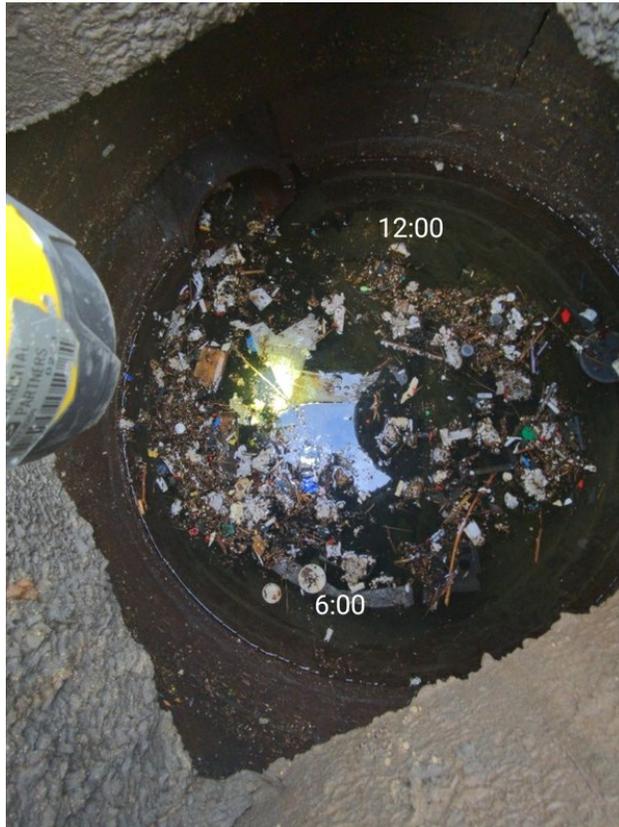
Floatables	Yes
Floatables Type	Trash
Floatables Note	Trash should be removed. Possibly coming from catch basin located upstream. 12:00 incoming pipe is mapped but does not have an asset connected to it. Verify connectivity with Town if SWIN-3195 connects to manhole and if it is the 12:00 incoming connection. Could not locate 9:00 connection that is mapped on GIS.
Odor	No
Surface Photos

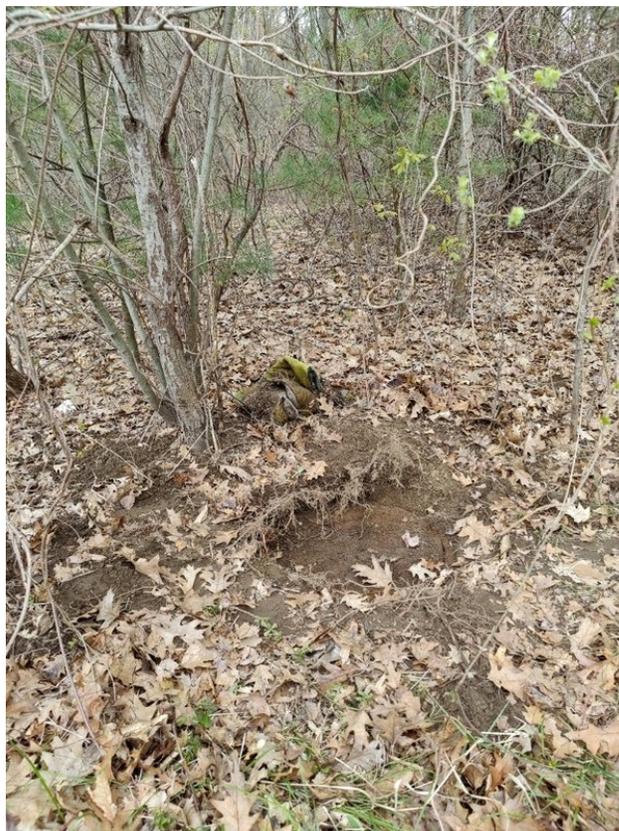
OF-109, OF-109

General Notes	Unable to sample at upstream structure because MH is mostly covered by dirt and roots. EP opened structure enough to verify connectivity and determine that flow is coming from O'Hare Circle. Unable to locate MH at end of O'Hare Circle.
---------------	---

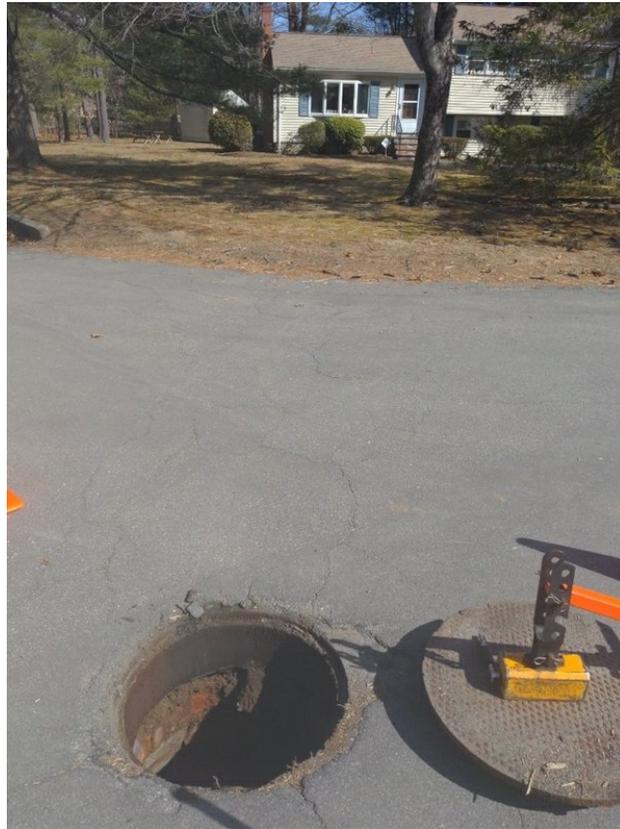
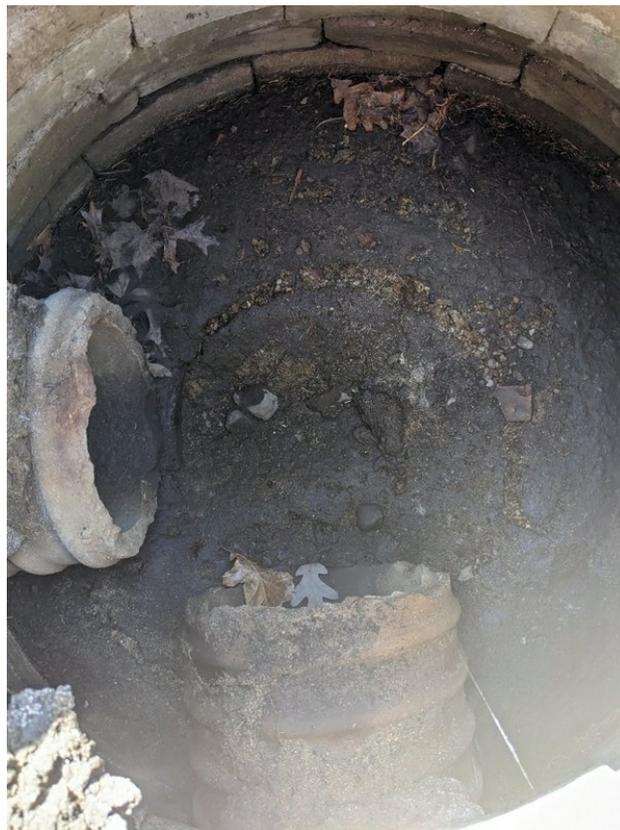
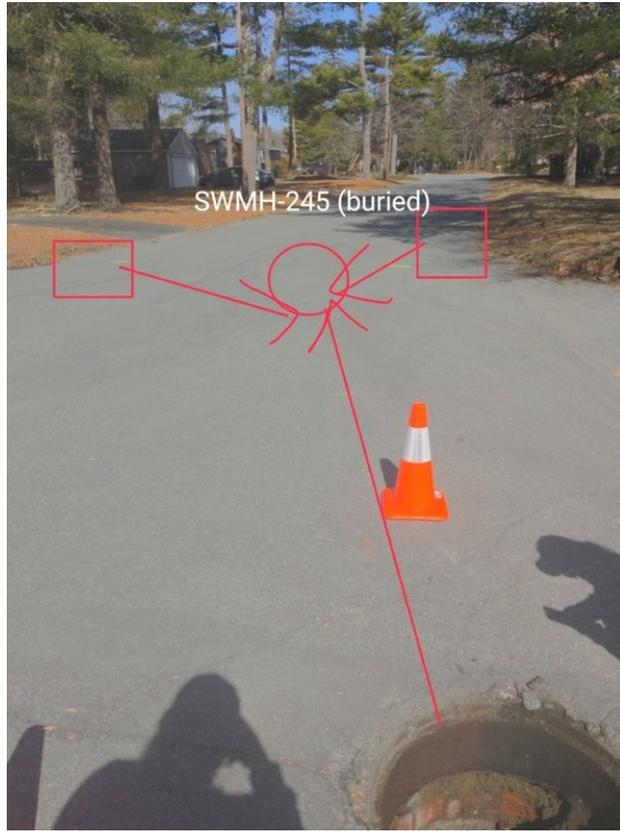
OF-769, SWMH-678

Floatables	No
Odor	No
General Notes	SWMH-245 is buried and is downstream of SWMH-678. Mapping has been updated to reflect the correct pipe connectivity.

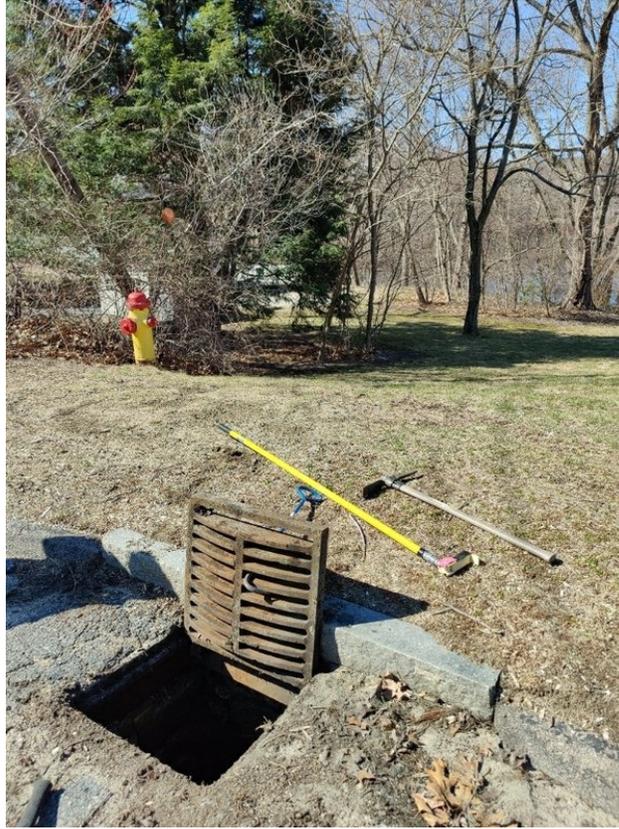
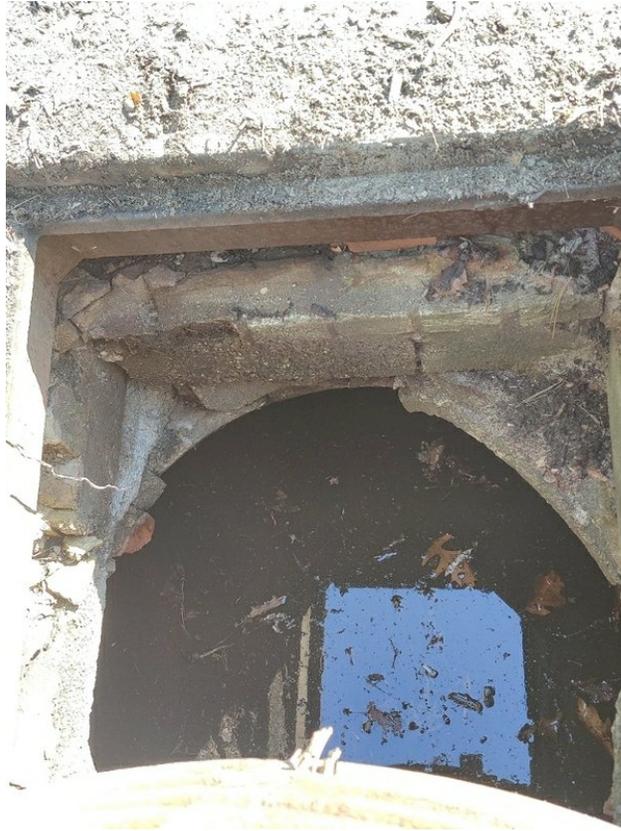
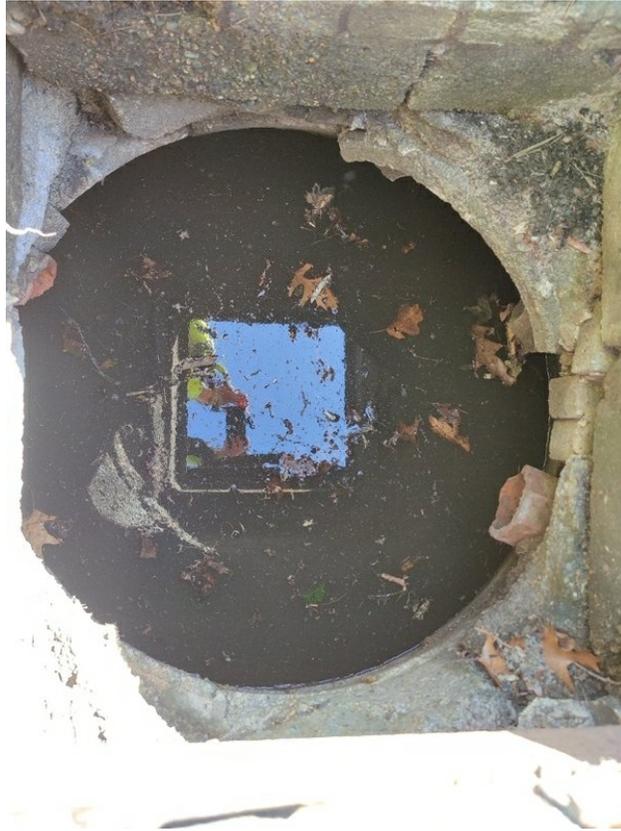
OF-764, SWMH-693

Floatables	No
Odor	No
General Notes	GIS identifies structure as MH but it's a catch basin

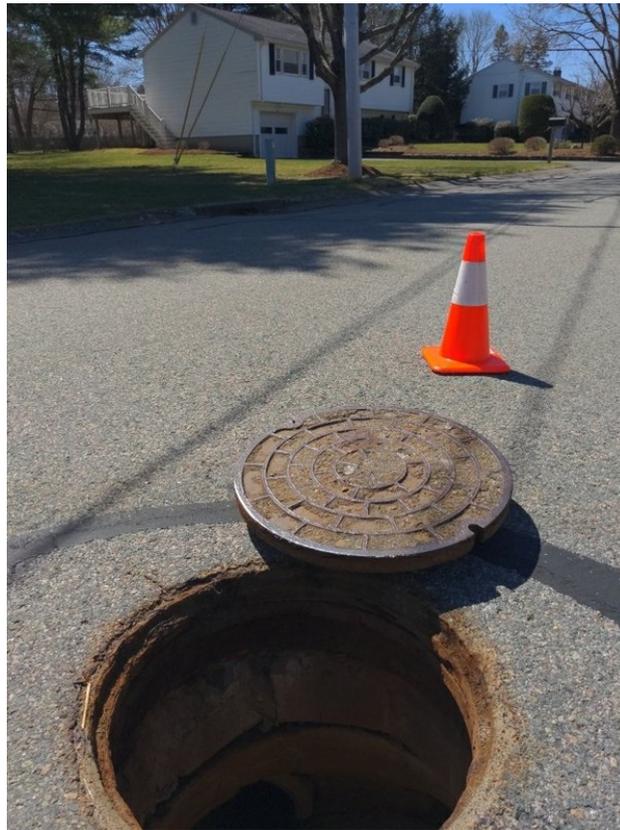
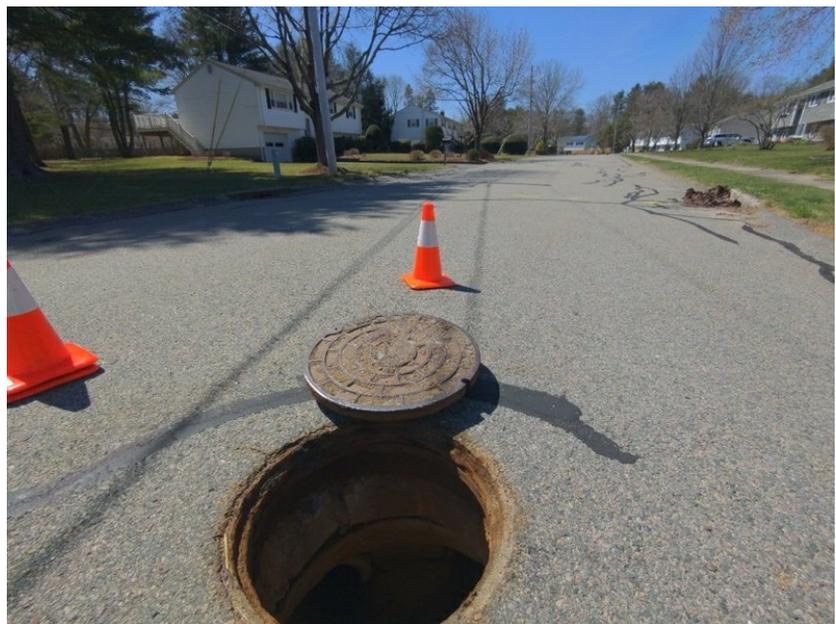
Floatables	No
Odor	No
General Notes	Could not locate the source of the trickling flow from the upstream catch basin. Recommend replacing frame and cover. Severe rust is observed.

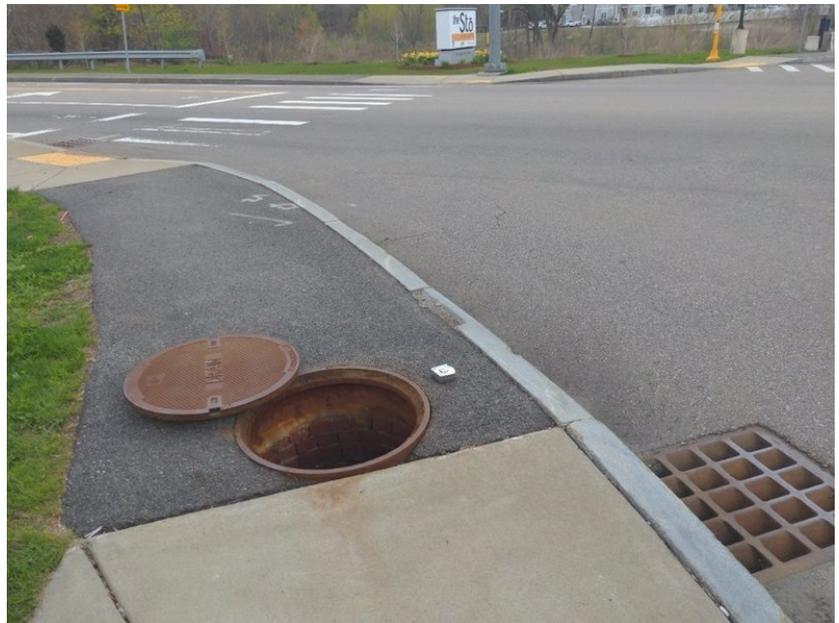
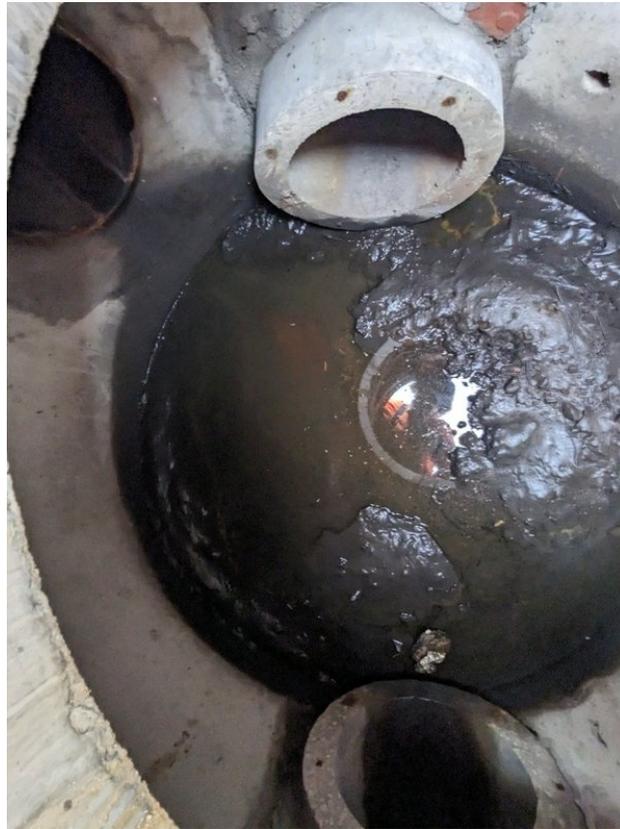
Maintenance Required	Yes
Maintenance Needs	Cleaning; deposits observed
Manhole Invert (inches)	62

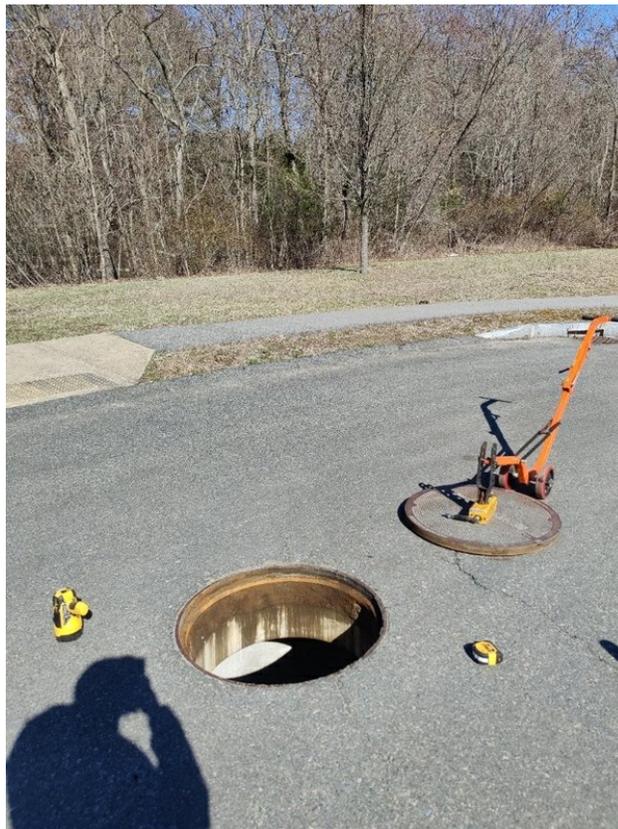
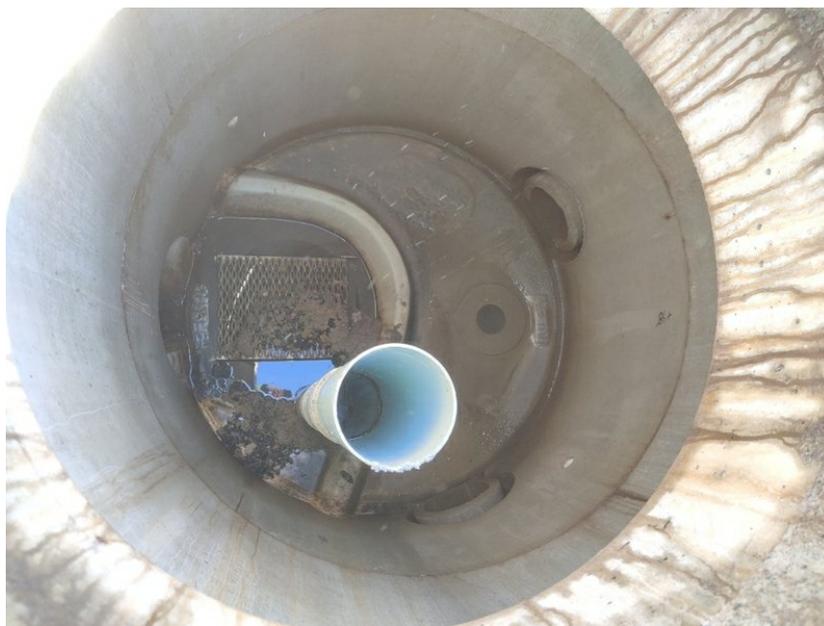
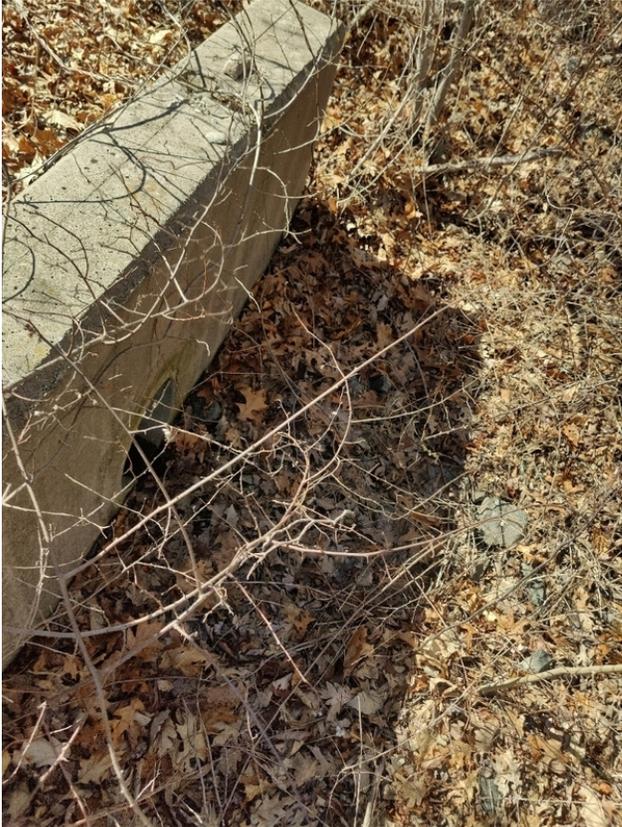
General Notes Stormceptor

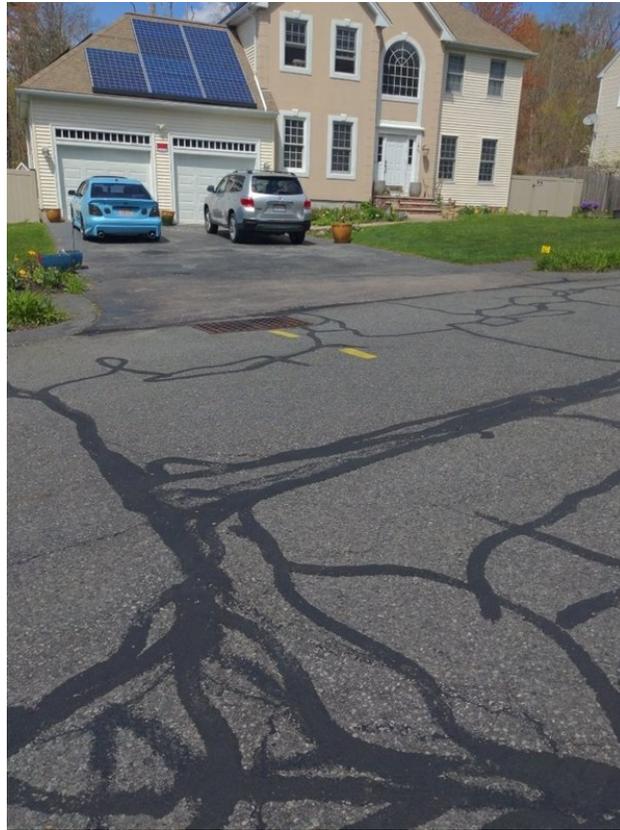
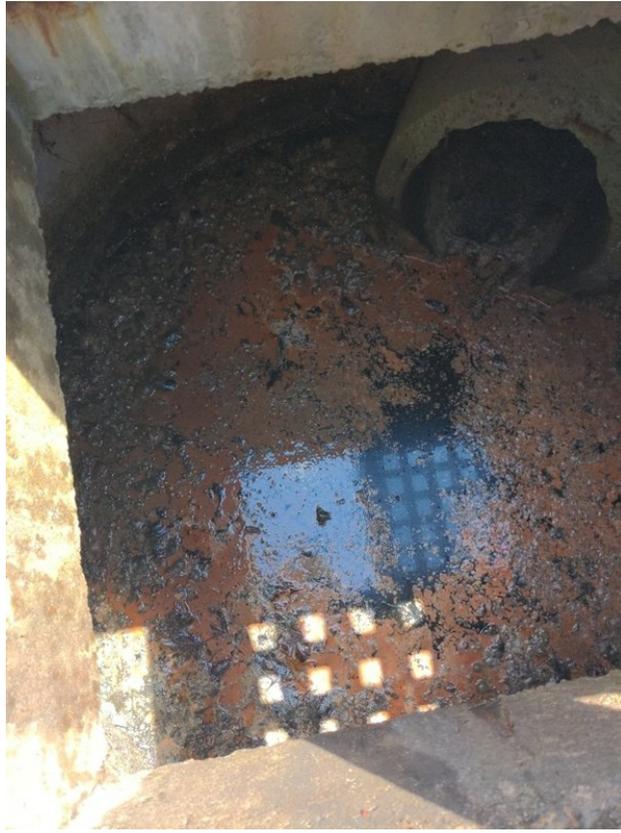
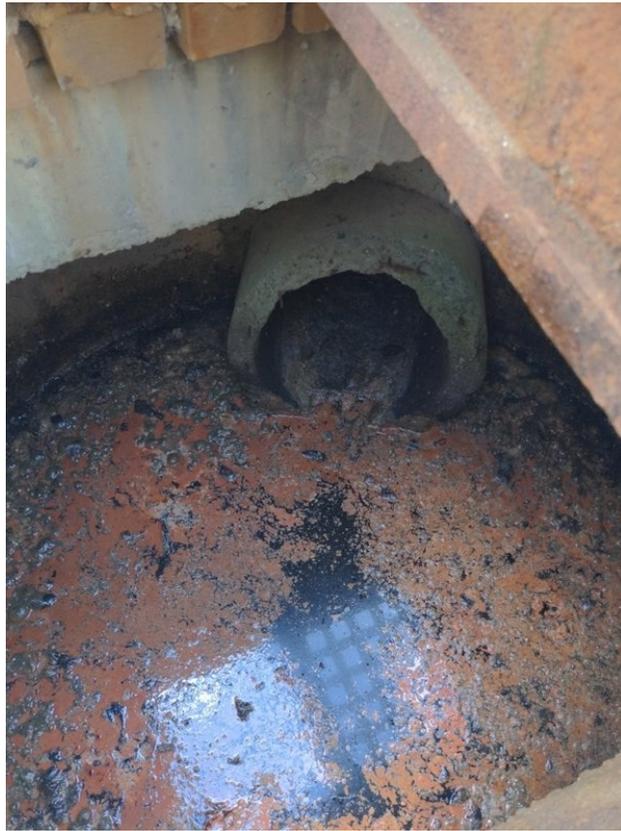
Maintenance Required	Yes
Maintenance Needs	Grease and possible paint has been dumped into structure. Cleaning is recommended.
Manhole Invert (inches)	0

Surfactants	0.5
Chlorine	0
Ammonia	6
Sampling Notes	Due to the turbidity and amount of floatables present in water, pH, temperature, SPC and Chlorine could not be measured. Surfactants is an approximate estimation.

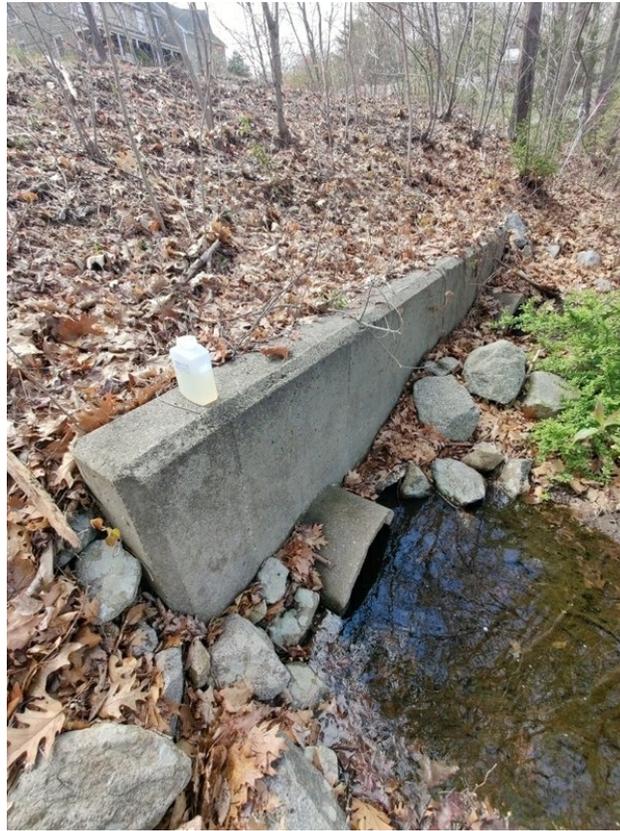
Temperature	57.6
pH	6.3
Specific Conductivity (SPC)	634
Surfactants	0.25
Chlorine	0.08
Ammonia	0
Sampling Notes	Likely just stream flow
General Notes	Sampling from outfall because upstream catch basin had silt sock. Manhole in system was unable to be located.

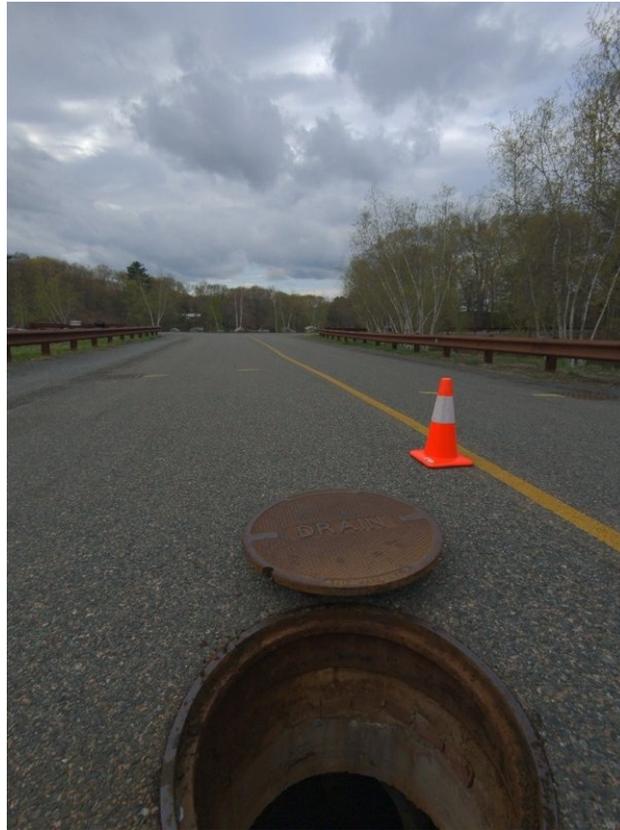
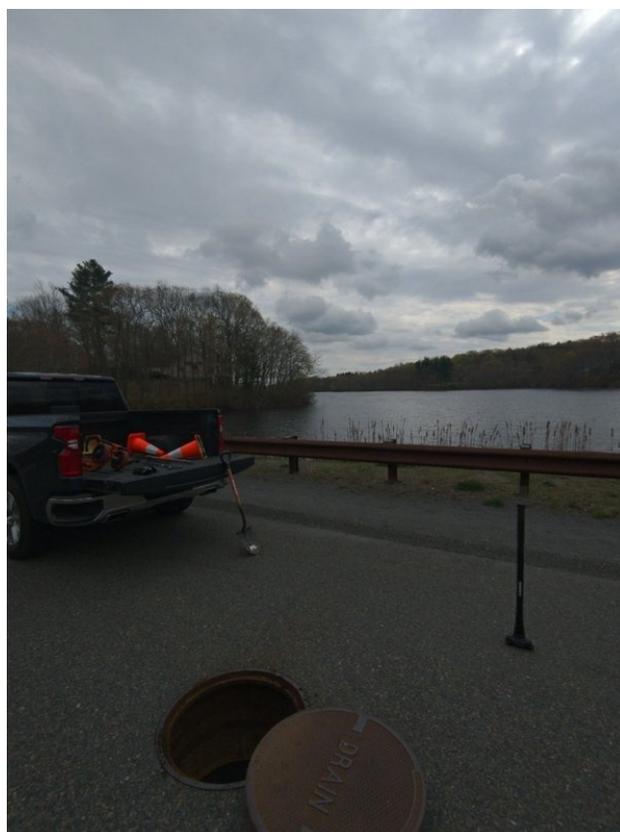
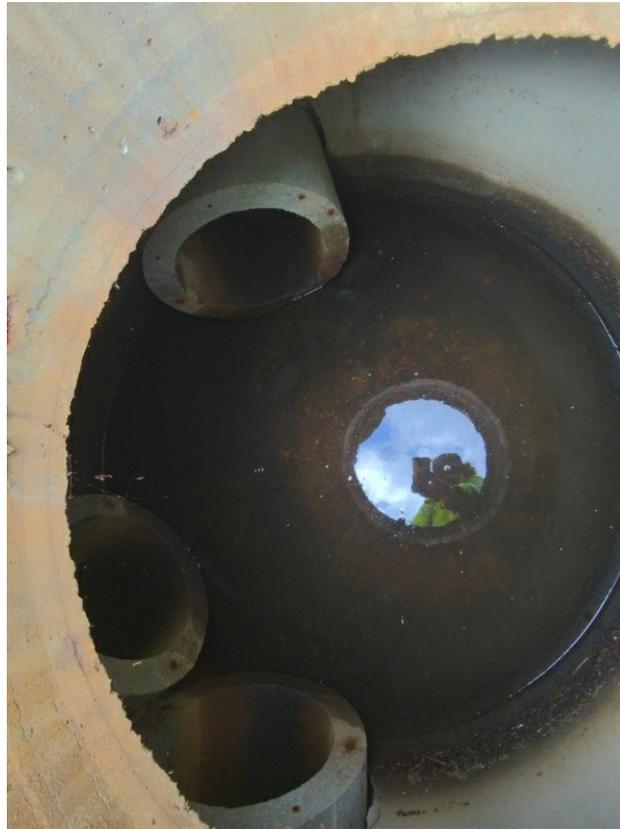
Could not open during the FY22 catchment investigations. Successfully opened during FY23 catchment investigations.

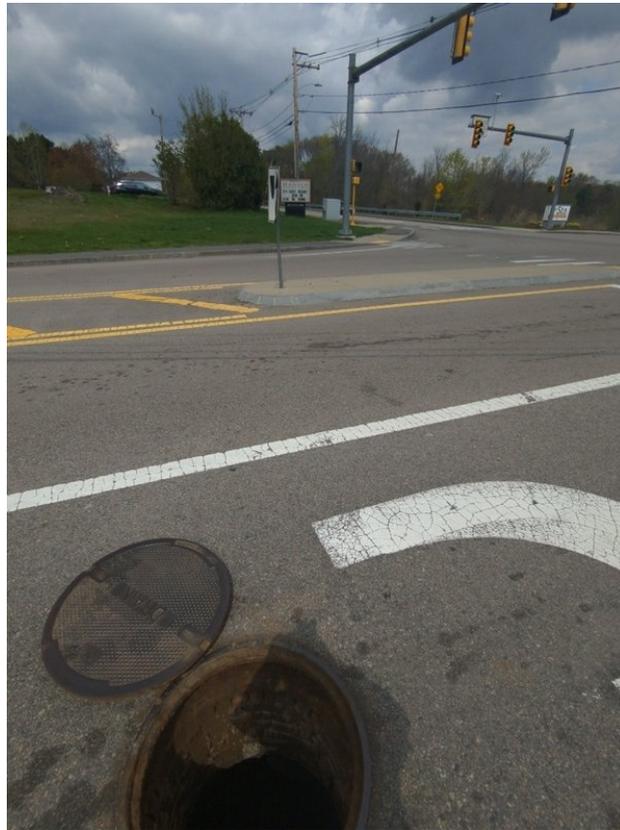
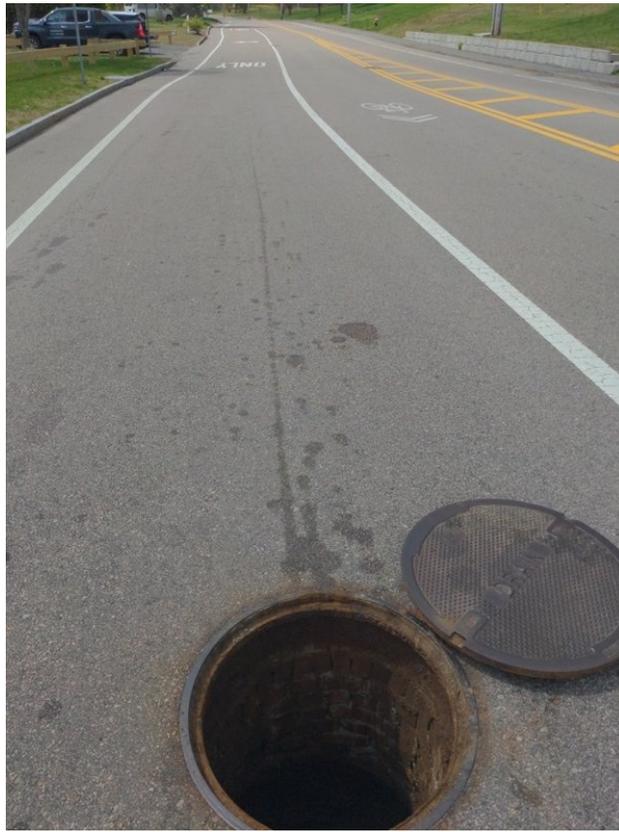
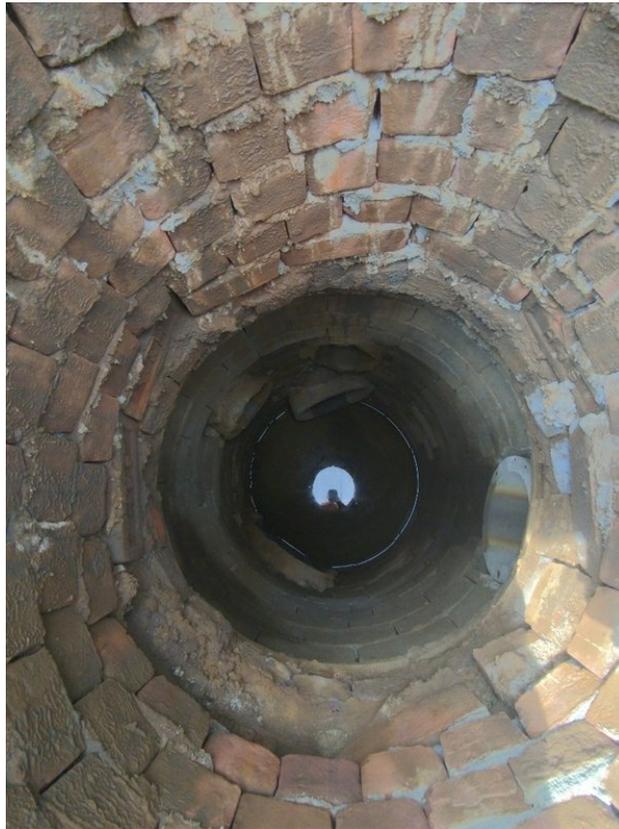
Floatables	No
Odor	No
General Notes	Confirm connectivity with Town

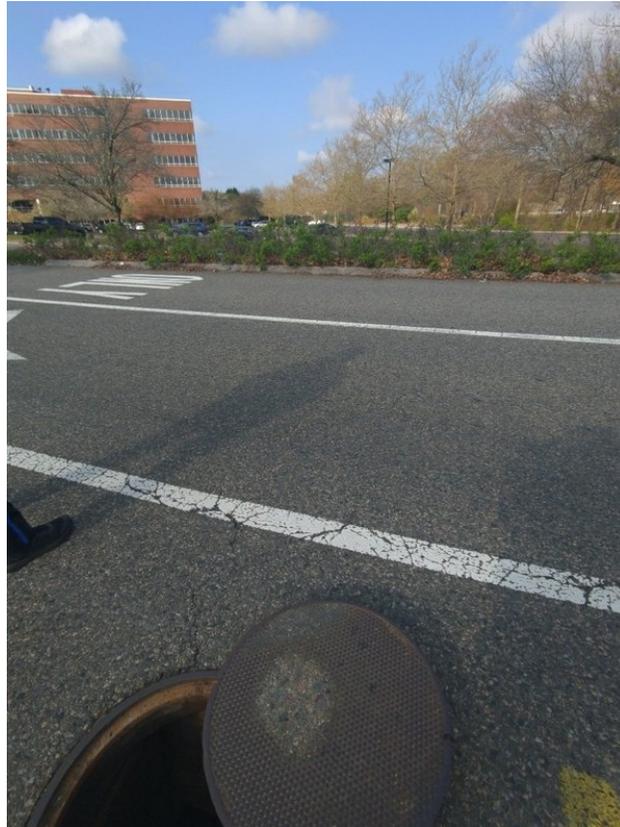
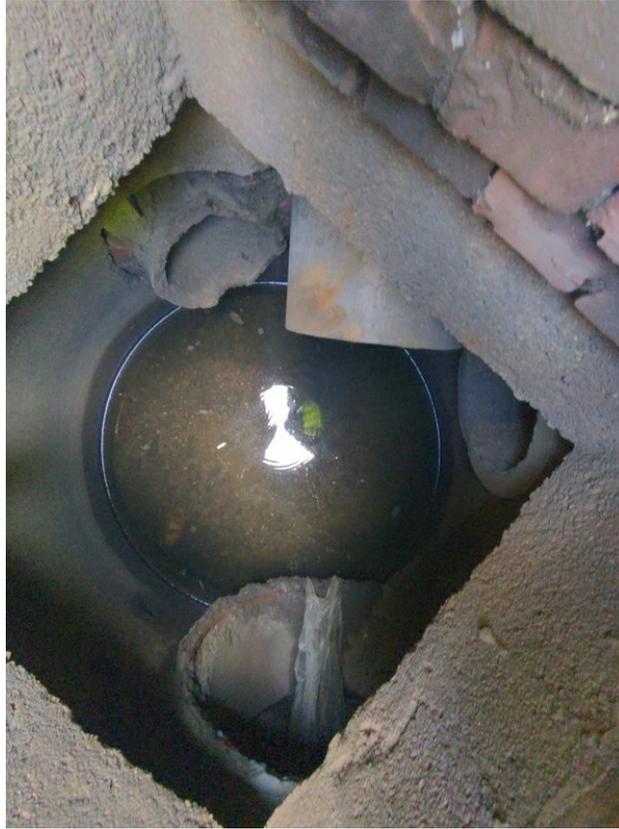
Pipe Notes	Unmapped in GIS
Pipes Submerged	No
Flow Present	No
Structure Notes	Standing water observed

Floatables	No
Odor	No
General Notes	Interconnection between private and Town.
Surface Photos

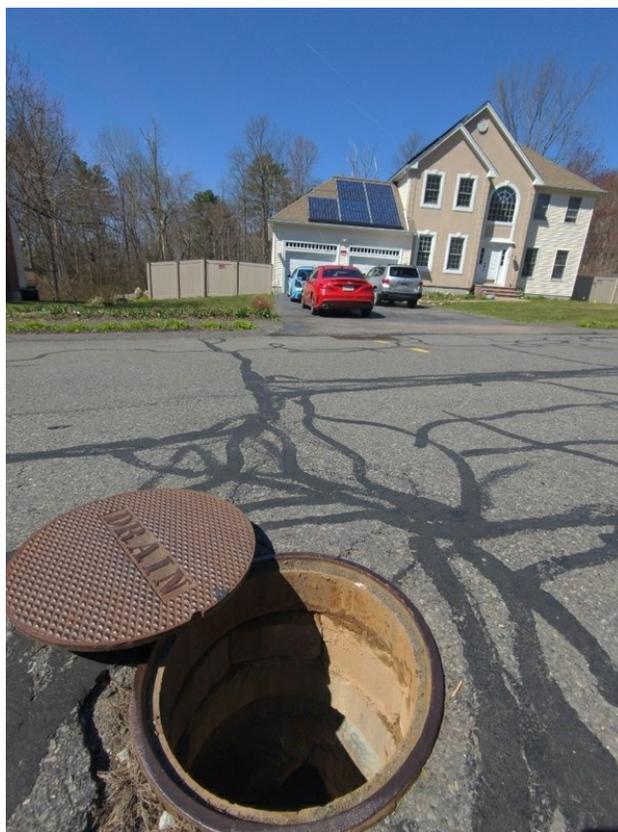
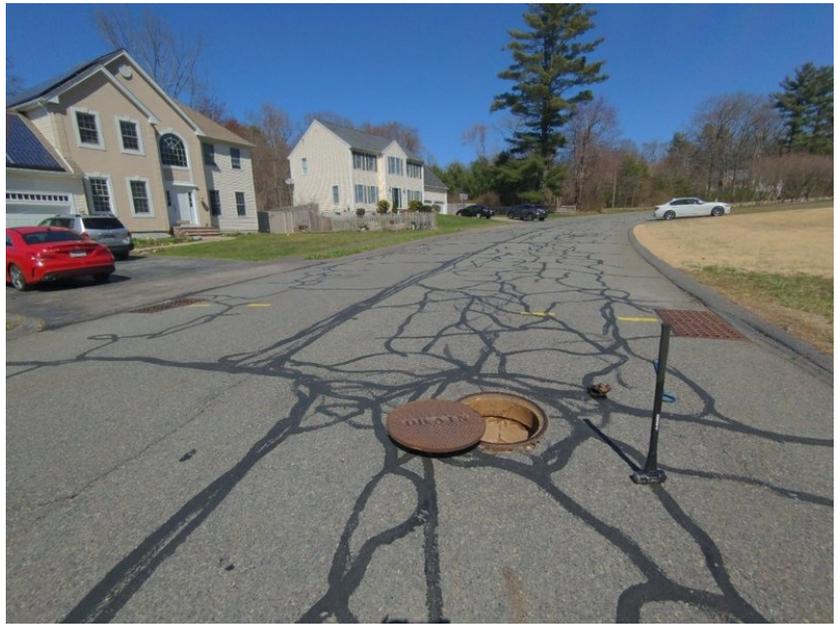
Floatables	Yes
Floatables Type	Grease
Floatables Note	Grease found in the upstream catch basin SWIN-677, located in front of 22 Chase Run
Odor	Yes
Odor Type	Rancid/Sour
Odor Note	Odor smells like feces.

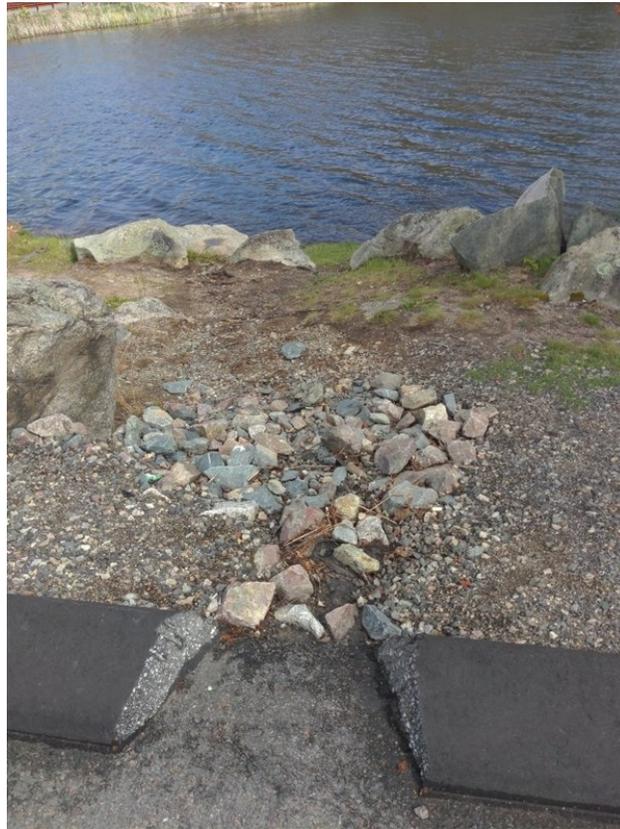
Floatables	No
Odor	No
General Notes	Deposits found in scupper

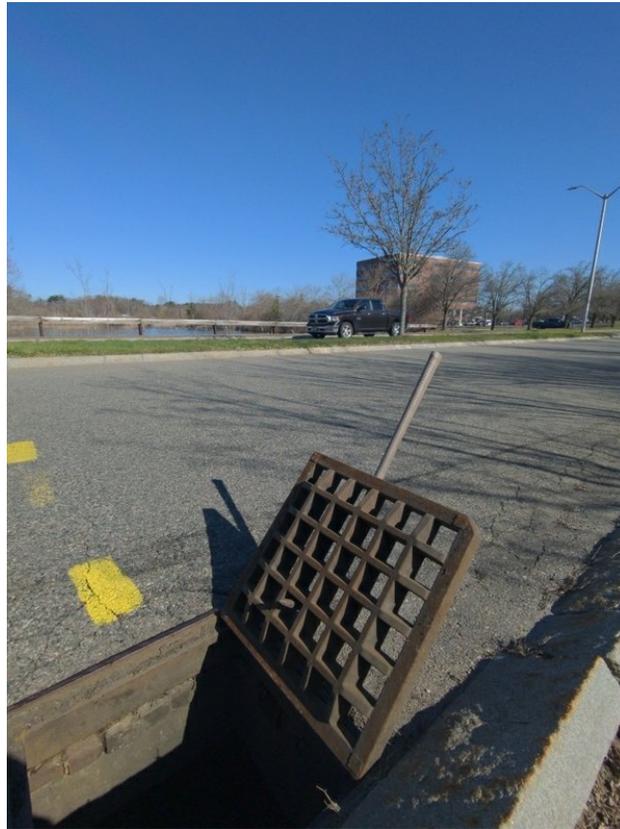
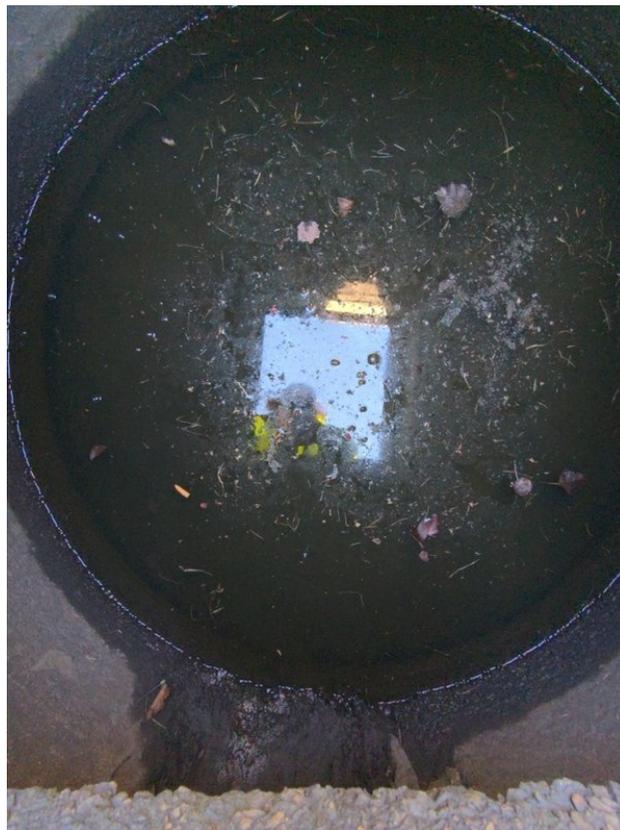
OF-CNL, SWIN-3008

Floatables	No
Odor	No
General Notes	Could not locate outfall
