ILLICIT DISCHARGE DETECTION AND ELIMINATION (IDDE) PLAN

Town of Stoughton

September 2023

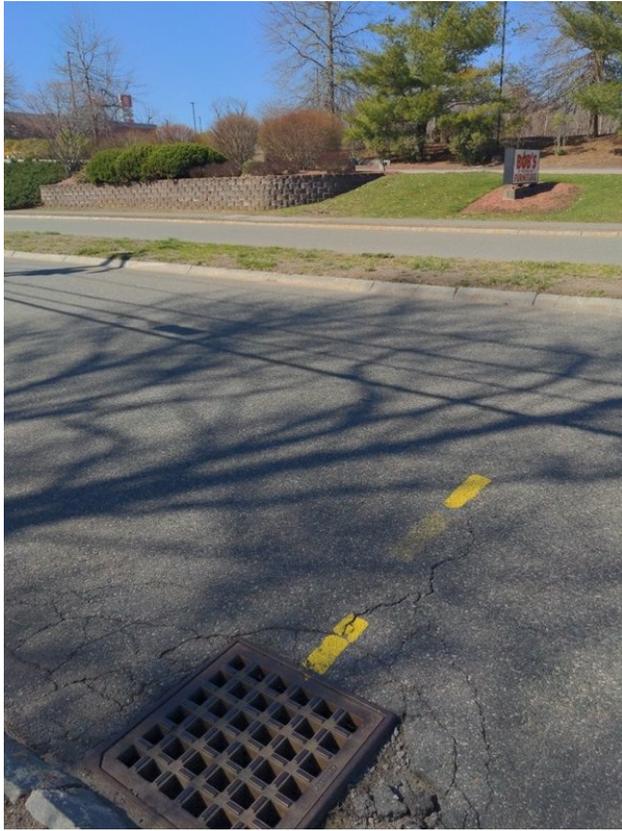
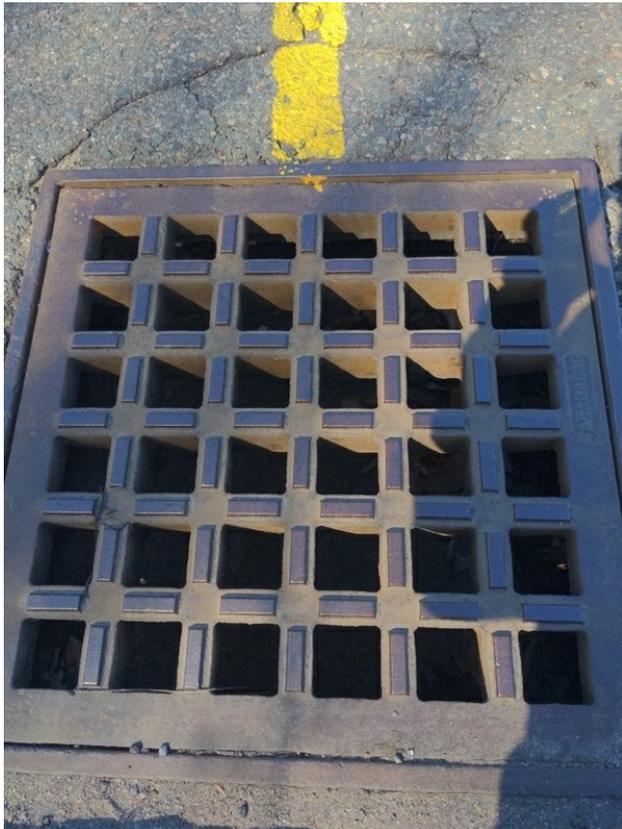
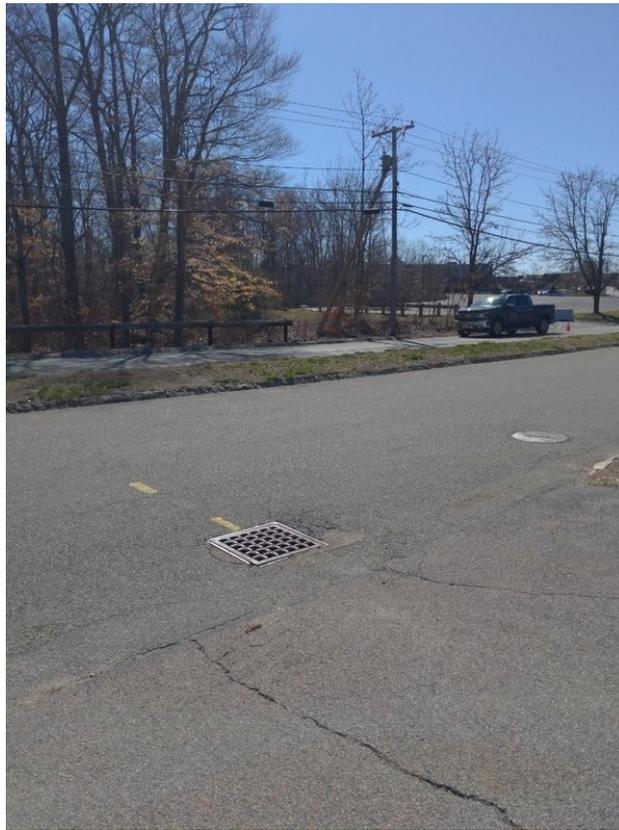
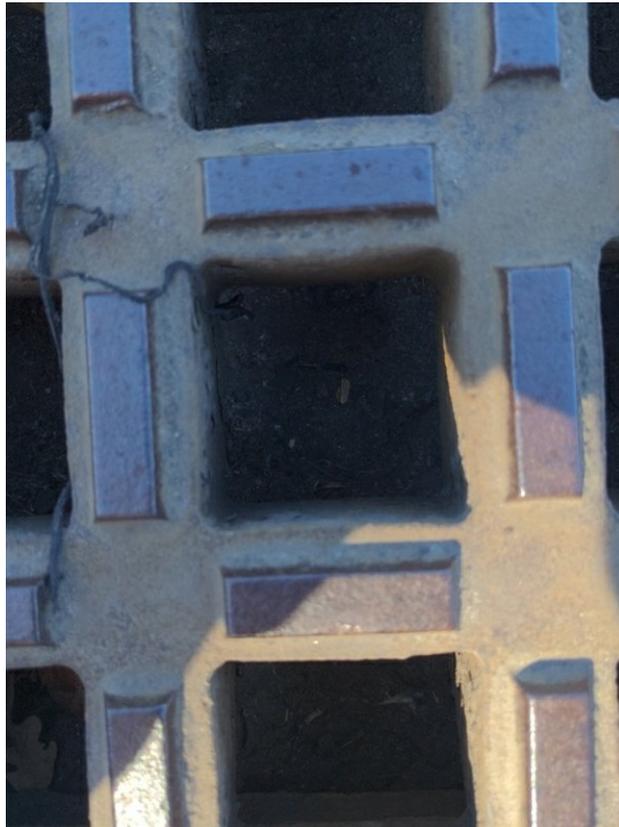
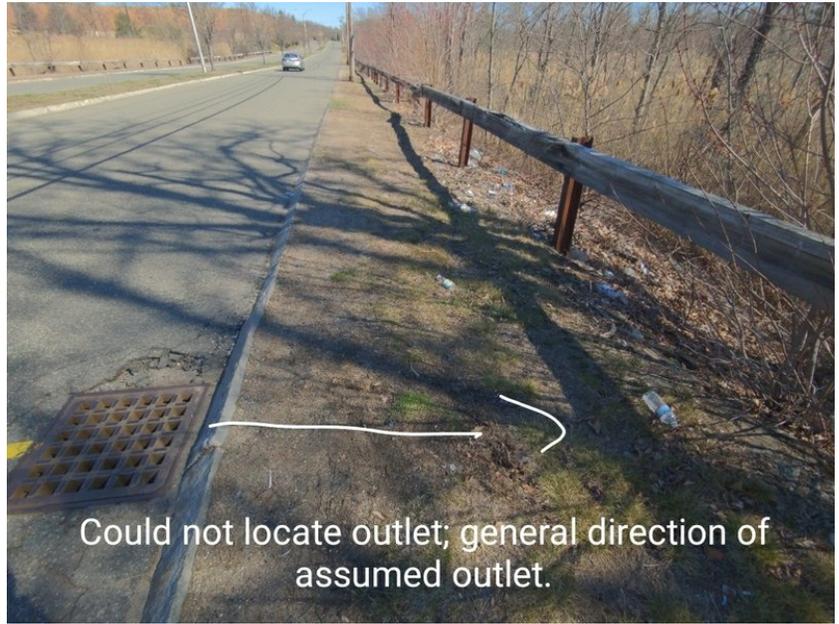
OF-CNL, SWIN-3228

Floatables	No
Odor	No
General Notes	Manhole across the street potentially connected to catchment, however, manhole could not be opened. Further Town assistance to open manhole and confirm connectivity required.

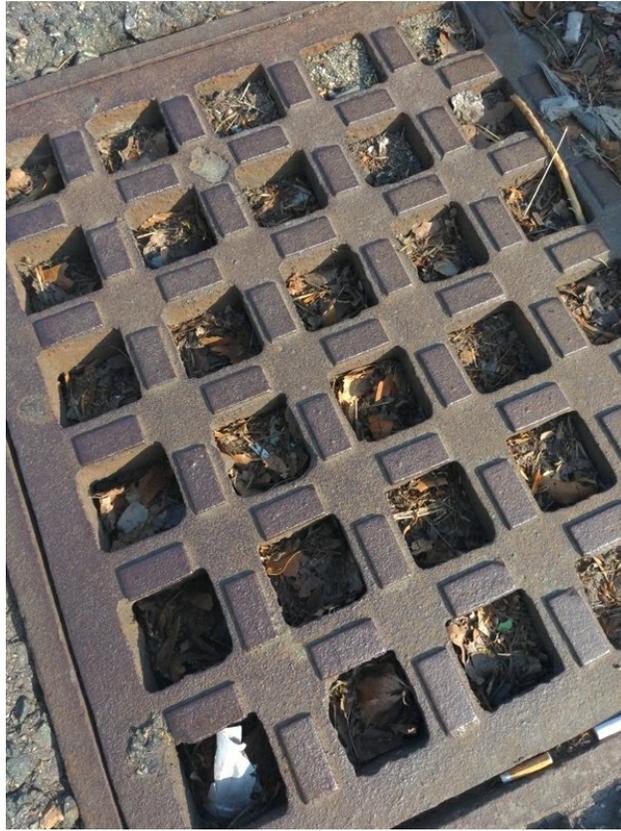
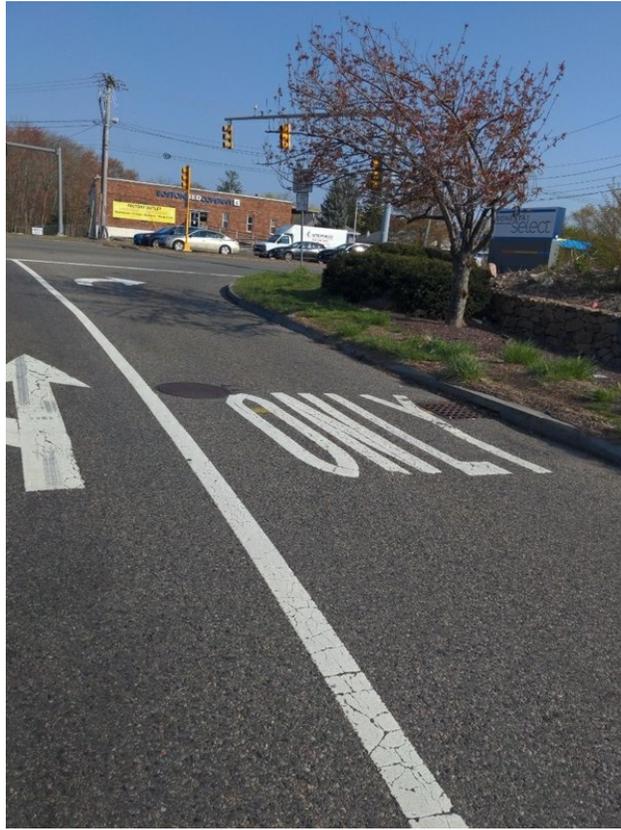
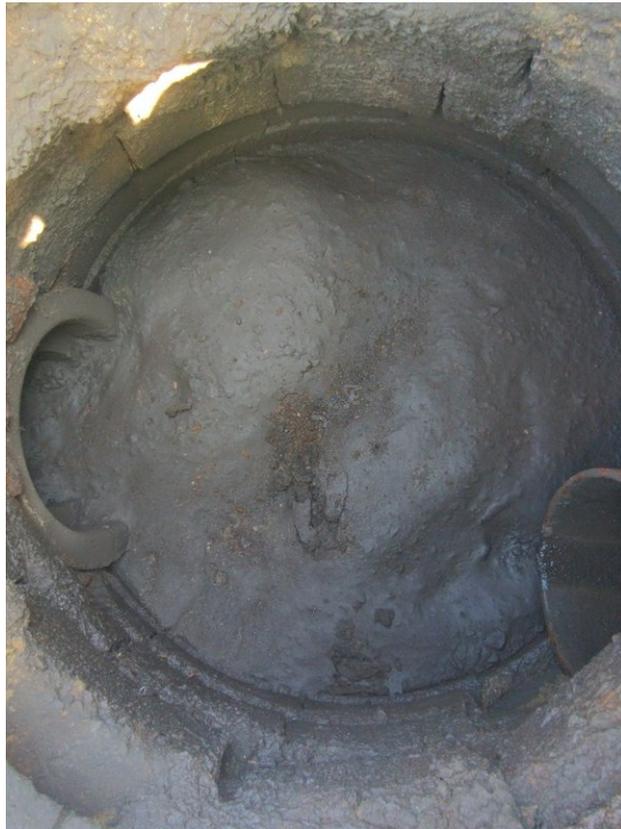
OF-792, SWMH-2039

Floatables	No
Odor	No
General Notes	Catch basin upstream are filled with debris
Surface Photos

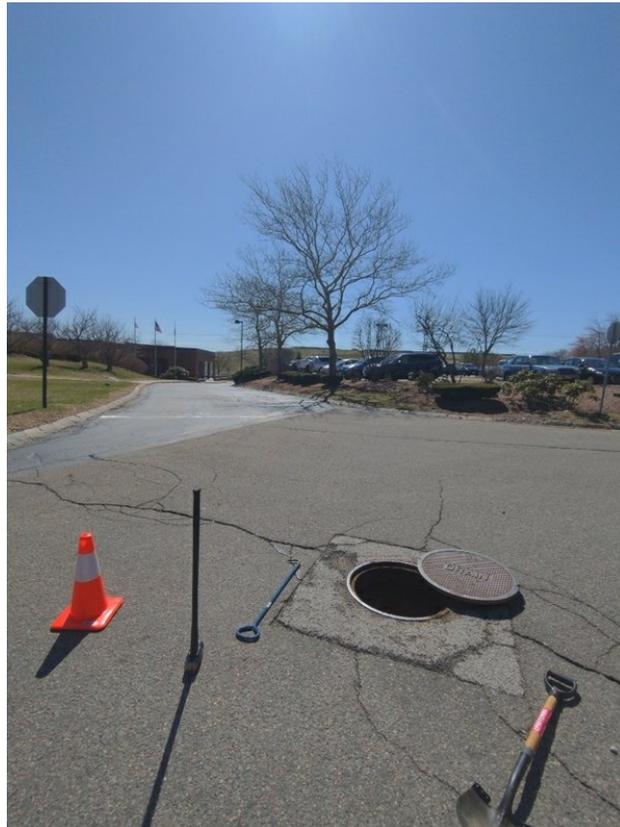
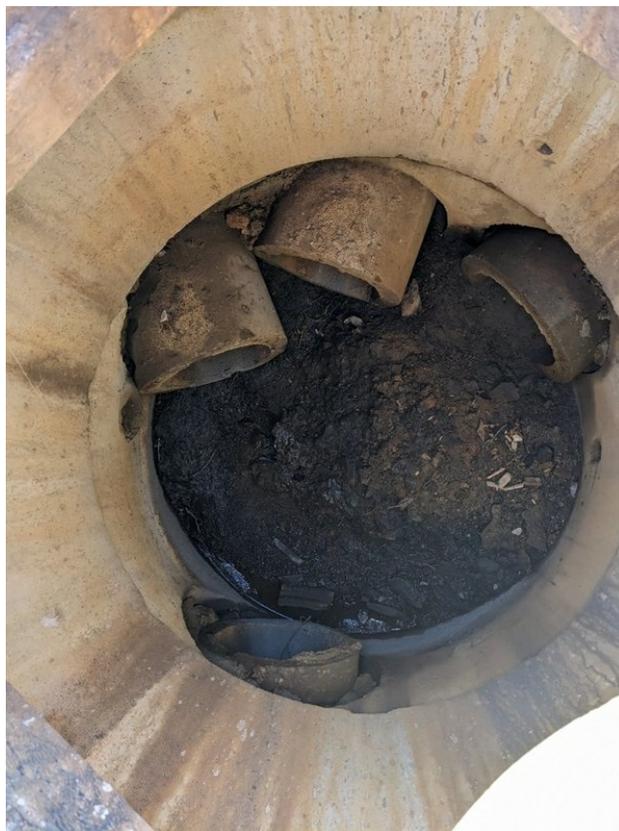
SWMH-2025-INTERCONNECTION, SWMH-2025

Floatables	No
Odor	No
General Notes	Located at the entrance of Amazon.

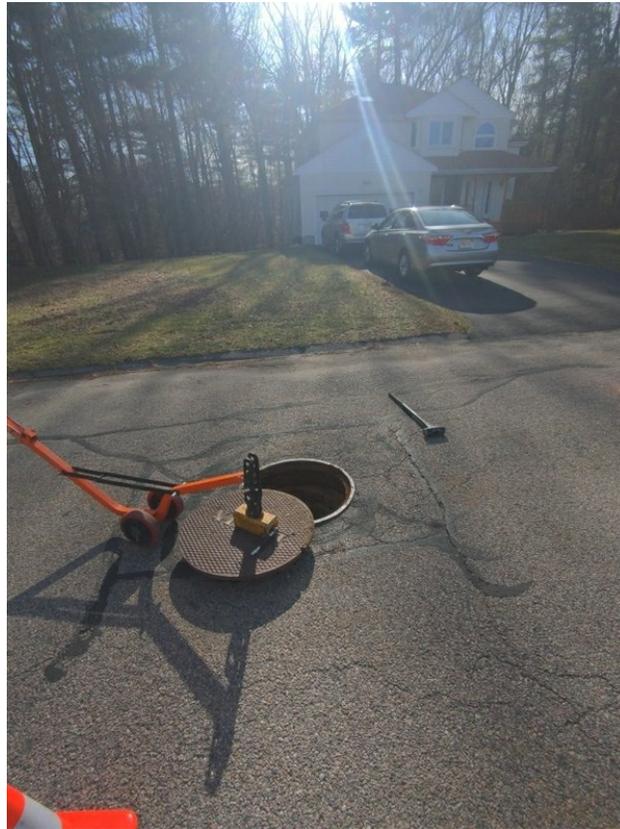
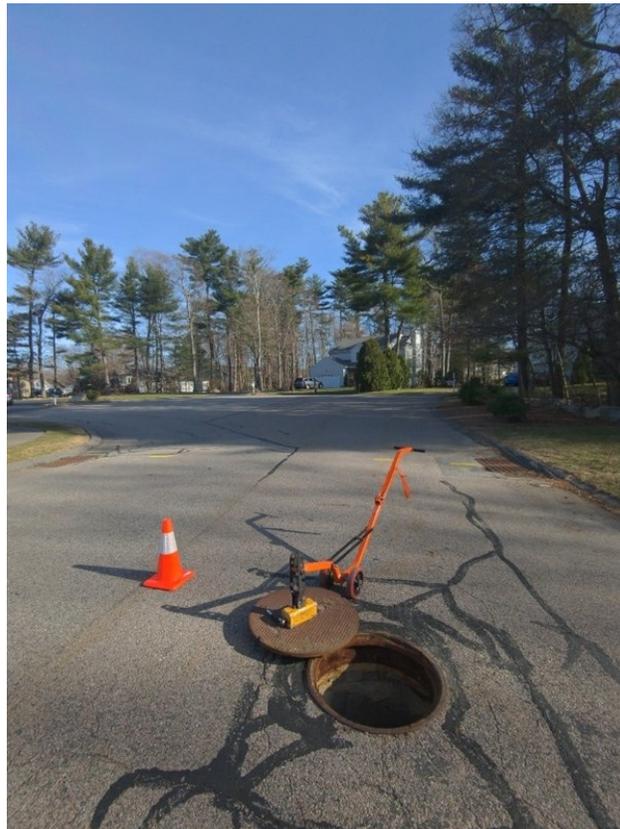
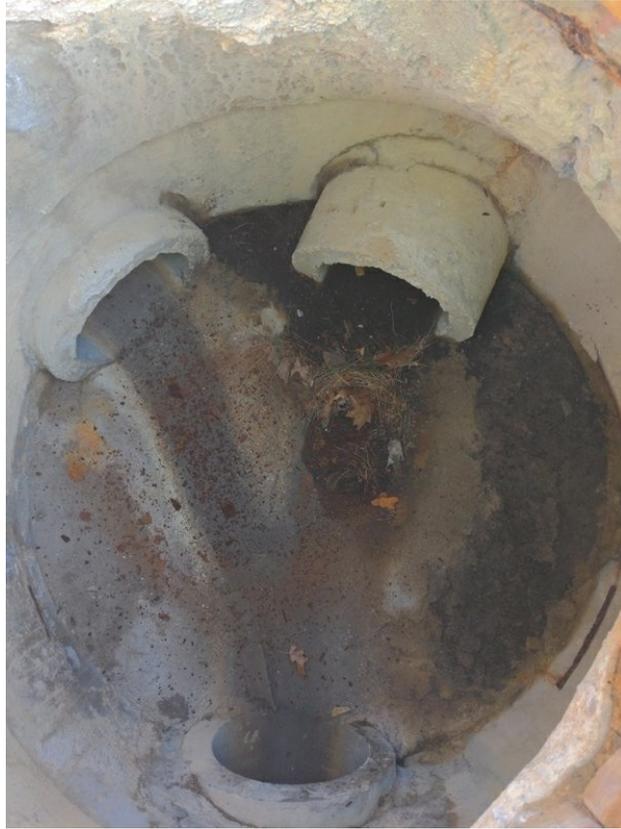
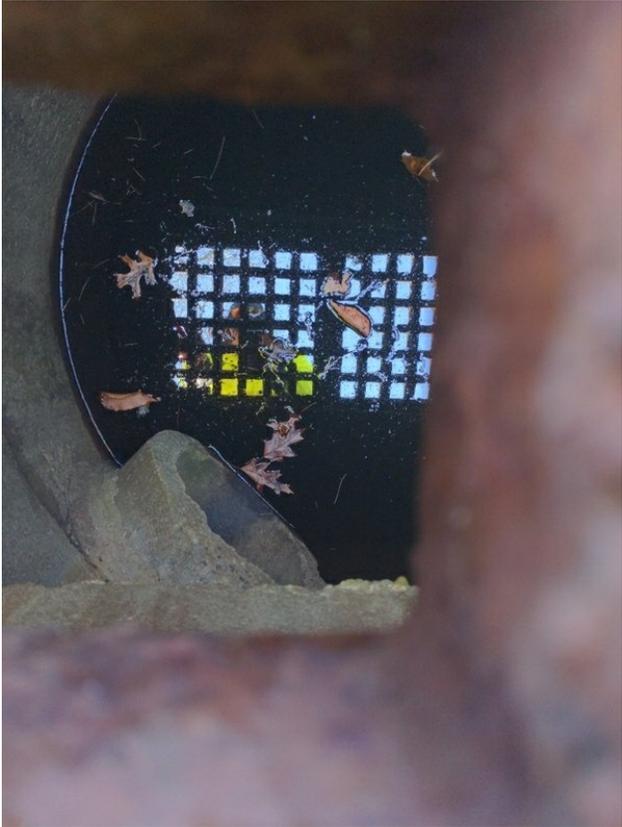
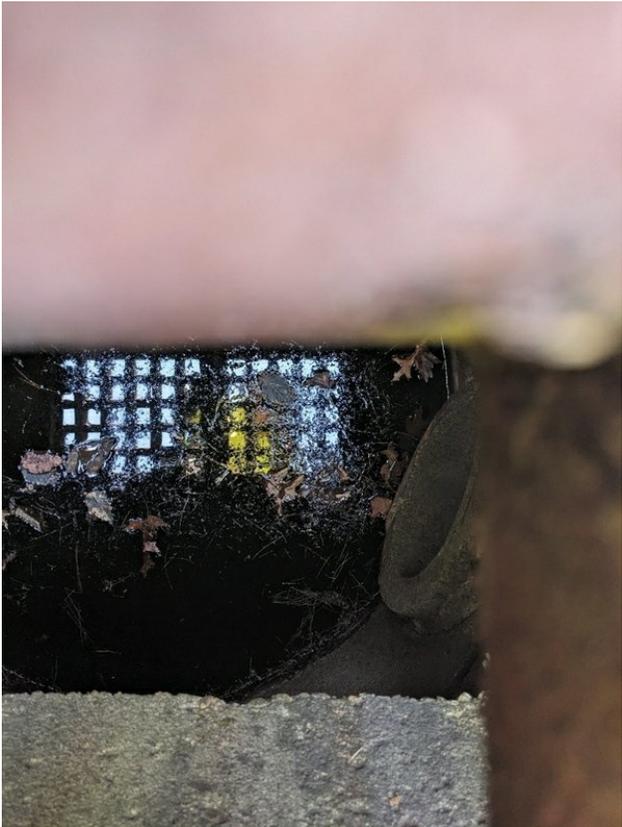
OF-516, SWMH-405

Floatables	No
Odor	No
General Notes	Structure is dry

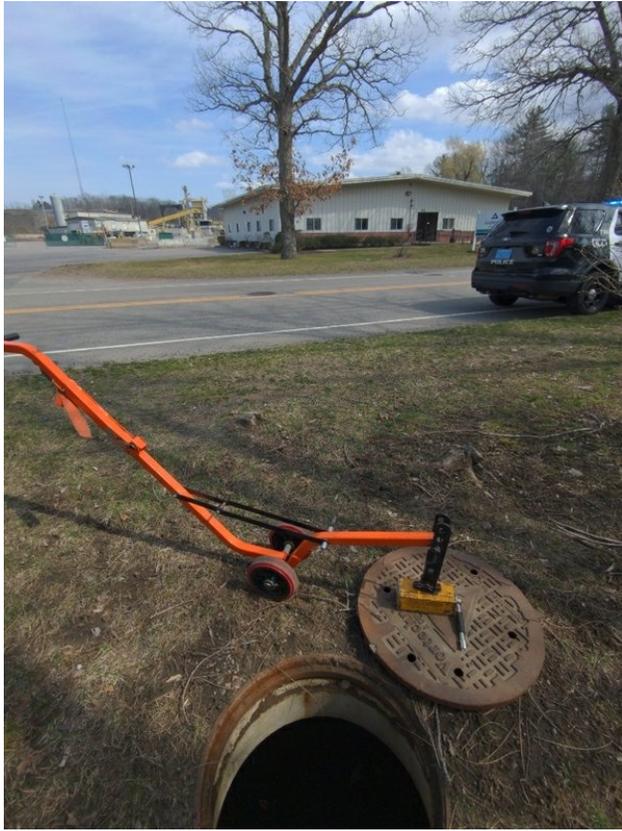
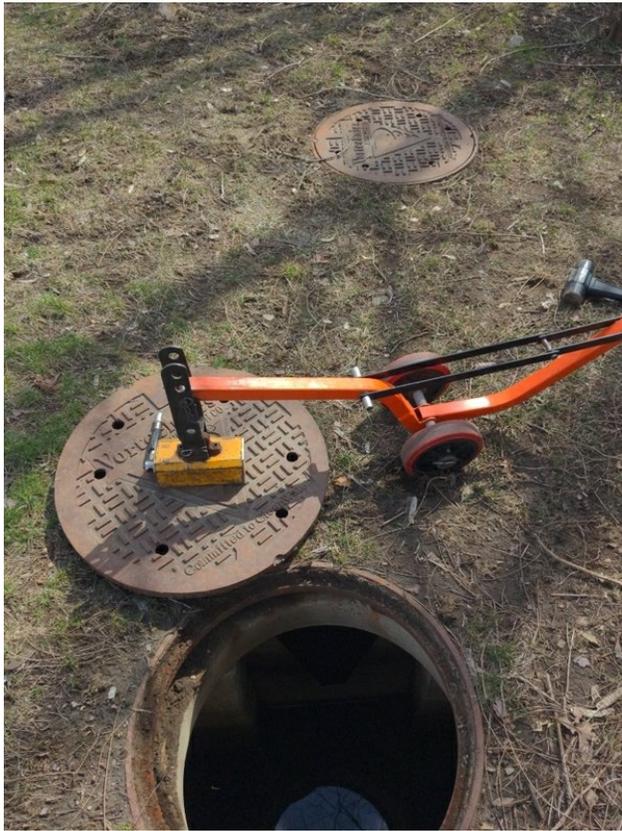
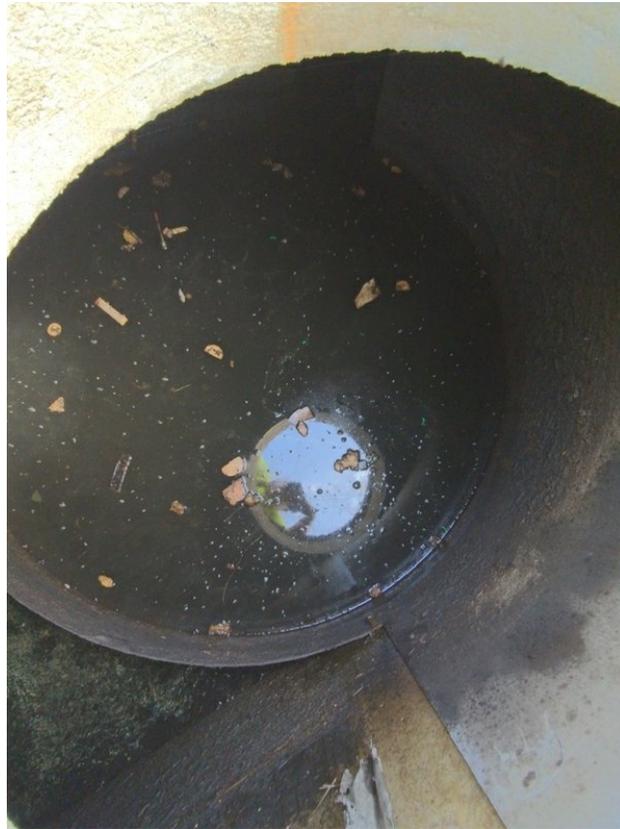
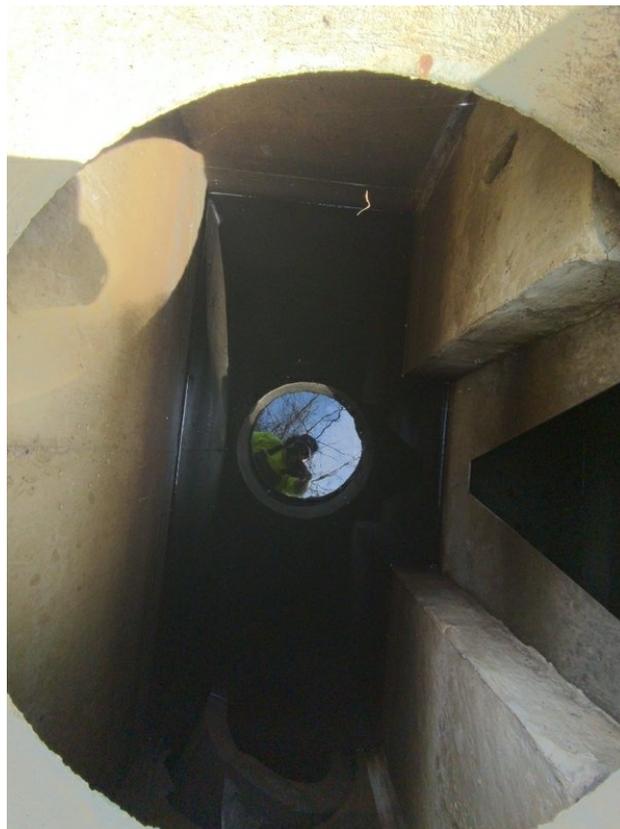
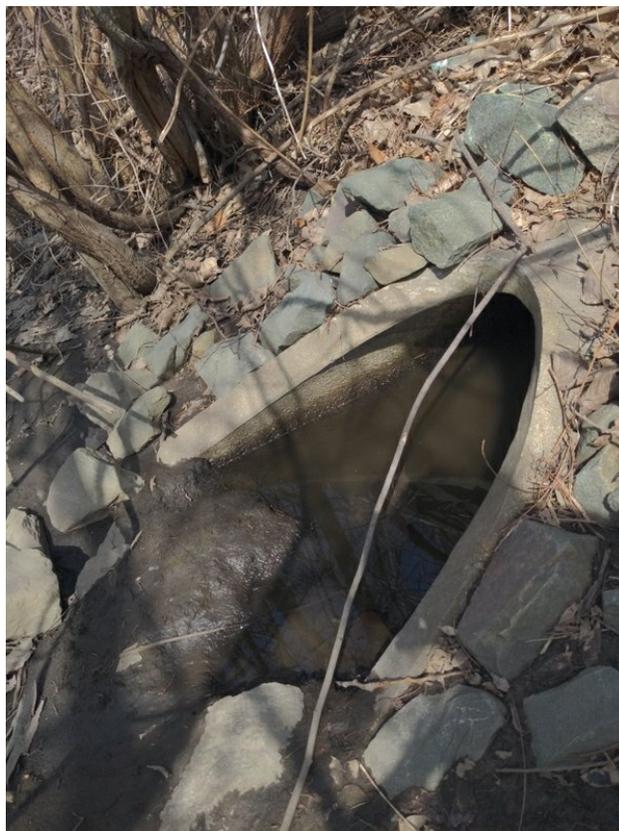
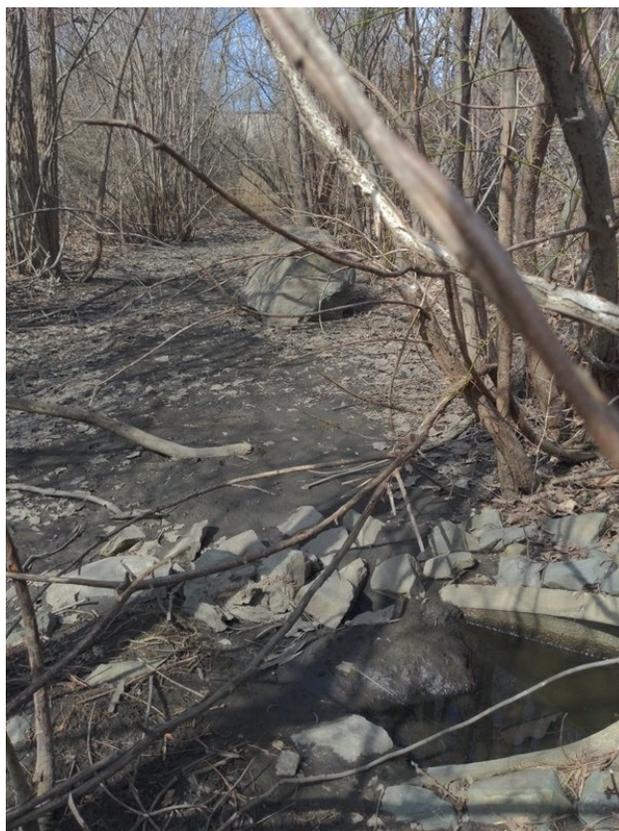
OF-NEW, Vortechincs

Floatables	Yes
Floatables Type	Oil and trash
Floatables Note	Consider cleaning floatables and refer to Vortechincs O &M for cleaning schedule.
Odor	No
General Notes	Vortechincs structures are located in the grass
Surface Photos

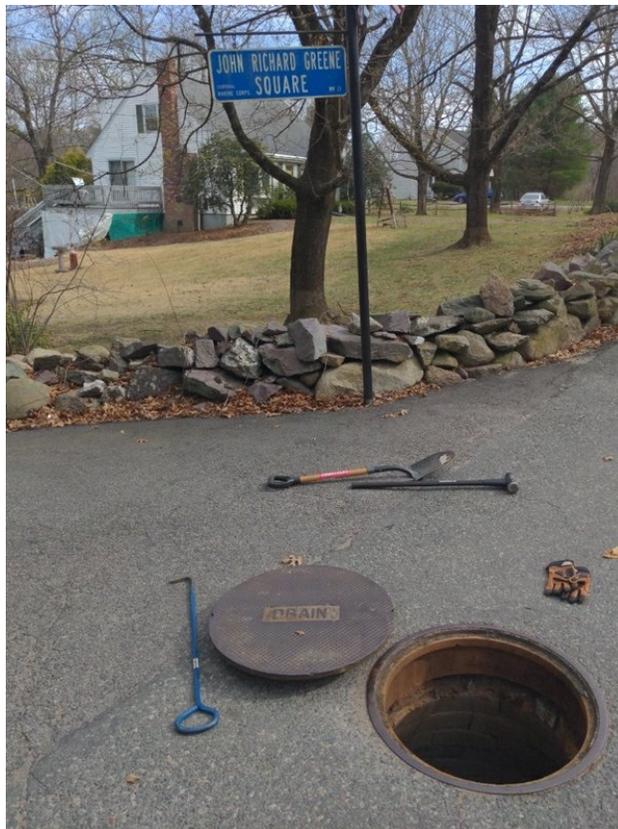
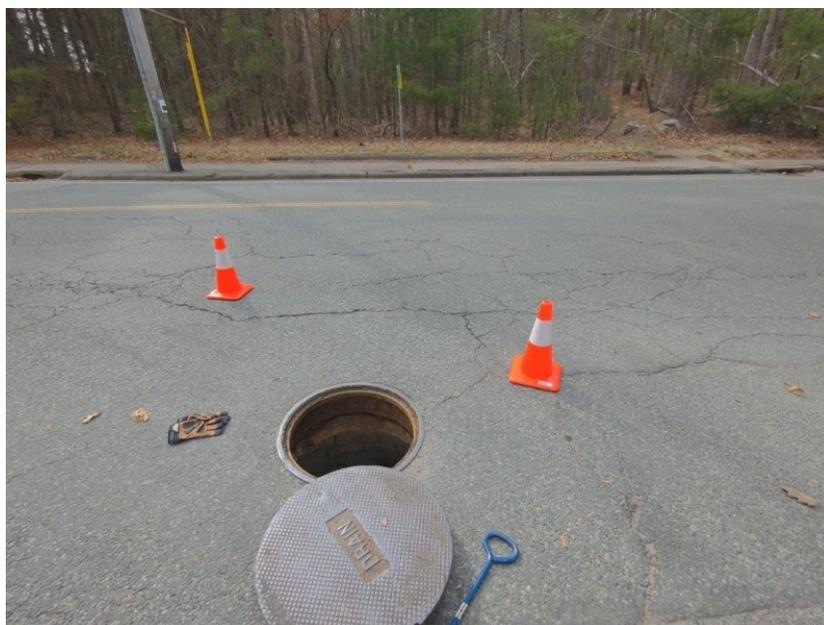
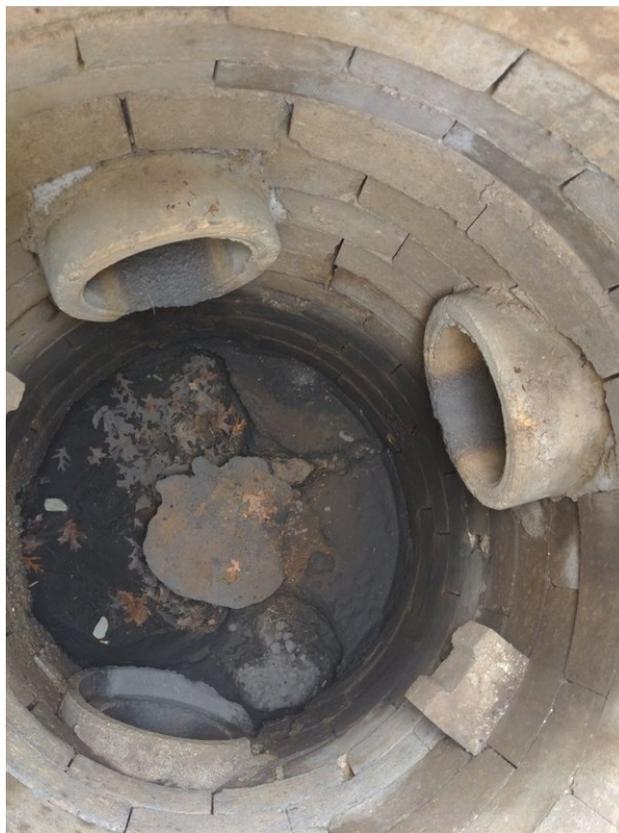
OF-NEW , SWMH-1022

Maintenance Required	Yes
Maintenance Needs	Base of manhole has eroded. Recommend repairing.
Manhole Invert (inches)	93

Pipe Clock Position	11
Flow Direction	In
Pipe Material	RCP
Pipe Diameter (inches)	12
Pipe Invert (inches)	57
Pipes Submerged	No
Flow Present	No
Structure Notes	Erosion observed at the bottom of structure.

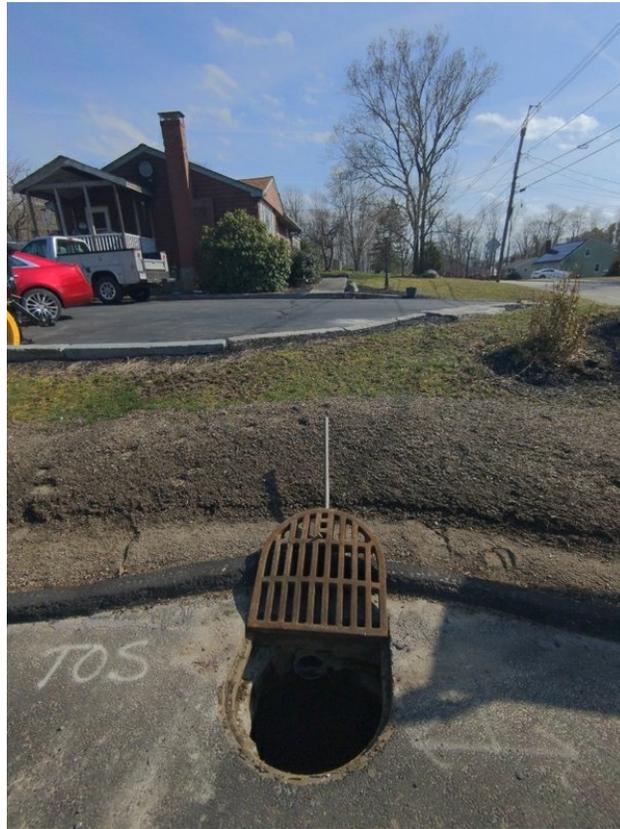
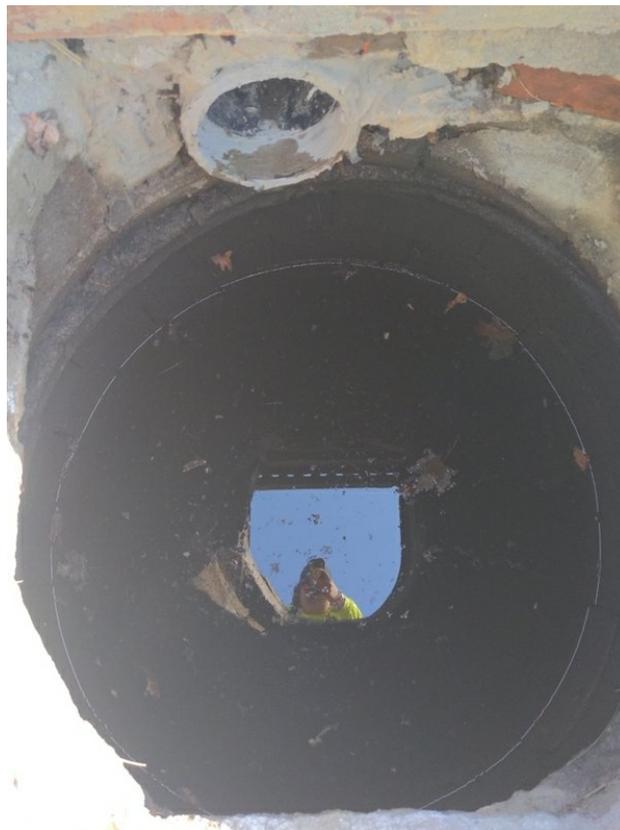
N/A (leaching catch basin), SWIN-1986

Floatables	No
Odor	No
General Notes	No other drainage connected to structure.

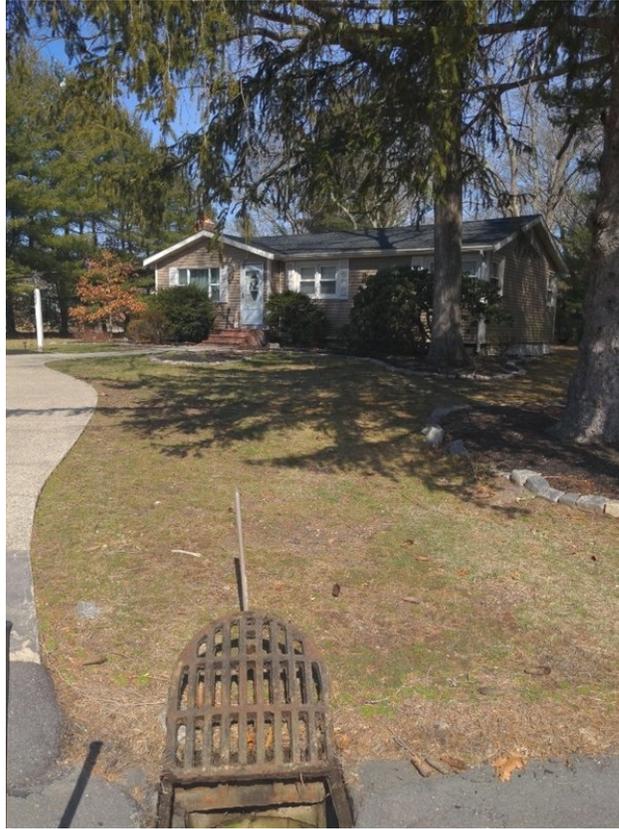
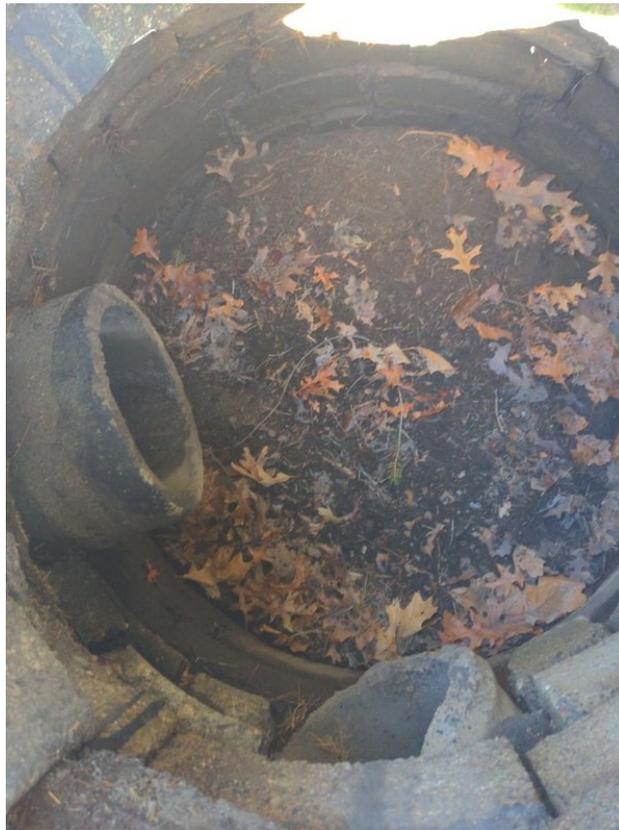
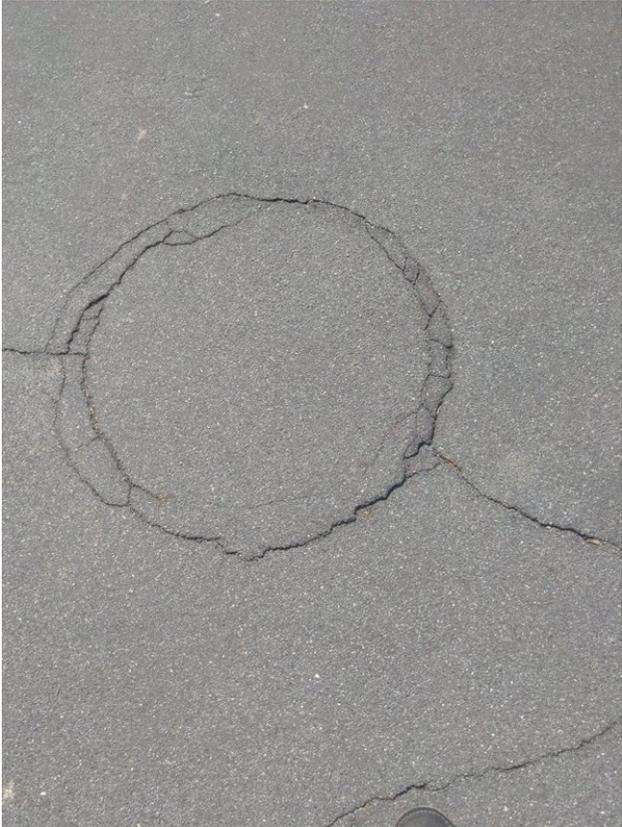
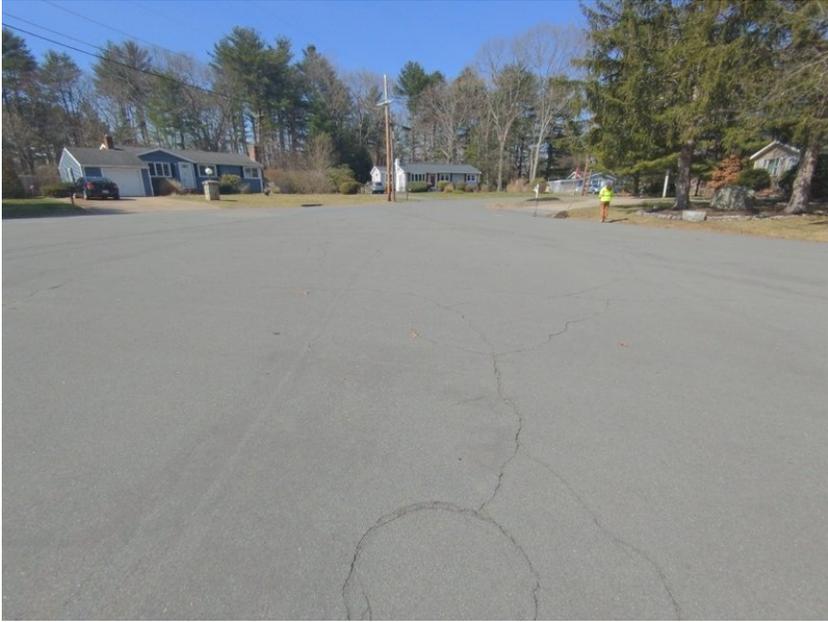
OF-769, SWIN-104

Floatables	No
Odor	No
General Notes	Manhole is completely paved over.

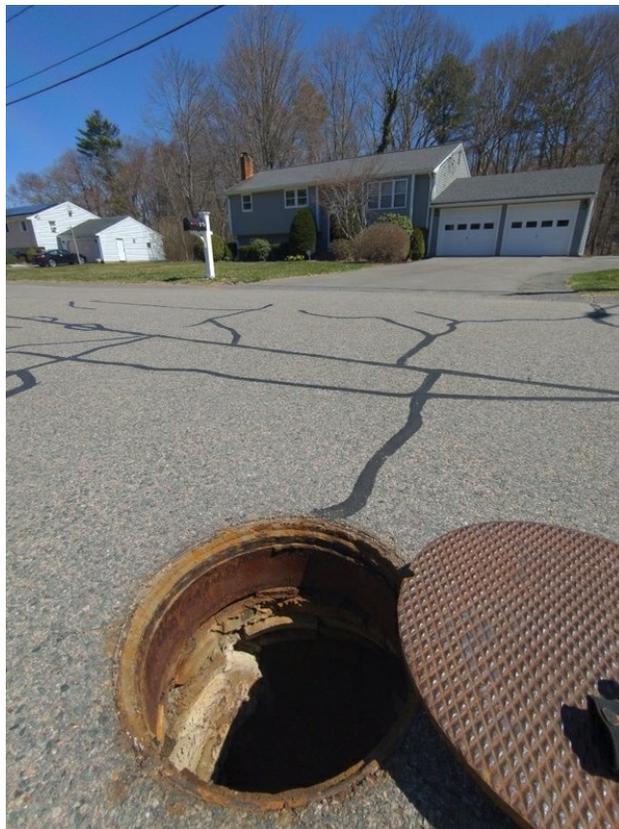
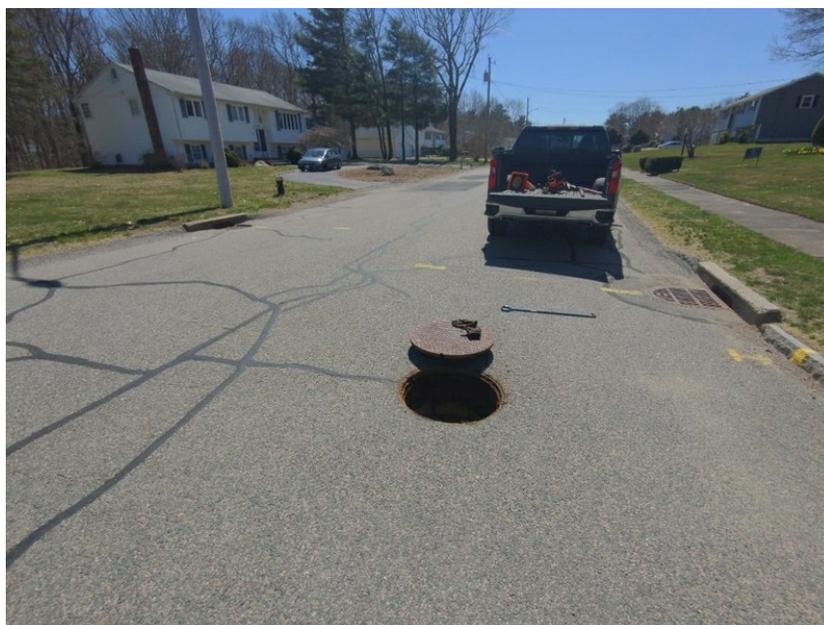
Replacement of the cover and frame is recommended. Severely rust is observed.

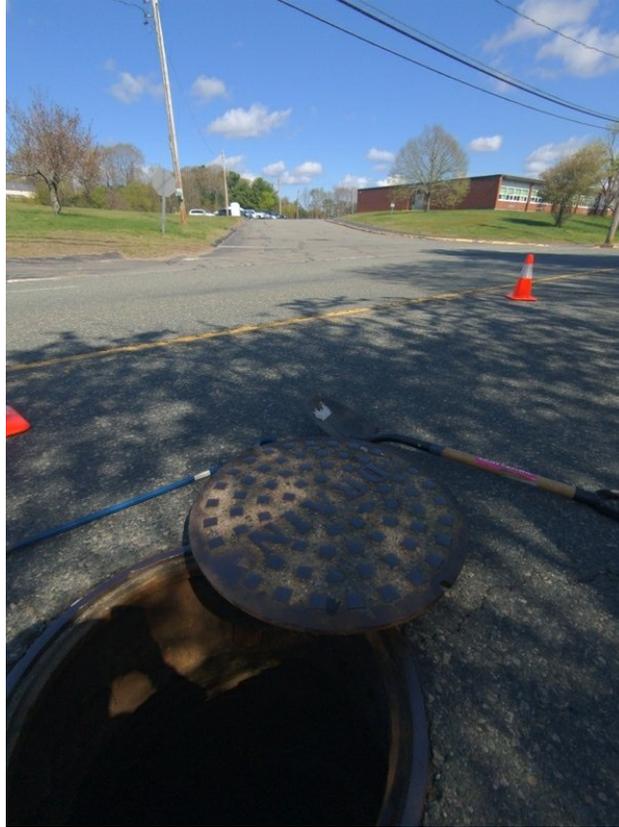
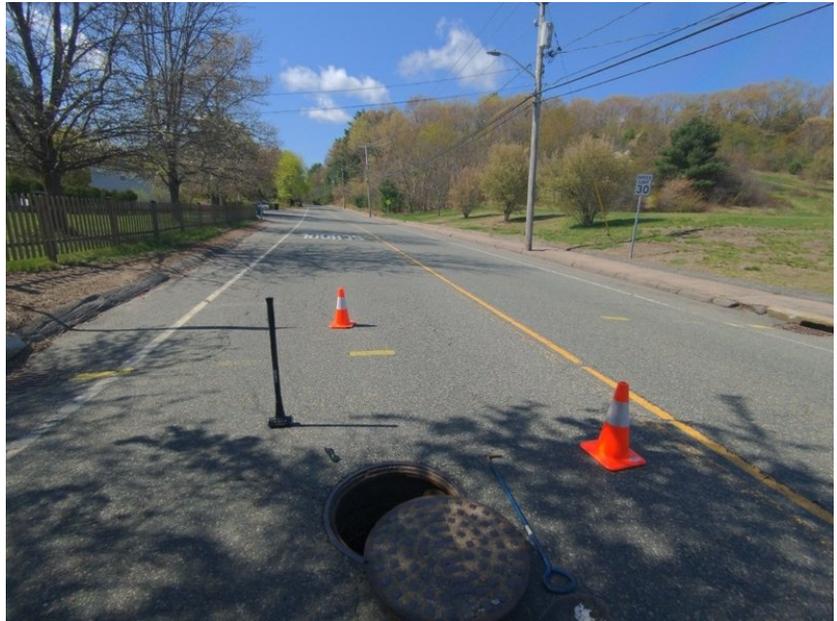
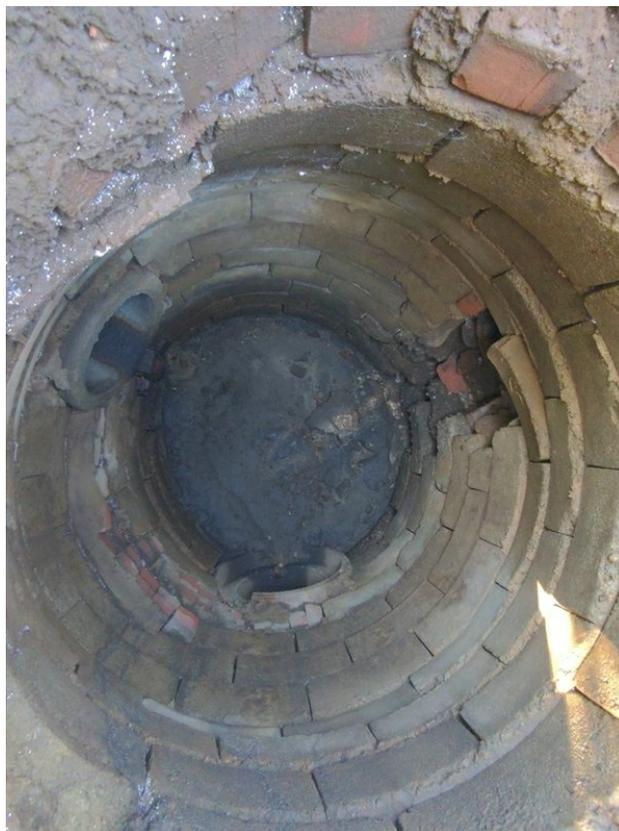
OF-65, SWMH-1021

Maintenance Required	Yes
Maintenance Needs	Debris and bricks found at the bottom of the structure and needs to be cleaned
Manhole Invert (inches)	78

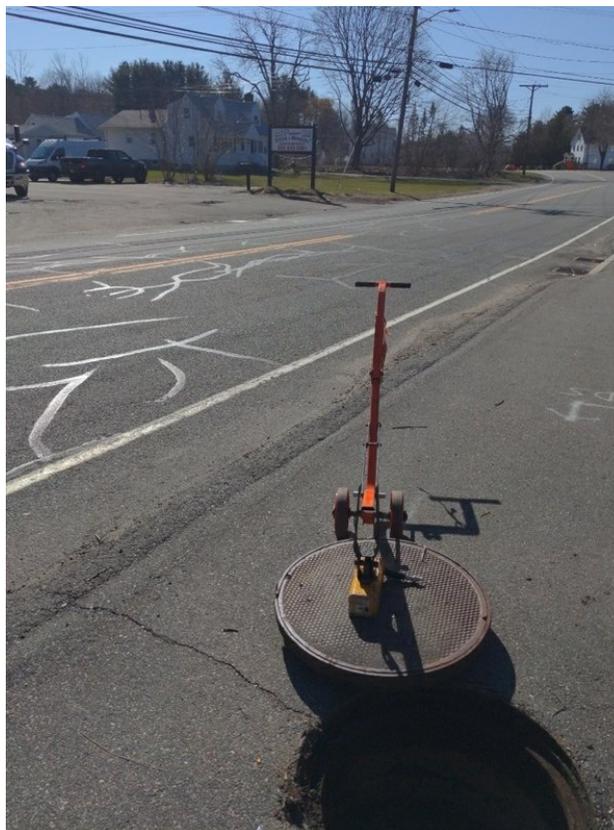
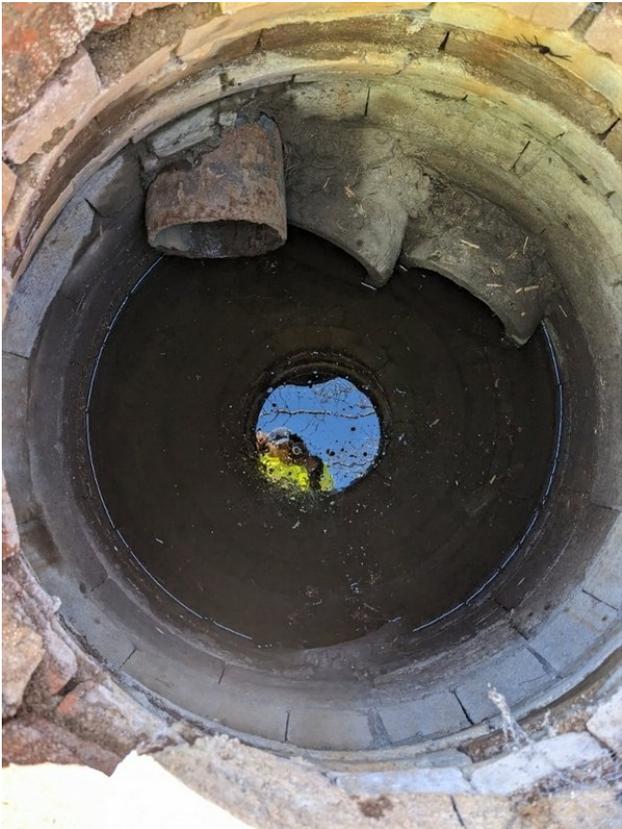
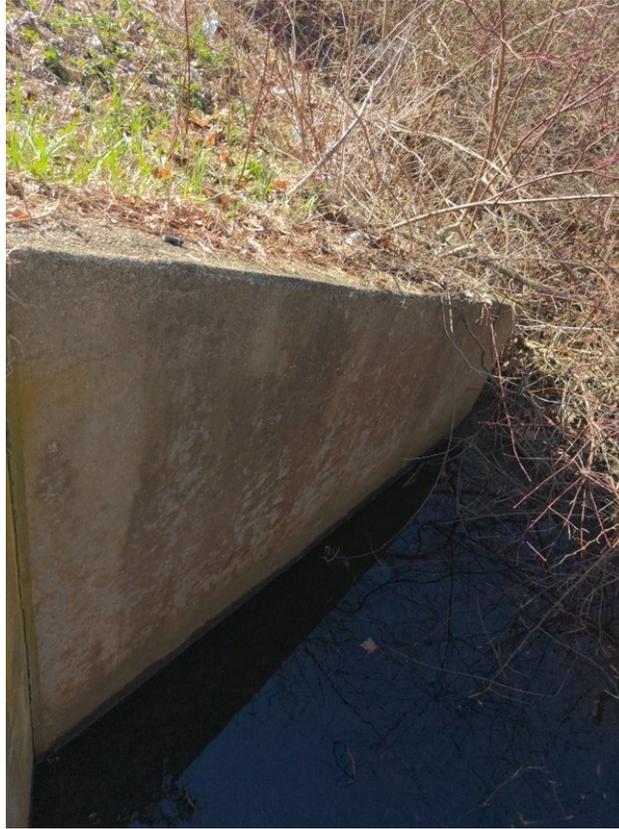
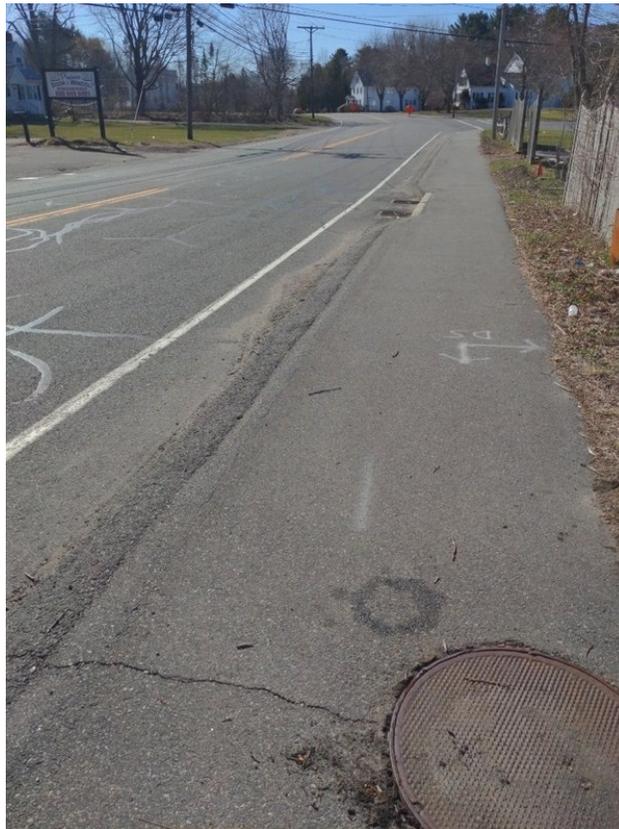
OF-801, SWMH-456

Maintenance Required	Yes
Maintenance Needs	Regrade the manhole structure and dewater the standing water. Replace cover and frame; when opening structure, frame came off with cover.
Manhole Invert (inches)	76

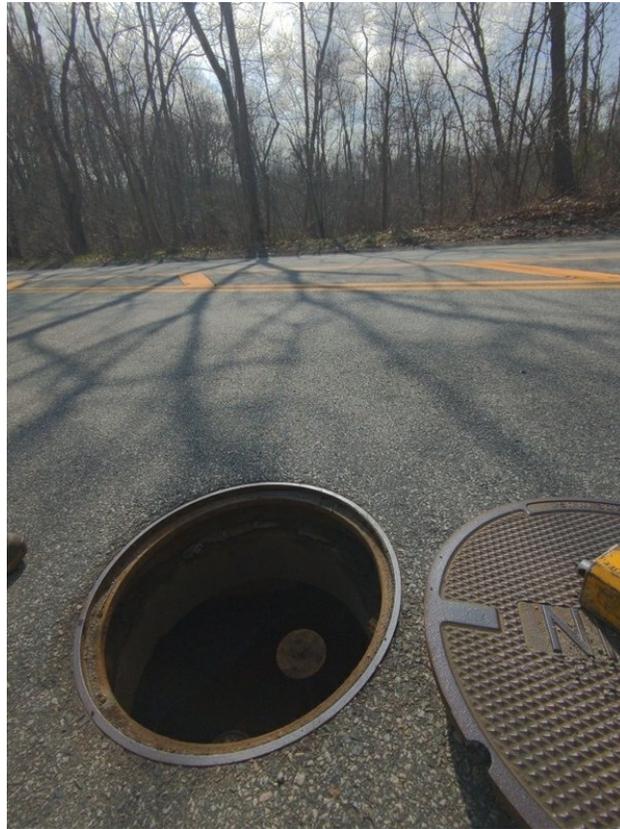
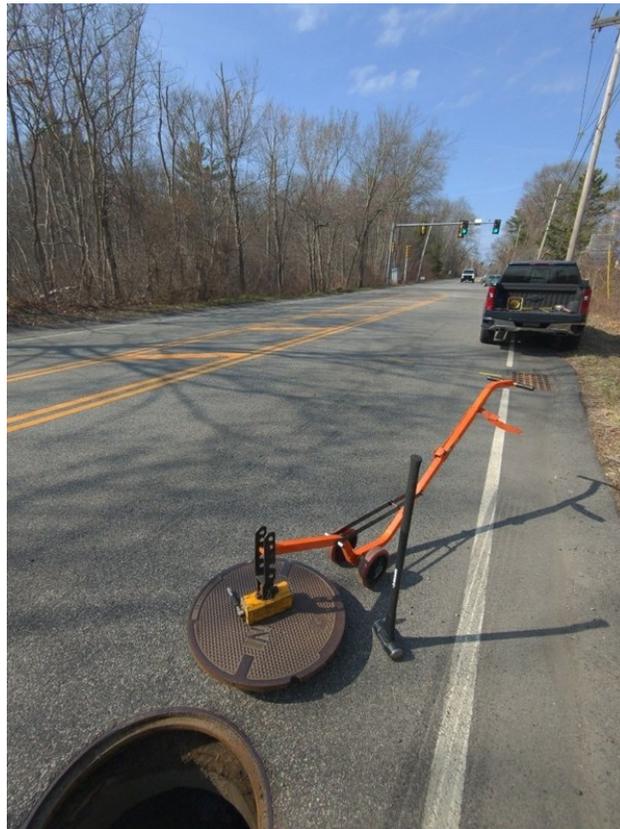
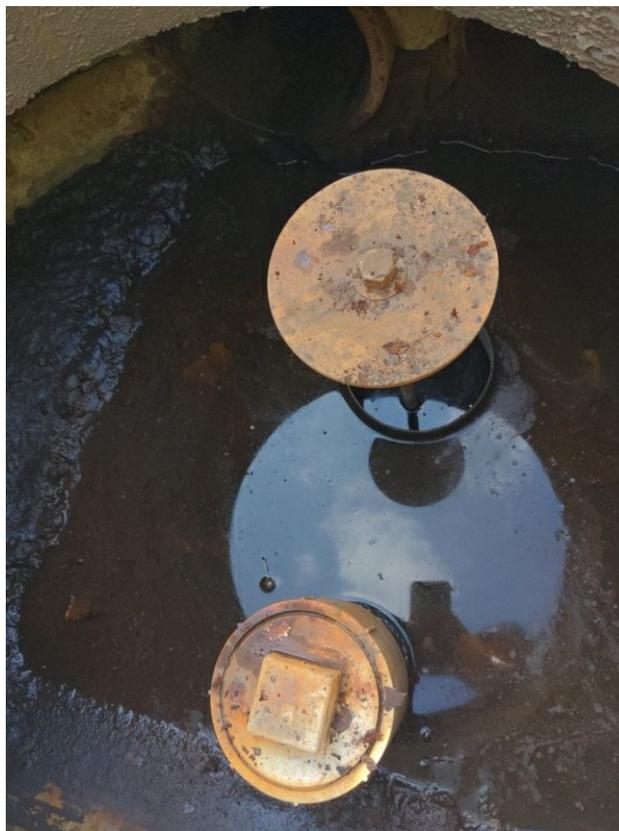
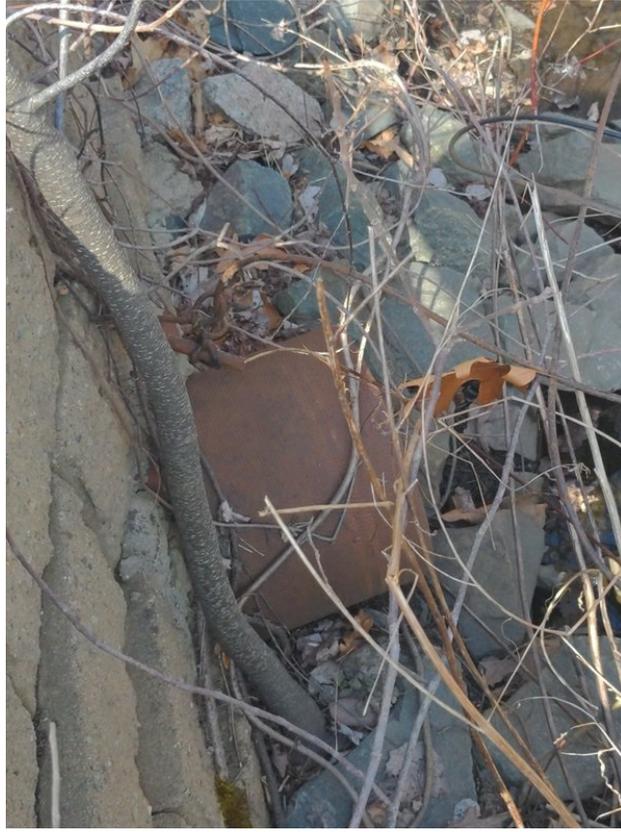
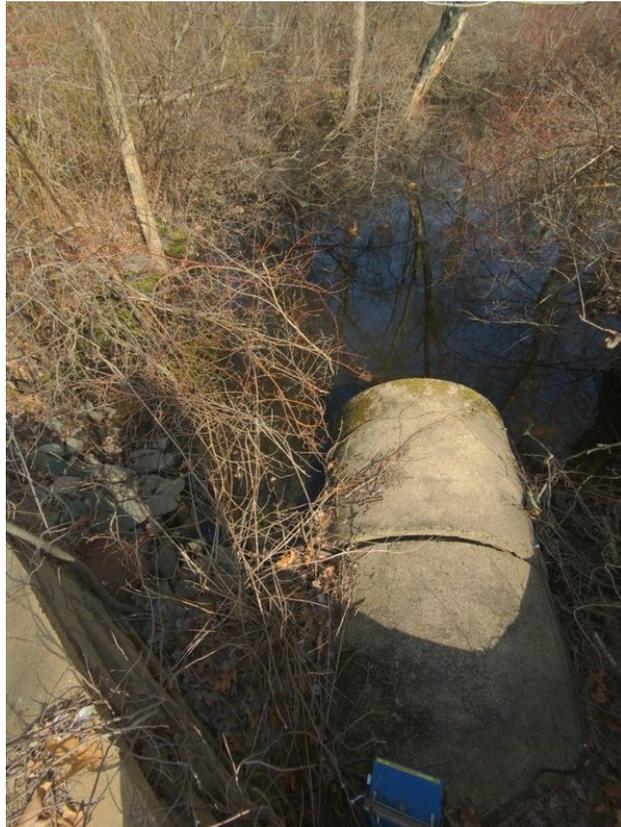
OF-616, SWMH-1696

Floatables	Yes
Floatables Type	Oil
Odor	No
General Notes	Clean floatables per O&M plan. Culvert has flow meter.
