ILLICIT DISCHARGE DETECTION AND ELIMINATION (IDDE) PLAN

Town of Stoughton

September 2023

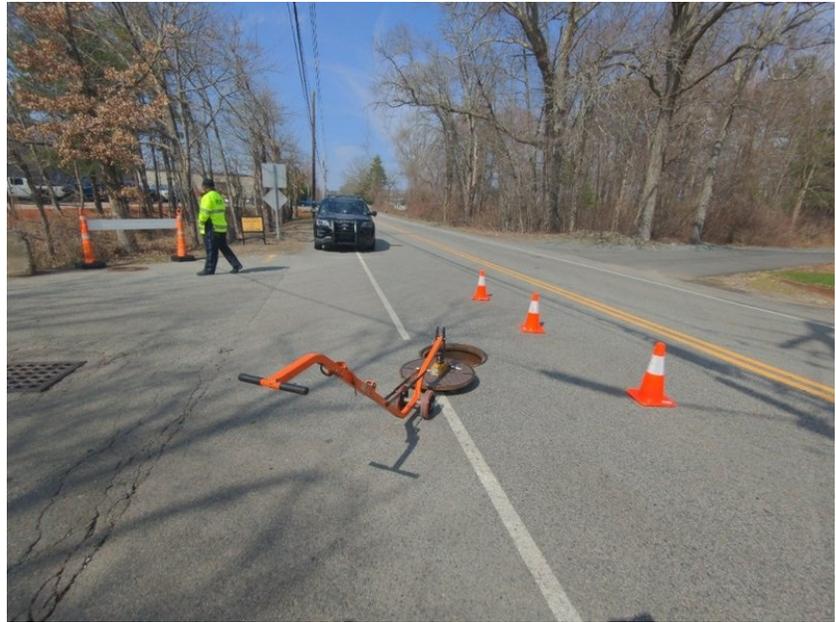
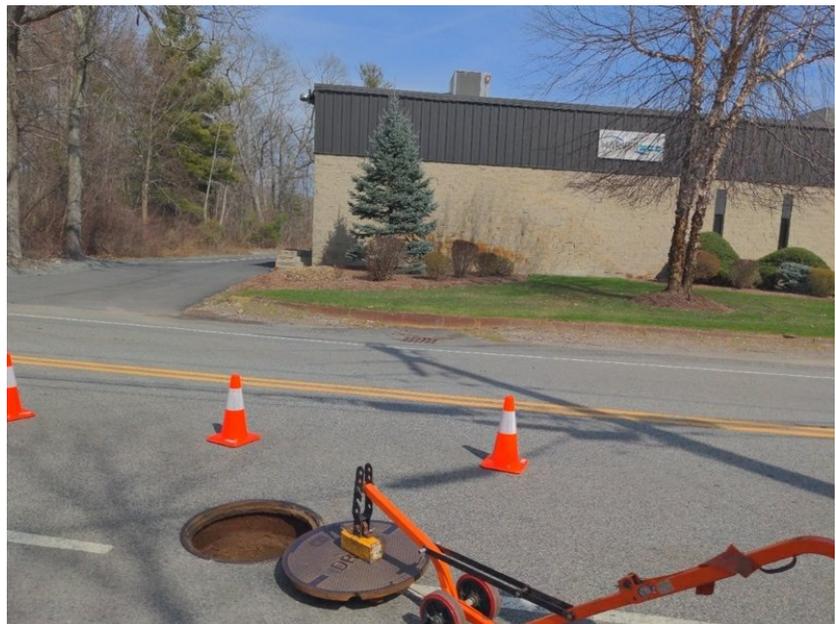
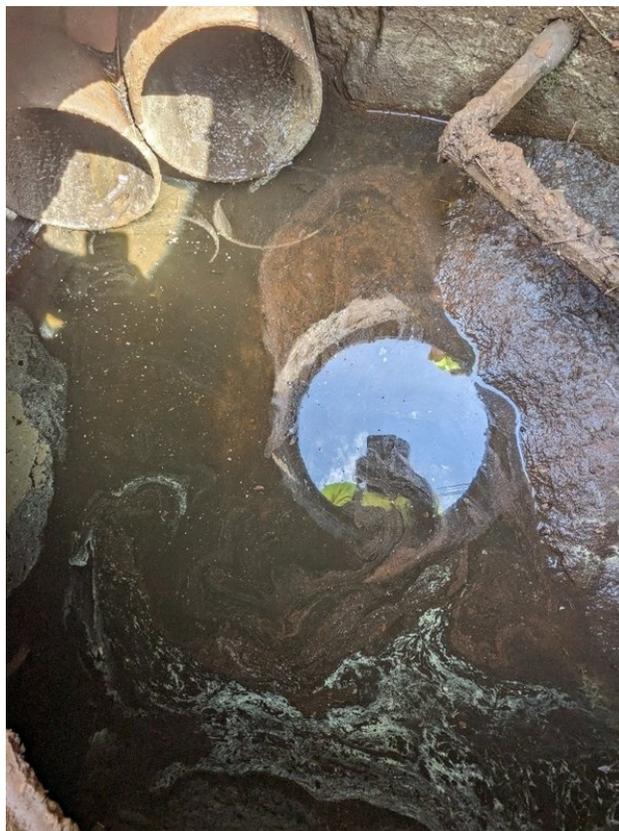
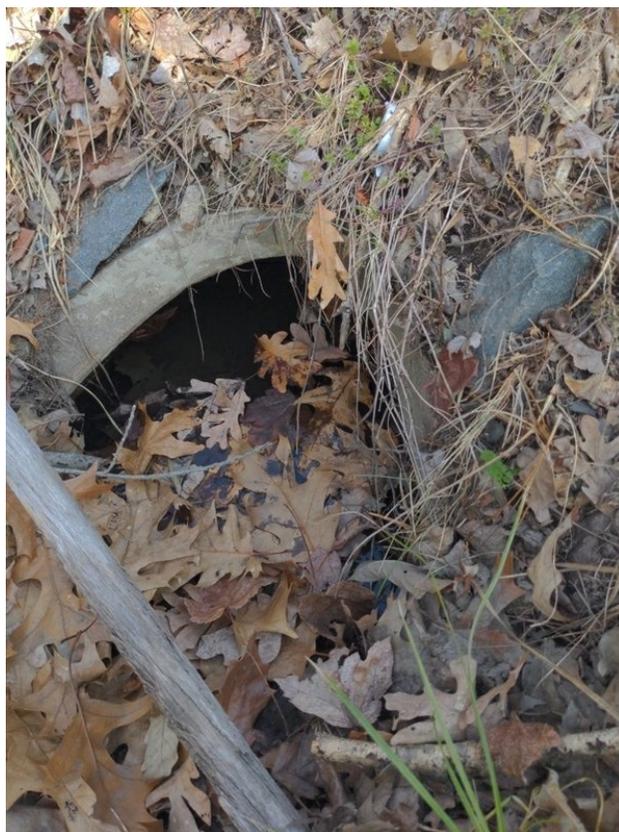
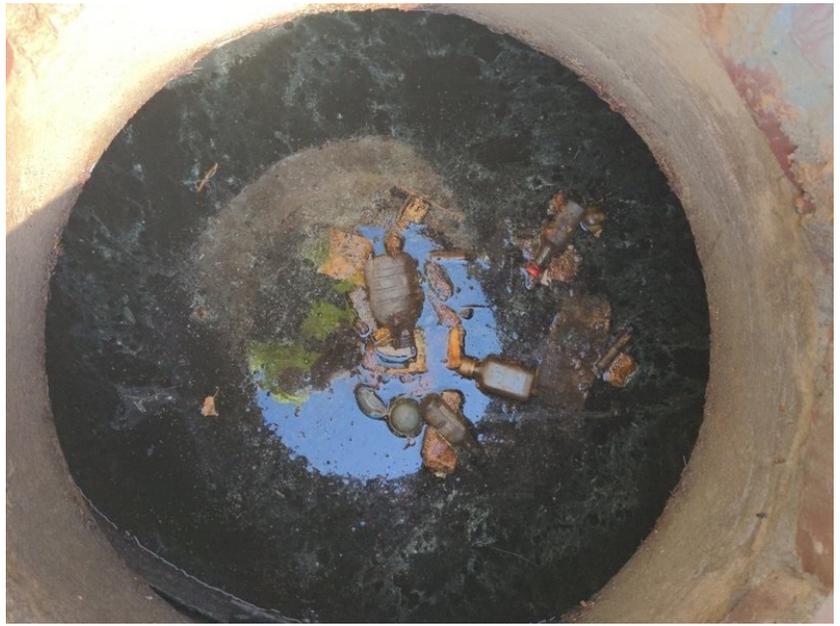
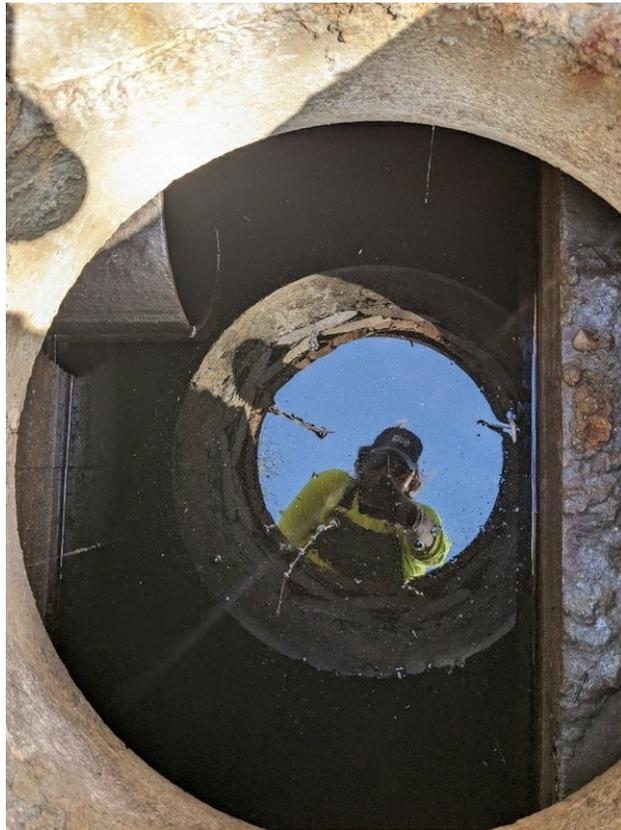
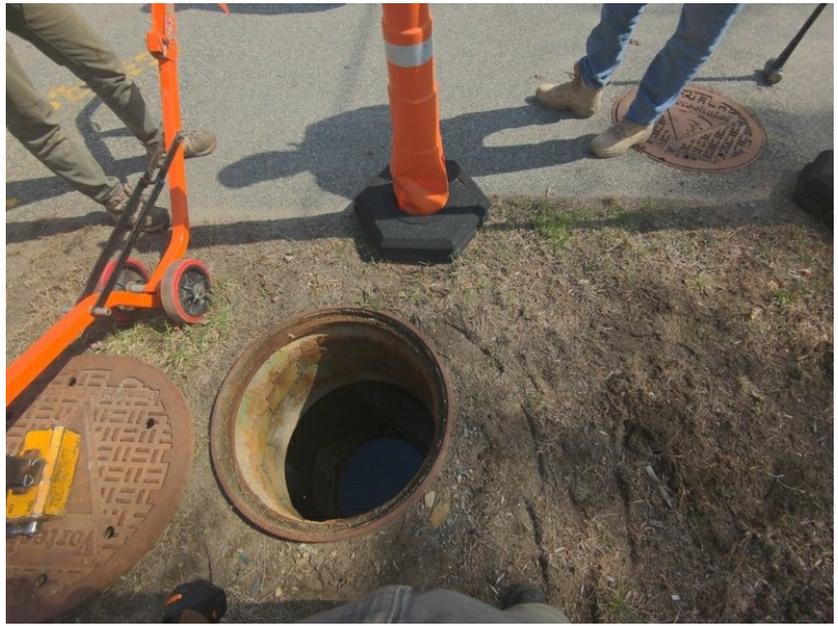
OF-754, SWMH-1695

Floatables	No
Odor	No
General Notes	Vortechnics structures should be cleaned. Refer to O&M to cleaning schedule. The structures are located in front of the Metropolitan Trucking Center Inc. building on 1074 Turnpike St.

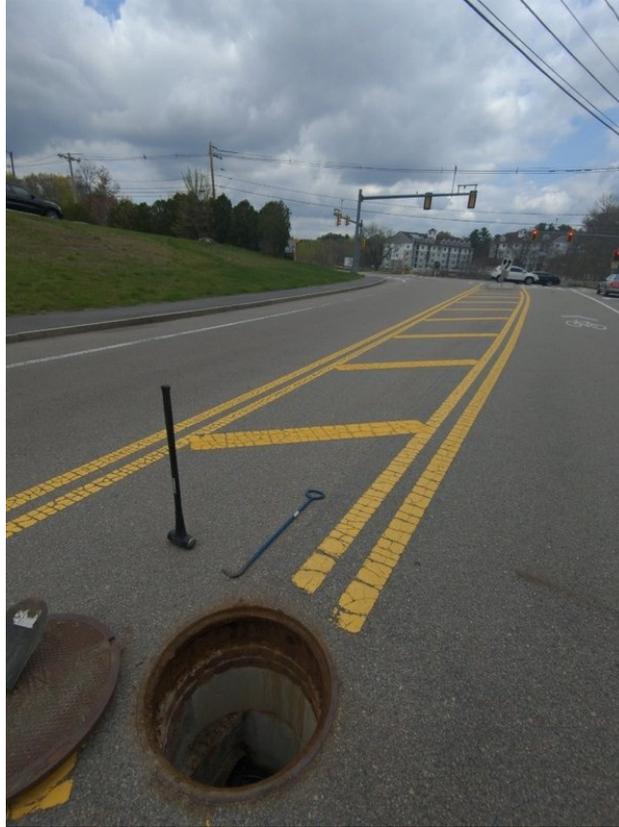
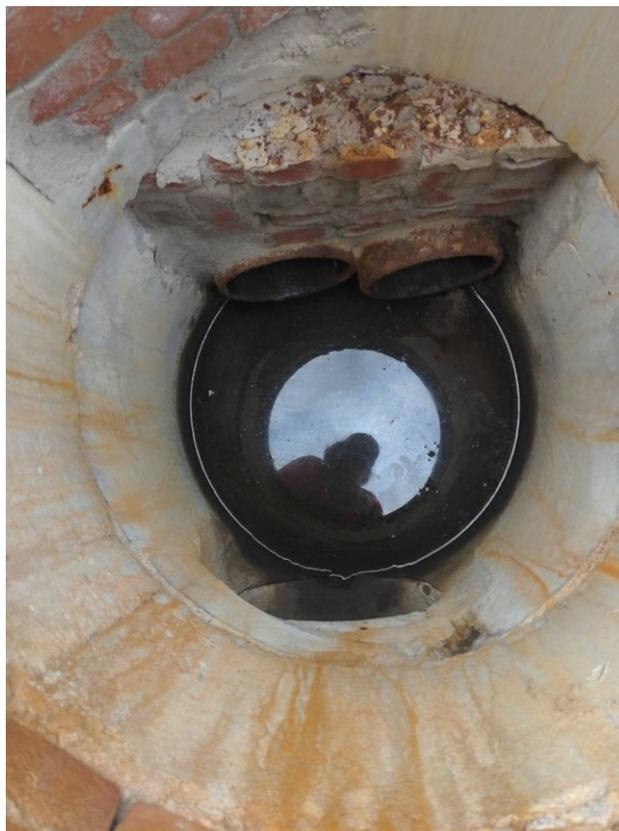
OF-65, SWMH-NEW

Pipes from catch basin are dual pipes.

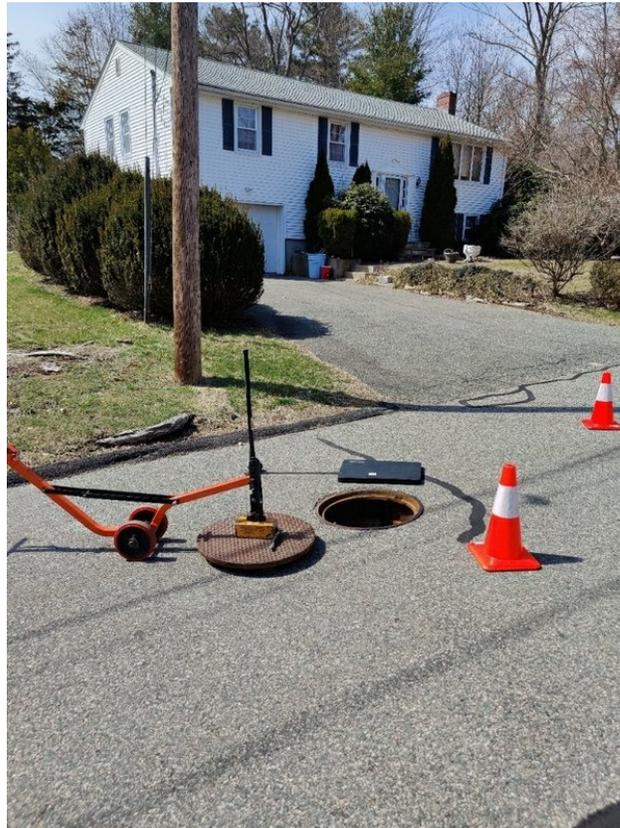
General Notes Grate and rim on SWIN-504 needs to be replaced

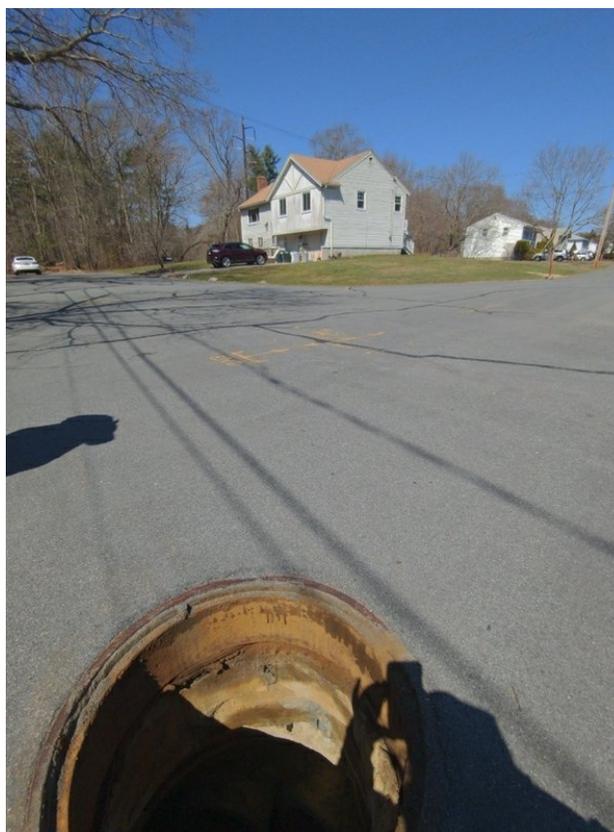
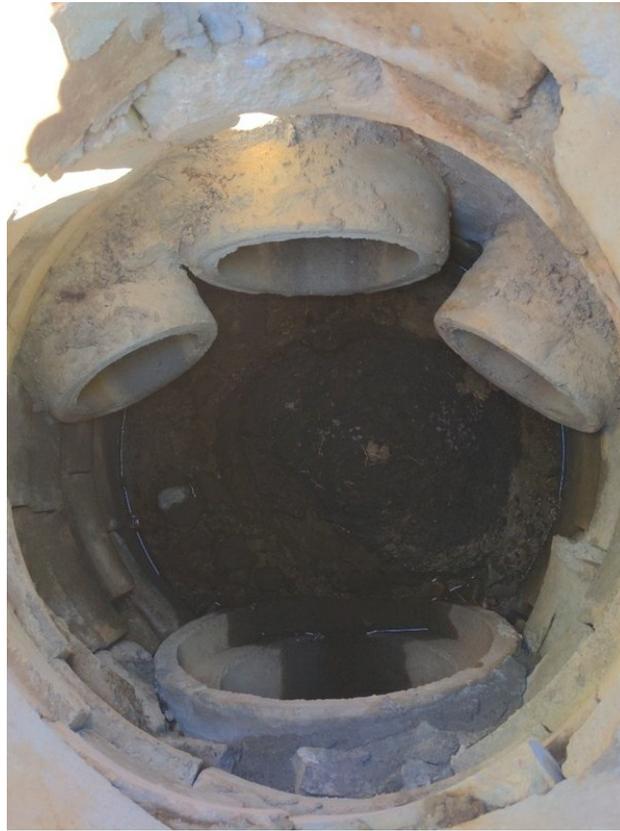
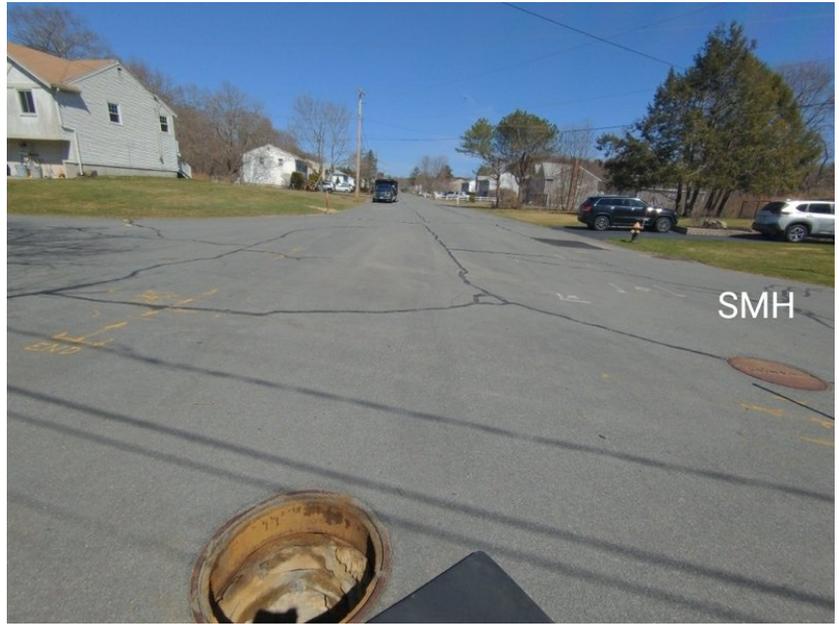
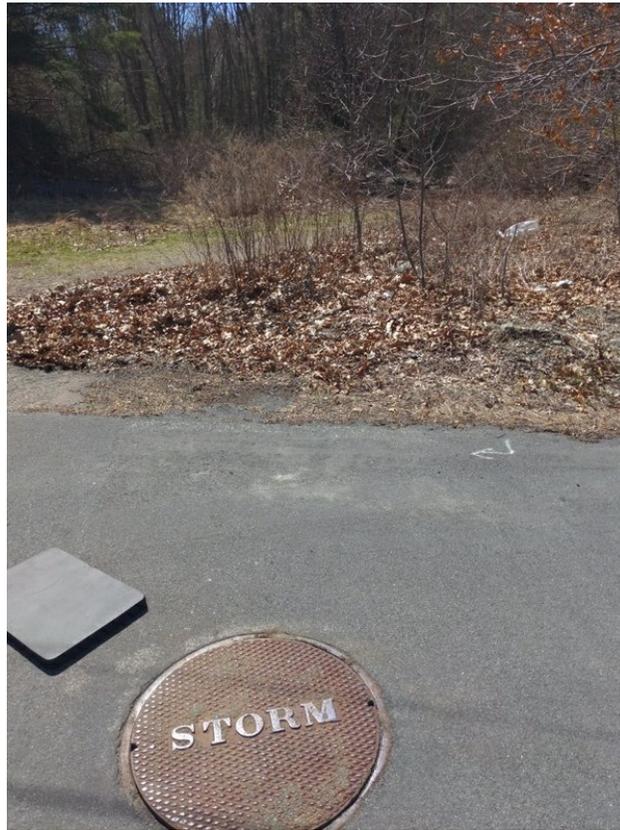
Floatables	No
Odor	No
General Notes	Erosion around the outfall. The pipe segment is dislodged.

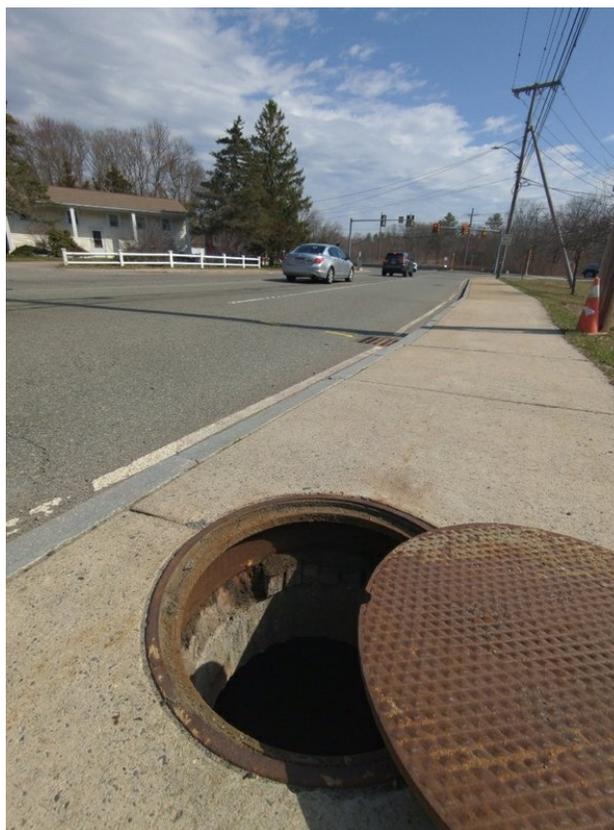
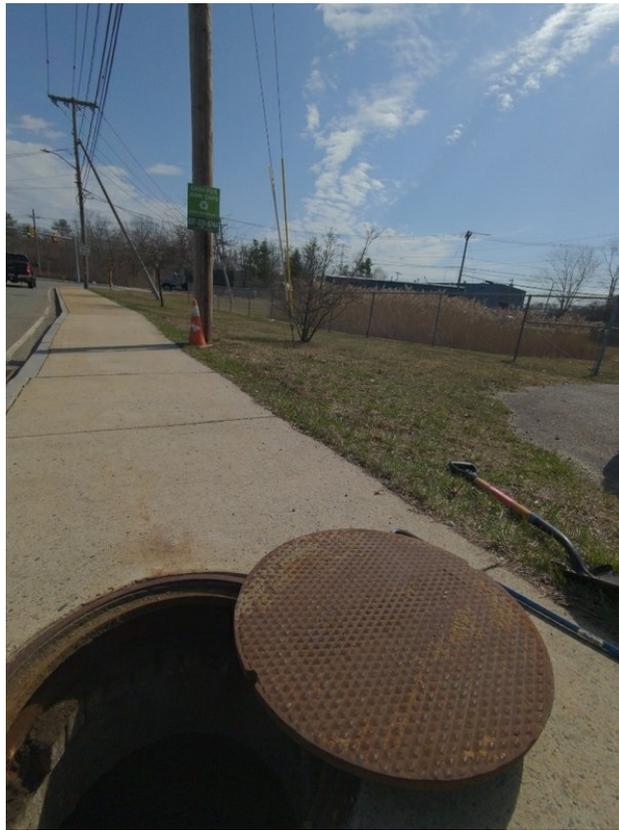
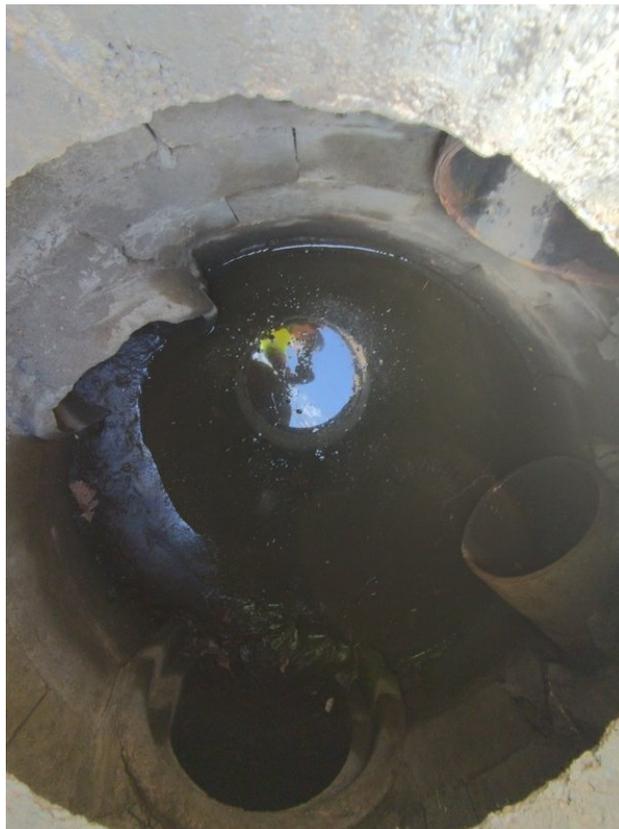
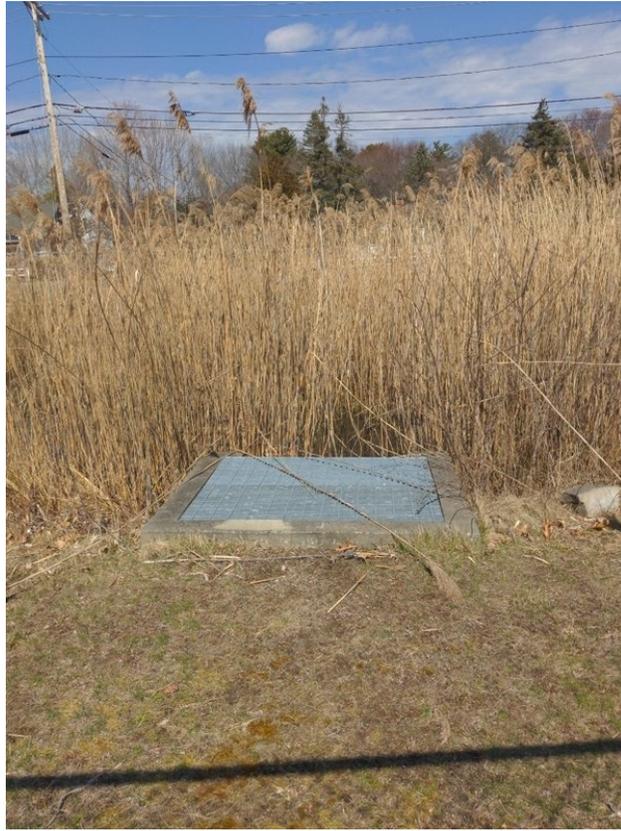
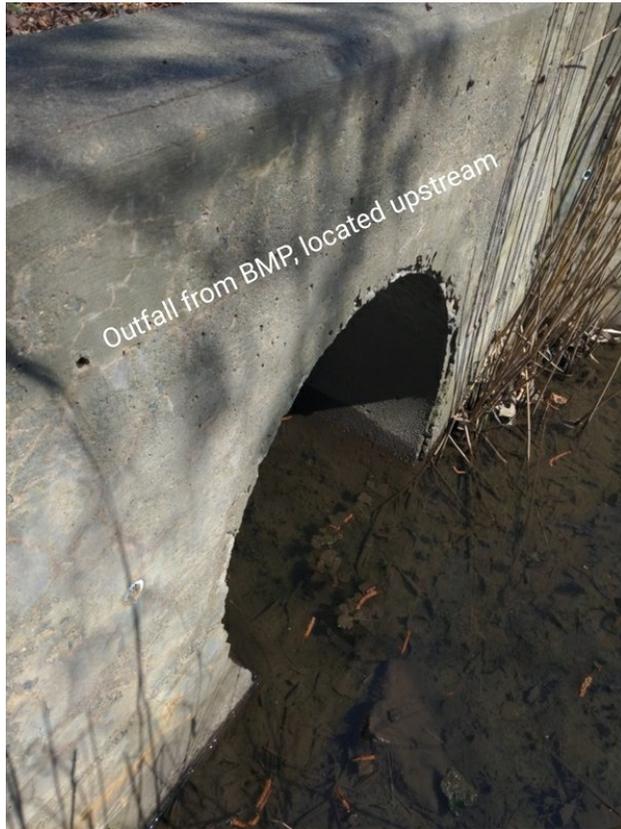
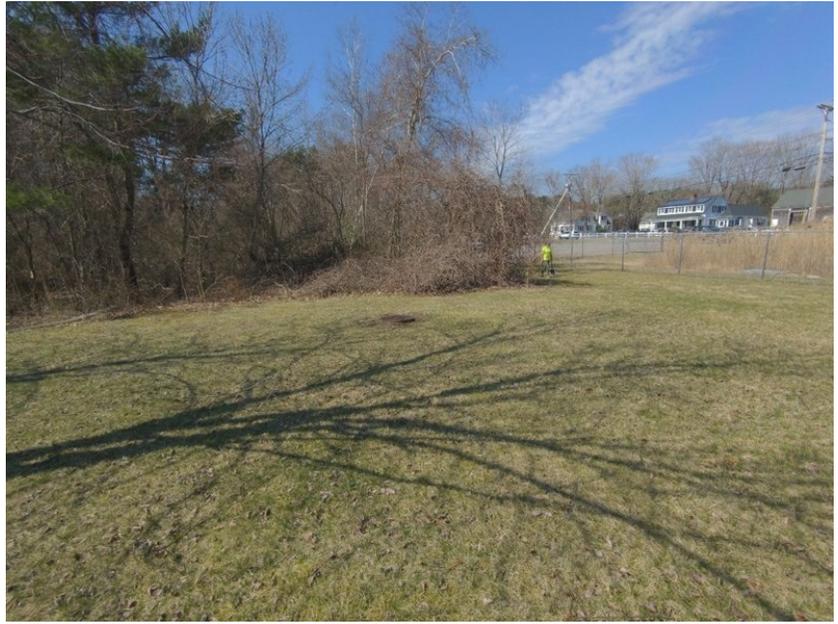
OF-NEW, SWMH-1789

Pipe Diameter (inches)	15
Pipe Invert (inches)	50
Pipes Submerged	Partially
Submerged Pipes	6:00 and 10:00
Flow Present	Yes
Flow Description	Trickle
Flow Source	2:00; trickle but not enough to sample
Structure Notes	Debris found in outgoing 6:00 and incoming 10:00 pipes

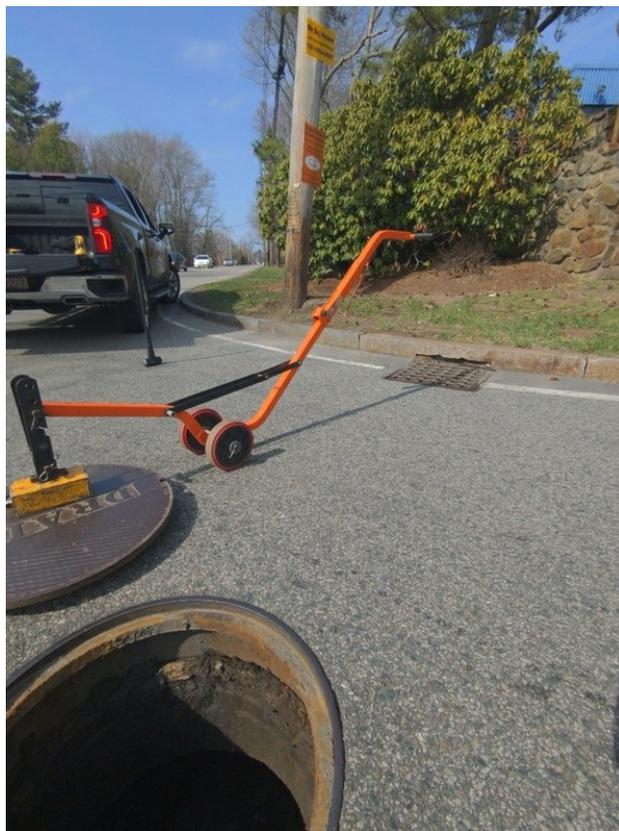
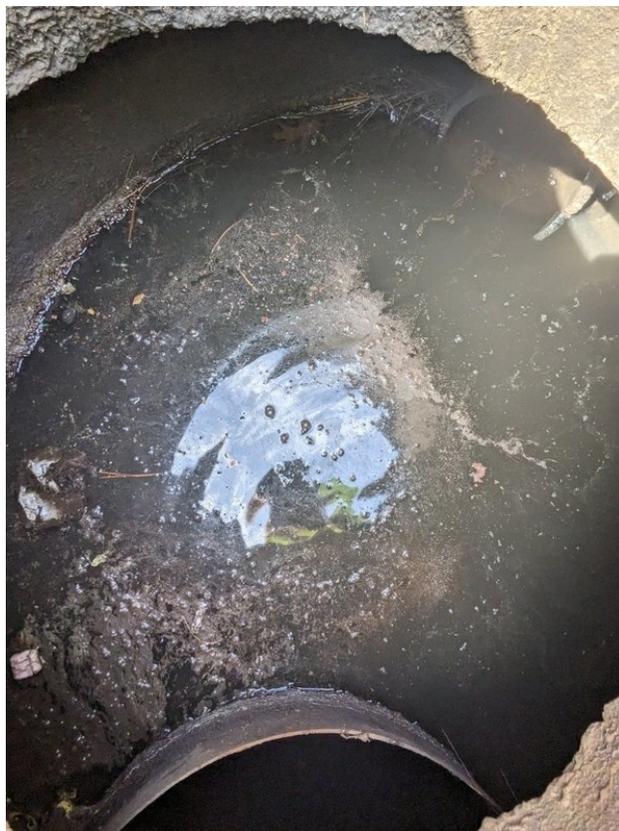
OF-616, SWMH-2041

Floatables	Yes
Floatables Type	Oil
Odor	No
General Notes	Both the outgoing and incoming pipes have deposits and should be cleaned.

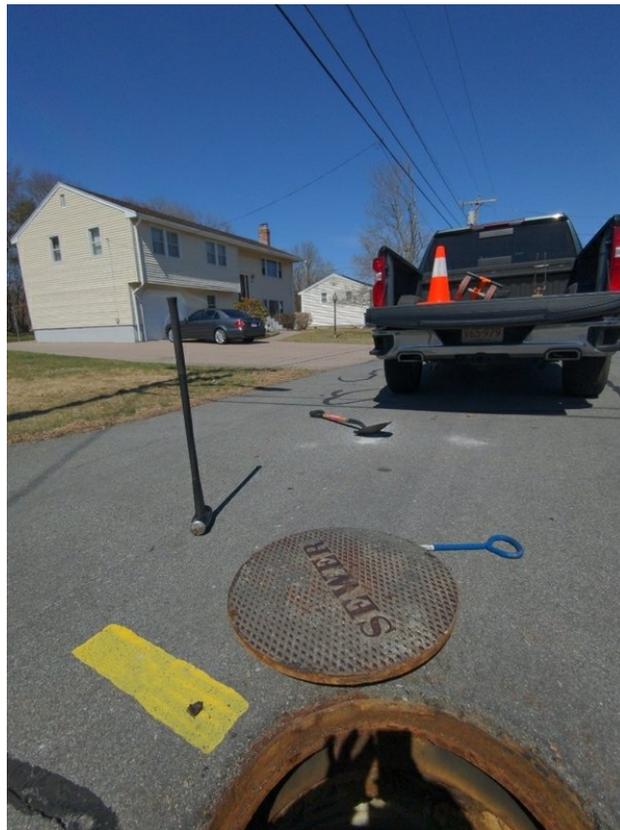
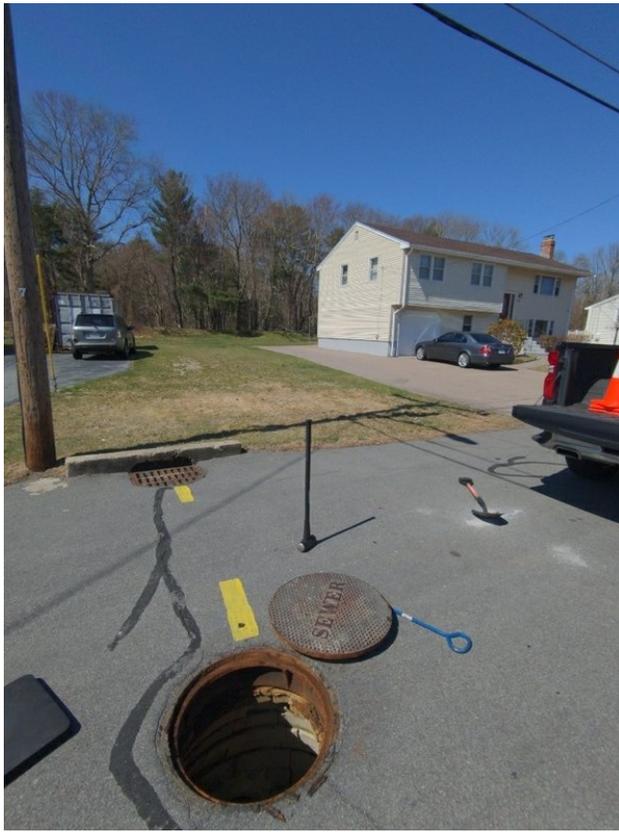
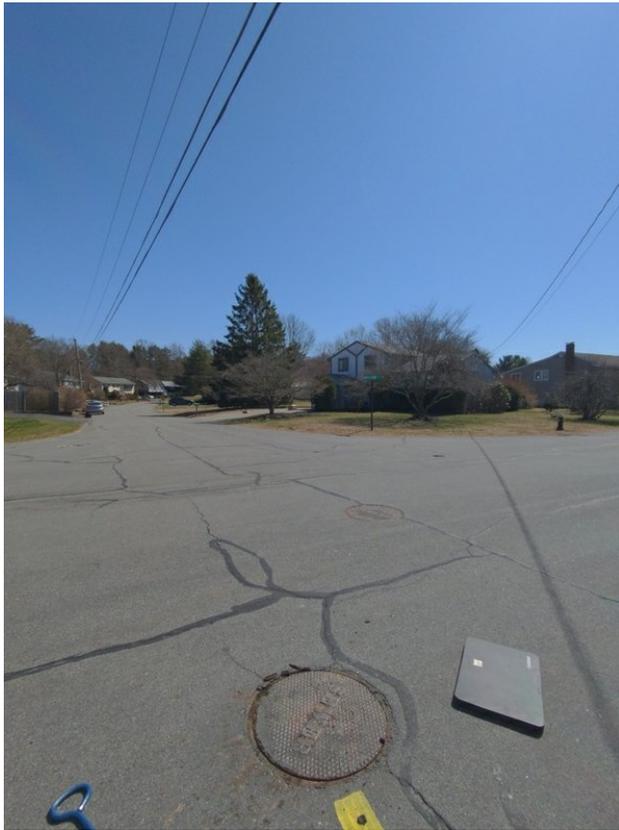
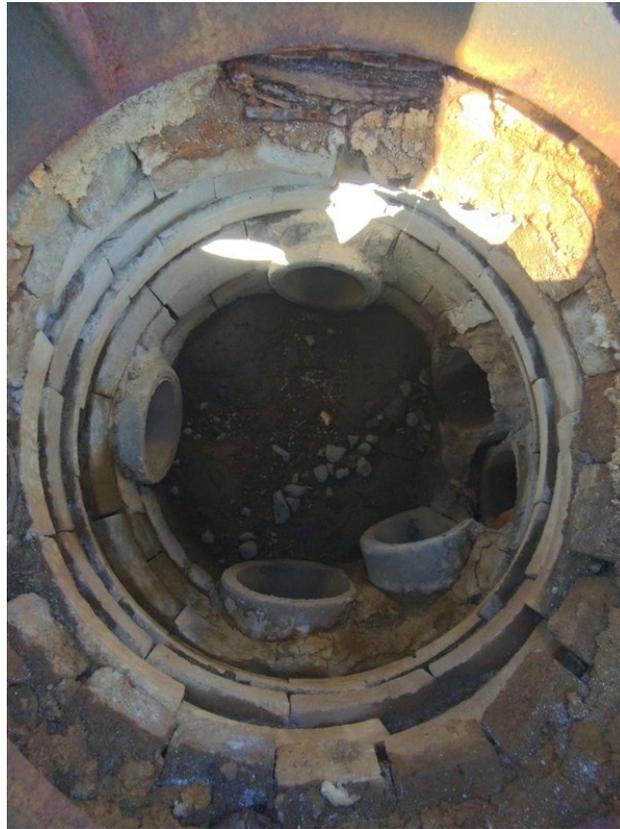
OF-463, SWMH-124

Floatables	No
Odor	No
General Notes	Manhole cover says SEWER.

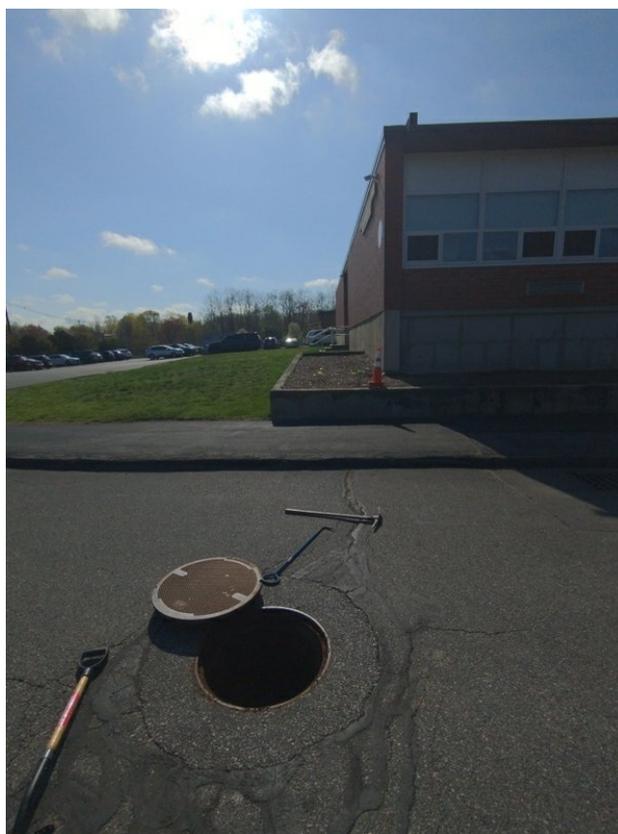
OF-65, SWMH-1232

Maintenance Required	Yes
Maintenance Needs	Debris and bricks found at the bottom of the structure. Cleaning recommended.
Manhole Invert (inches)	89

Confirm with Town if 9:00 incoming pipe is abandoned.

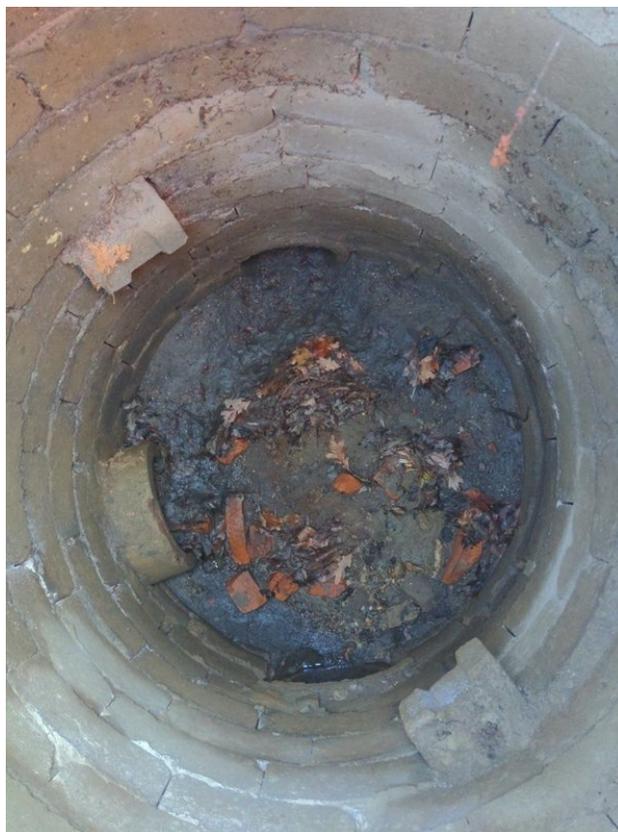
Interior Photos

Maintenance Required	Yes
Maintenance Needs	Cleaning. Floatables observed
Manhole Invert (inches)	63
Pipes Submerged	Fully
Flow Present	No
Structure Notes	Unable accurate readings on pipe details. Mapping seems accurate; Town to assist in locating outfall

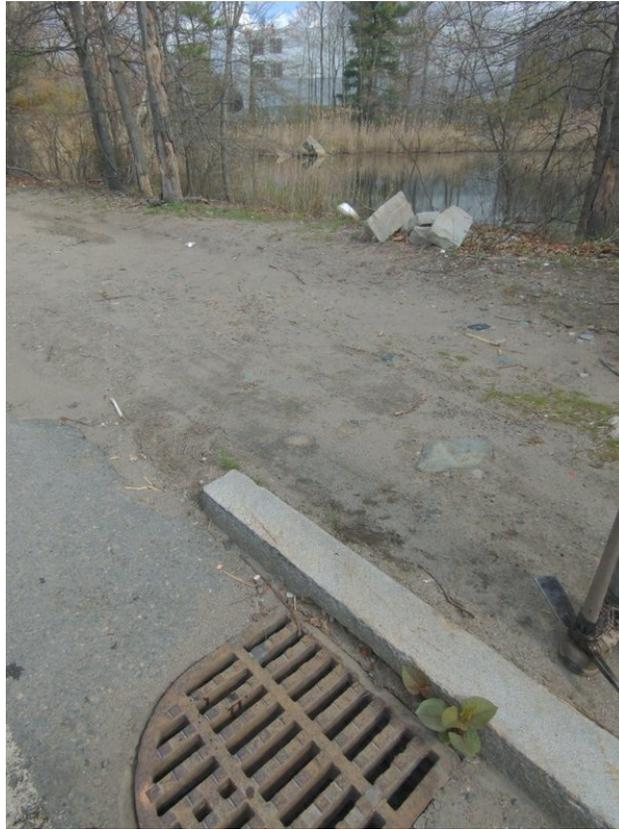
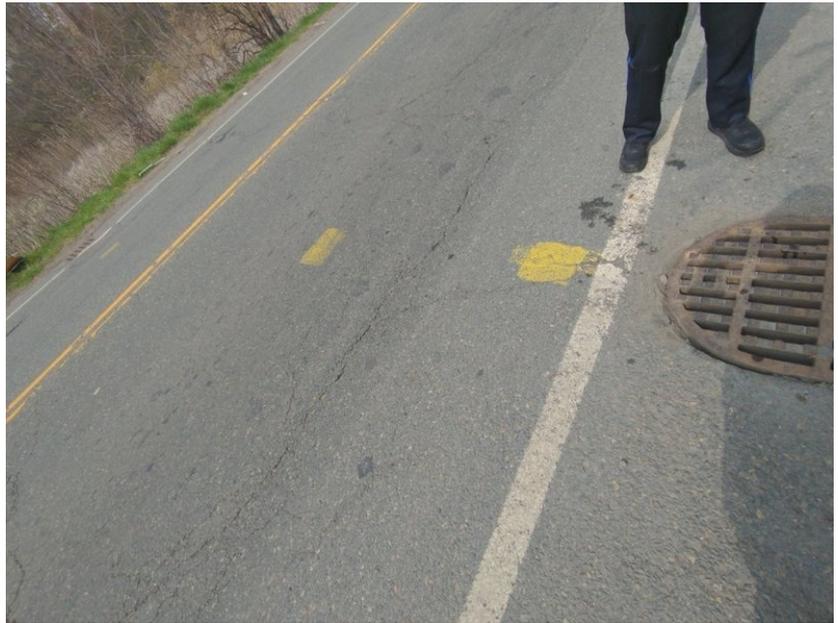
Floatables	Yes
Floatables Type	Trash and oils
Floatables Note	Cleaning recommended
Odor	No
General Notes	Cannot locate outfall.
Surface Photos

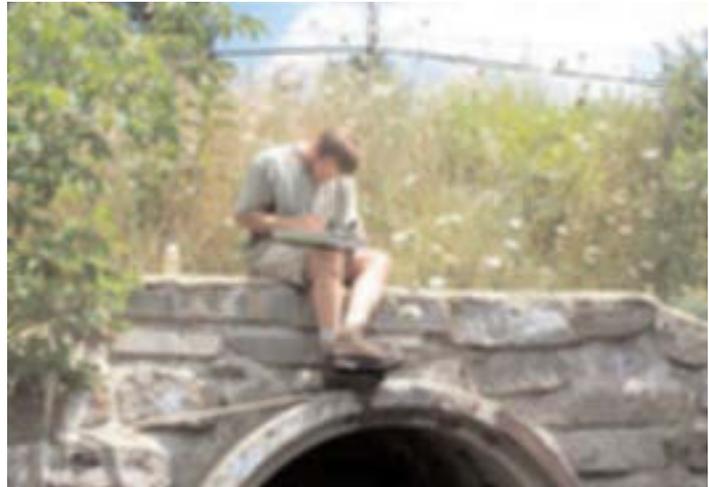
(and the permitting authority) can locate any specific outfall to check on discharges. The most basic way to meet the mapping requirement is to use an existing map (e.g., a topographic map) that shows receiving waters. You can then mark outfall locations on the map by hand (using existing information augmented by a field survey). Make sure the names of receiving waters are shown on the map; for receiving waters that don't have names, it is helpful to indicate the nearest named water body downstream. The graphic at the beginning of this chapter shows an example of a marked-up United States Geological Survey map (markings do not represent actual outfalls). The next step up is a more sophisticated paper map (e.g., blueprint-style). Figure 1 presents an example of a simple paper map showing outfalls and other key features of the storm sewer system.
