# WM Avon MRF: Material

# WM Avon Fire

## Avon Fire Overview

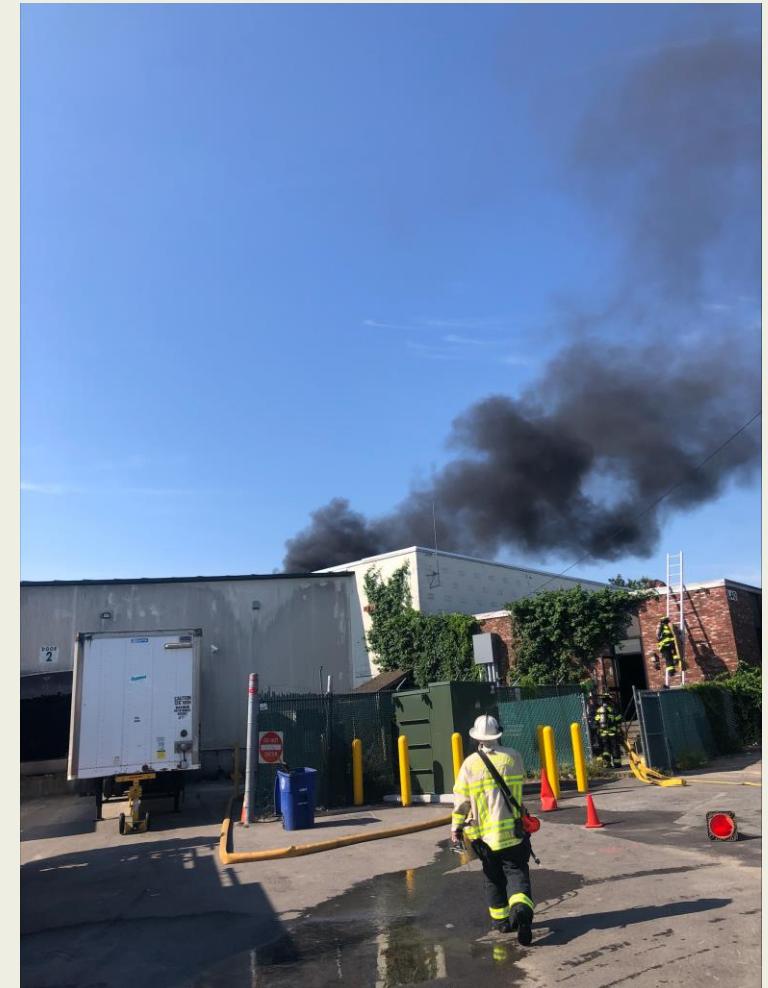
On 7/22/24 8:30am a fire started in the OCC screen while employees were on break. Situation was discovered when power went out to the building. Upon discovery, determination was made to evacuate. ~9 town fire departments responded and was able to put the fire out. No Injuries.

Equipment Damage:  
3 OCC shafts  
Conveyor belts  
E-stop Repairs

Building Damage:  
Roof  
Electrical  
Communication Systems

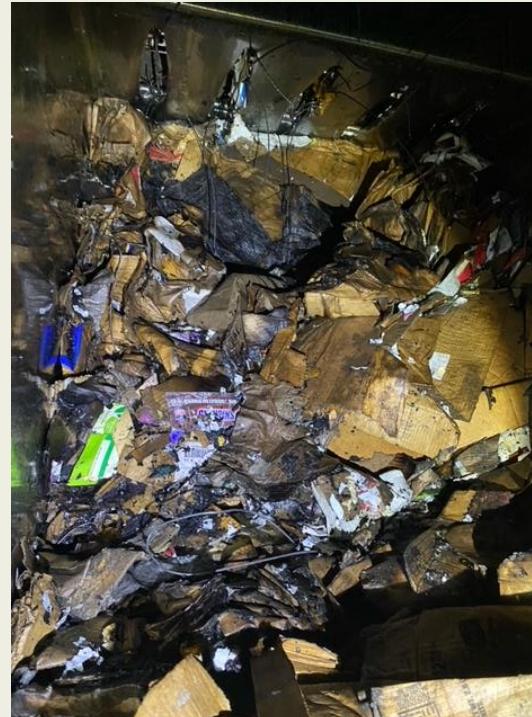
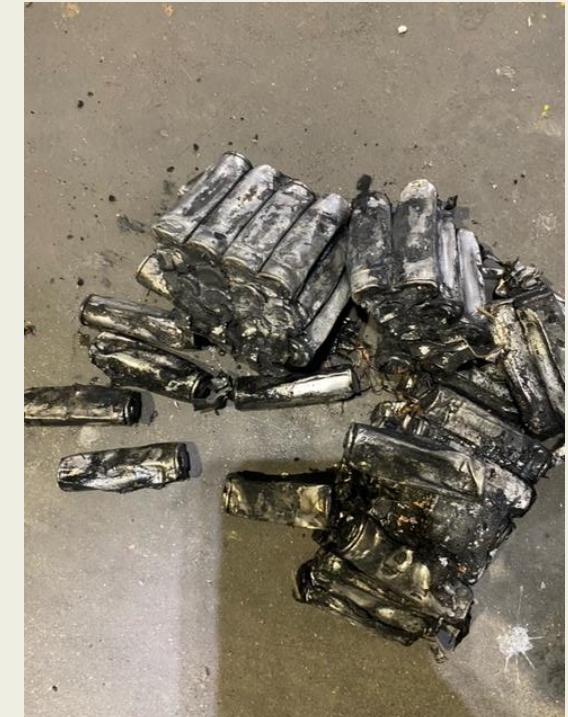
- Perfect environment for potential catastrophic events:
  - Fuel (fiber materials, dust, etc.)
  - Equipment that can cause batteries to ignite
  - Staff are not trained fire fighters but have to react frequently due to batteries ending up in recycling bins
