STOUGHTON DOWNTOWN REDEVELOPMENT PLAN

Volume III: Existing Conditions Memorandum

Appendices

Stoughton, Massachusetts April 2015

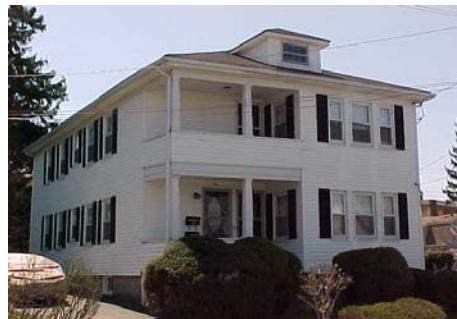
NAME OF SLUM & BLIGHT AREA:
159 Stoughton Downtown Redevelopment Area

<u>Component</u>	<u>Condition</u>
Roofing	
Windows and Doors	
Exterior Walls	
Porch/Stairs/Deck	
Foundation	
Storefront & Signage	
Parking Lots	
Environmental	Probable lead paint based on age of building
Other:	
Overall Property Rating: (Excellent / Good / Fair / Poor)	
briefly state why.

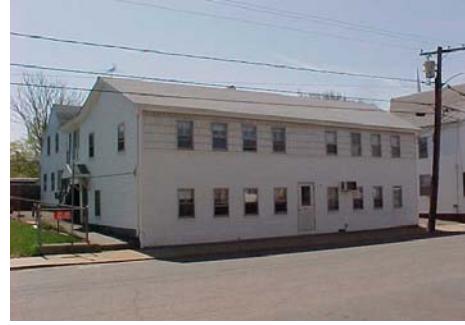
<u>Component</u>	<u>Condition</u>
Roofing	
Windows and Doors	
Exterior Walls	
Porch/Stairs/Deck	
Foundation	
Storefront & Signage	
Parking Lots	
Environmental	Probable lead paint based on age of building
Other:	Has access to Pleasant Street
Overall Property Rating: (Excellent / Good / Fair / Poor)	
briefly state why.

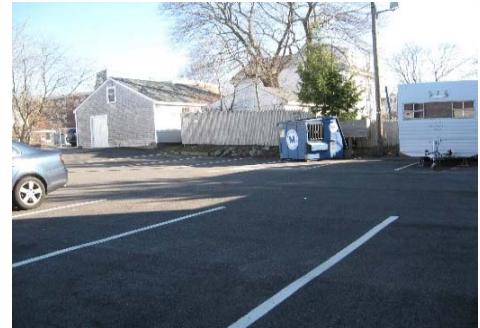
- Physical Deterioration of Building
 - Abandoned Property
 - Chronic High Occupancy Turnover
 - Chronic High Vacancy Rate
 - Significant Decline in Property Value
 - Abnormally Low Property Value
 - Known or Suspected Environmental Contamination
 - Other (please explain)
- ü *The property is not contributing to slum and blight*

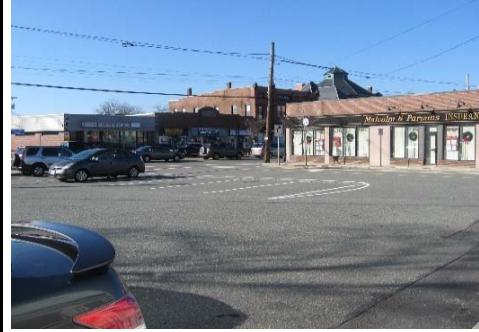
<u>Component</u>	<u>Condition</u>
Roofing	
Windows and Doors	
Exterior Walls	
Porch/Stairs/Deck	
Foundation	
Storefront & Signage	
Parking Lots	
Environmental	
Other:	Helps to provide parking for 054 304
Overall Property Rating: (Excellent / Good / Fair / Poor)	
briefly state why.

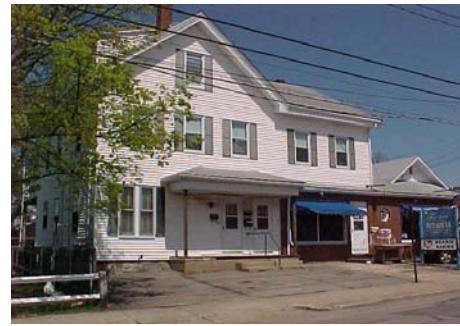
- Physical Deterioration of Building
 - Abandoned Property
 - Chronic High Occupancy Turnover
 - Chronic High Vacancy Rate
 - Significant Decline in Property Value
 - Abnormally Low Property Value
 - Known or Suspected Environmental Contamination
 - Other (please explain)
- The property is not contributing to slum and blight*

Roofing
 Windows and Doors
 Exterior Walls
 Porch/Stairs/Deck
 Foundation
 Storefront & Signage
 Parking Lots: Front yard fully paved
 Environmental: Probable lead paint based on age of building
 Other:

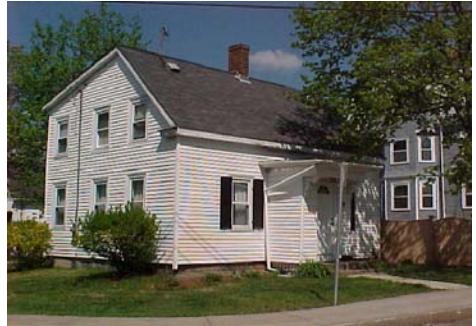
<u>Component</u>	<u>Condition</u>
Roofing	
Windows and Doors	
Exterior Walls	
Porch/Stairs/Deck	
Foundation	
Storefront & Signage	
Parking Lots	
Environmental	Probable lead paint based on age of building
Other:	
Overall Property Rating: (Excellent / Good / Fair / Poor)	
briefly state why.

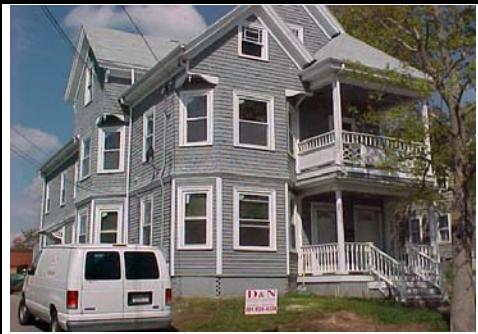
<u>Component</u>	<u>Condition</u>
Roofing	
Windows and Doors	
Exterior Walls	Some peeling paint
Porch/Stairs/Deck	
Foundation	
Storefront & Signage	
Parking Lots	
Environmental	Probable lead paint based on age of building
Other:	
Overall Property Rating: (Excellent / Good / Fair / Poor)	
briefly state why.

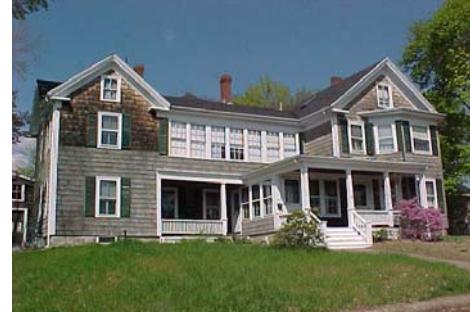
<u>Component</u>	<u>Condition</u>
Roofing	
Windows and Doors	
Exterior Walls	Some peeling paint
Porch/Stairs/Deck	
Foundation	
Storefront & Signage	
Parking Lots	
Environmental	Probable lead paint based on age of building
Other:	
Overall Property Rating: (Excellent / Good / Fair / Poor)	
briefly state why.

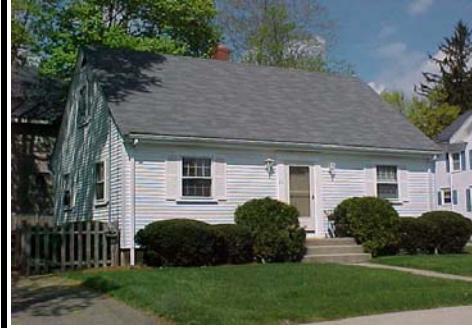
<u>Component</u>	<u>Condition</u>
Roofing	
Windows and Doors	
Exterior Walls	
Porch/Stairs/Deck	
Foundation	
Storefront & Signage	
Parking Lots	
Environmental	Probable lead paint based on age of building
Other:	
Overall Property Rating: (Excellent / Good / Fair / Poor)	
briefly state why.

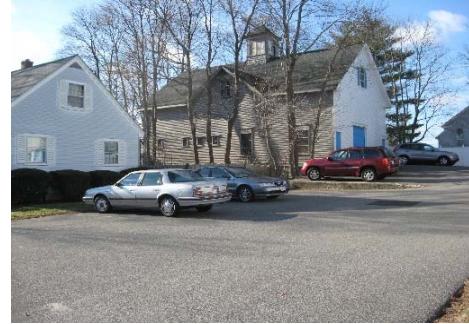
Component	Condition
Roofing	
Windows and Doors	
Exterior Walls	Paint is peeling or not present
Porch/Stairs/Deck	
Foundation	
Storefront & Signage	
Parking Lots	
Environmental	
Other:	
Overall Property Rating: (Excellent / Good / Fair / Poor)	
briefly state why.

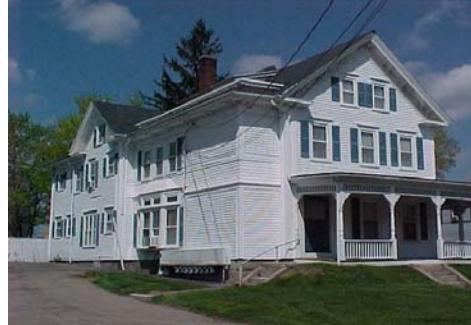
<u>Component</u>	<u>Condition</u>
Roofing	
Windows and Doors	
Exterior Walls	Some peeling paint
Porch/Stairs/Deck	
Foundation	
Storefront & Signage	
Parking Lots	Significant paving for parking lot
Environmental	Probable lead paint based on age of building
Other:	
Overall Property Rating: (Excellent / Good / Fair / Poor)	
briefly state why.

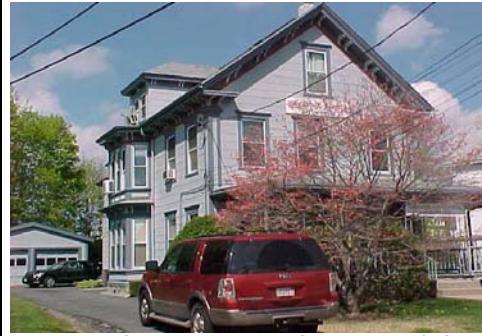
<u>Component</u>	<u>Condition</u>
Roofing	
Windows and Doors	
Exterior Walls	
Porch/Stairs/Deck	
Foundation	
Storefront & Signage	
Parking Lots	
Environmental	Probable lead paint based on age of building
Other:	
Overall Property Rating: (Excellent / Good / Fair / Poor)	
briefly state why.

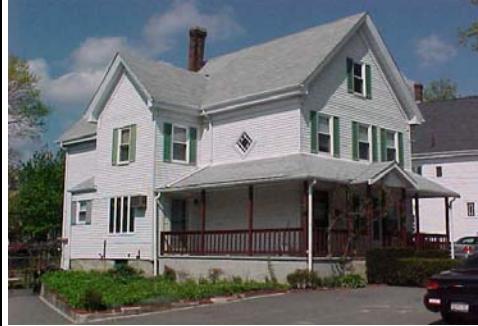
<u>Component</u>	<u>Condition</u>
Roofing	
Windows and Doors	
Exterior Walls	
Porch/Stairs/Deck	
Foundation	
Storefront & Signage	
Parking Lots	Front yard is paved
Environmental	Probable lead paint based on age of building
Other:	
Overall Property Rating: (Excellent / Good / Fair / Poor)	
briefly state why.

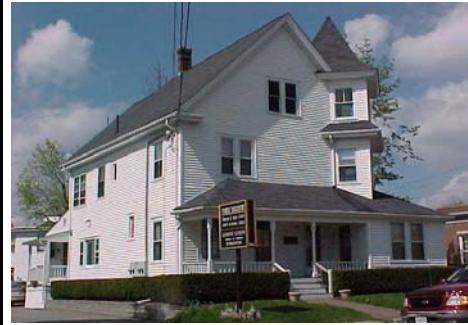
<u>Component</u>	<u>Condition</u>
Roofing	
Windows and Doors	
Exterior Walls	
Porch/Stairs/Deck	
Foundation	
Storefront & Signage	
Parking Lots	
Environmental	Probable lead paint based on age of building
Other:	
Overall Property Rating: (Excellent / Good / Fair / Poor)	
briefly state why.

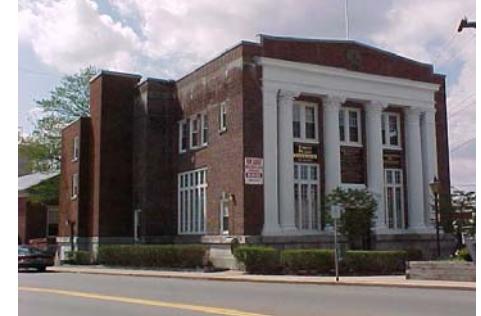
<u>Component</u>	<u>Condition</u>
Roofing	
Windows and Doors	
Exterior Walls	
Porch/Stairs/Deck	
Foundation	
Storefront & Signage	
Parking Lots	
Environmental	Probable lead paint based on age of building
Other:	
Overall Property Rating: (Excellent / Good / Fair / Poor)	
briefly state why.

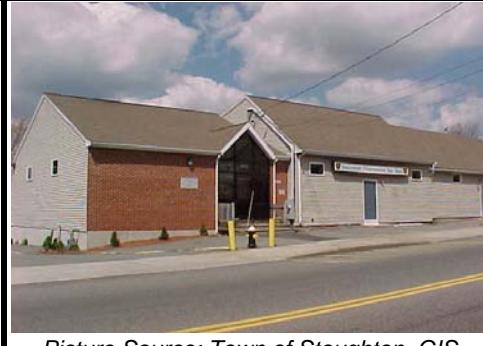
Parcel ID: 054 385 0
 Address: 845 WASHINGTON ST
 Land Use: 954
 Zoning: GB
 Building Type: CLUBHOUSE
 Stories: 1
 Exterior Construction: VINYL
 Interior Construction: DRYWALL
 Building Age: 1940
 Assessed Value: \$355,600
 Building Condition: Good
 Ownership: CLUB OF SAN JOHN
 FILARMONICA SOCIETY INC
 Commercial/Residential: Nonprofit
 Storefront Construction:
 Vacant: yes no other: No

<u>Component</u>	<u>Condition</u>
Roofing	
Windows and Doors	
Exterior Walls	
Porch/Stairs/Deck	
Foundation	
Storefront & Signage	
Parking Lots	Front setback fully paved
Environmental	Probable lead paint based on age of building
Other:	
Overall Property Rating: (Excellent / Good / Fair / Poor)	
briefly state why.

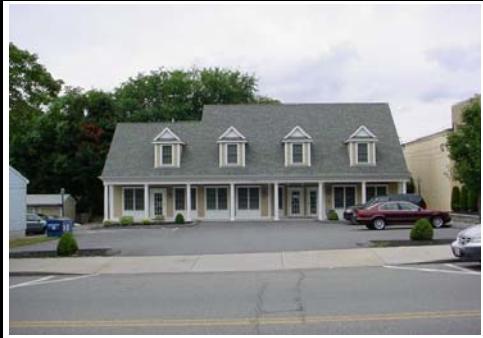
Parcel ID: 054 386 1
 Address: 839 WASHINGTON ST
 Land Use: 343
 Zoning: CBD
 Building Type: CONDO-OFC
 Stories: 2
 Exterior Construction: CLAPBOARD
 Interior Construction: DRYWALL
 Building Age: 2006
 Assessed Value: \$209,000
 Building Condition: Good
 Ownership: PELAYO REALTY LLC
 Commercial/Residential: C
 Storefront Construction:
 Vacant: yes no other: No - two law offices and a dentist

Roofing
 Windows and Doors
 Exterior Walls
 Porch/Stairs/Deck
 Foundation
 Storefront & Signage
 Parking Lots
 Environmental
 Other:
 Overall Property Rating:
 (Excellent / Good / Fair / Poor)
 briefly state why.

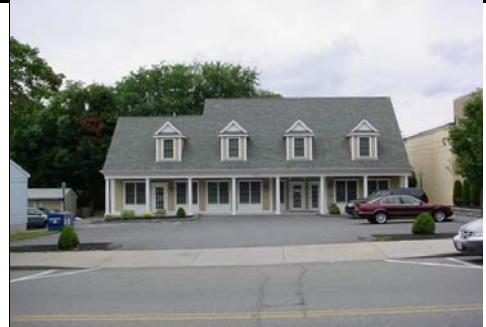
Parcel ID: 054 386 2
Address: 839 WASHINGTON ST
Land Use: 343
Zoning: CBD
Building Type: CONDO-OFC
Stories: 2
Exterior Construction: CLAPBOARD
Interior Construction: DRYWALL
Building Age: 2006
Assessed Value: \$280,200
Building Condition: Good
Ownership: TTTK LLC
Commercial/Residential: C
Storefront Construction:
Vacant: yes no other: No - two law offices and a dentist

<u>Component</u>	<u>Condition</u>
Roofing	
Windows and Doors	
Exterior Walls	
Porch/Stairs/Deck	
Foundation	
Storefront & Signage	
Parking Lots	Front setback fully paved
Environmental	
Other:	
Overall Property Rating: (Excellent / Good / Fair / Poor)	
briefly state why.

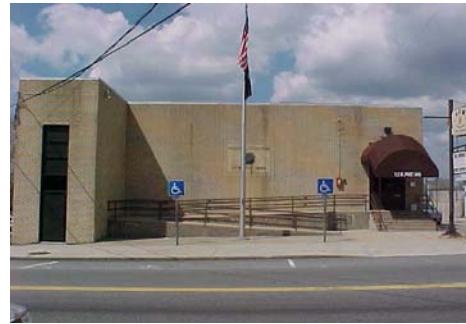
Parcel ID: 054 387 0
 Address: 837 WASHINGTON ST
 Land Use: 954
 Zoning: CBD
 Building Type: CLUBHOUSE
 Stories: 1
 Exterior Construction: BRICK VENR
 Interior Construction: PLYWD PANL
 Building Age: 1961
 Assessed Value: \$377,800
 Building Condition: Avg-Good
 Ownership: ROMANUK MICHAEL POST 1645
 VETERANS OF FOREIGN WARS
 Commercial/Residential: Nonprofit
 Storefront Construction:
 Vacant: yes no other: No - VFW Post

<u>Component</u>	<u>Condition</u>
Roofing	
Windows and Doors	
Exterior Walls	
Porch/Stairs/Deck	
Foundation	
Storefront & Signage	
Parking Lots	
Environmental	Probable lead paint based on age of building
Other:	
Overall Property Rating: (Excellent / Good / Fair / Poor)	
briefly state why.

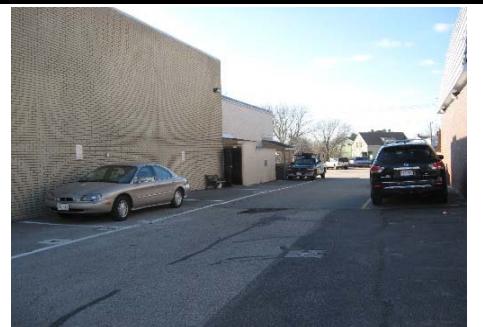
Parcel ID: 054 388 0
 Address: WASHINGTON ST
 Land Use: 901
 Zoning: CBD
 Building Type:
 Stories:
 Exterior Construction:
 Interior Construction:
 Building Age:
 Assessed Value: \$13,700
 Building Condition:
 Ownership MASS BAY TRANS AUTHORITY
 Commercial/Residential: C
 Storefront Construction:
 Vacant: yes no other: Access to MBTA parking lot - 054 404

Roofing
 Windows and Doors
 Exterior Walls
 Porch/Stairs/Deck
 Foundation
 Storefront & Signage
 Parking Lots
 Environmental
 Other:
 Overall Property Rating:
 (Excellent / Good / Fair / Poor)
 briefly state why.

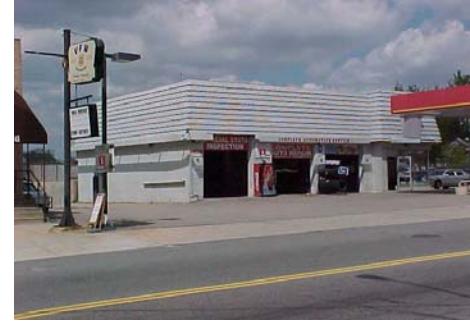
Parcel ID: 054 389 0
 Address: 825 WASHINGTON ST
 Land Use: 334
 Zoning: CBD
 Building Type: SERVICE ST
 Stories: 1
 Exterior Construction: CONC BLOCK
 Interior Construction: DRYWALL
 Building Age: 1965
 Assessed Value: \$513,400
 Building Condition: Avg-Good
 Ownership: CHRISTAMARIA REALTY LLC
 Commercial/Residential: C
 Storefront Construction:
 Vacant: yes no other: Unsure - on Loopnet but article cached; may be a Getty

<u>Component</u>	<u>Condition</u>
Roofing	
Windows and Doors	
Exterior Walls	
Porch/Stairs/Deck	
Foundation	
Storefront & Signage	
Parking Lots	Lot is fully paved
Environmental	Probable lead paint based on age of building
Other:	MassDEP: Open/Closed (see <i>Existing Conditions Memorandum</i> , April 2015)
Overall Property Rating: (Excellent / Good / Fair / Poor)	
briefly state why.

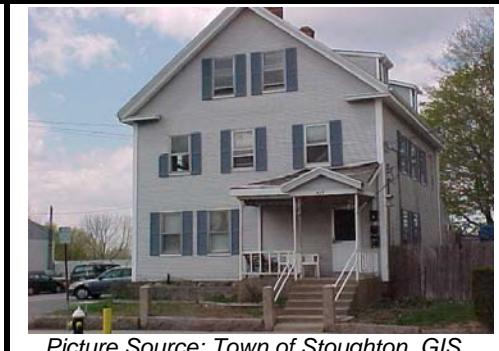
Parcel ID: 054 390 0
 Address: 815 WASHINGTON ST
 Land Use: 105
 Zoning: CBD
 Building Type: MULTI-CONV
 Stories: 2H
 Exterior Construction: VINYL
 Interior Construction: PLASTER
 Building Age: 1930
 Assessed Value: \$262,000
 Building Condition: Average
 Ownership: SILVA DANIEL S
 Commercial/Residential: R
 Storefront Construction:
 Vacant: yes no other: No

<u>Component</u>	<u>Condition</u>
Roofing	
Windows and Doors	
Exterior Walls	Paint, minor repairs needed
Porch/Stairs/Deck	
Foundation	Dumping behind building
Storefront & Signage	
Parking Lots	
Environmental	Probable lead paint based on age of building
Other:	MassDEP: Closed (see <i>Existing Conditions Memorandum</i> , April 2015)
Overall Property Rating: (Excellent / Good / Fair / Poor)	
briefly state why.

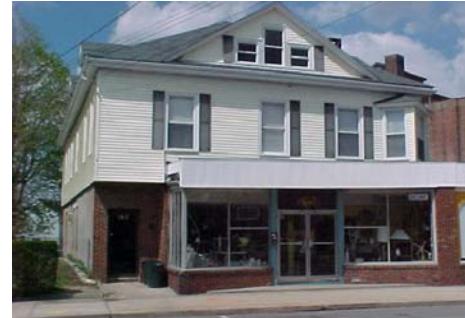
Parcel ID: 054 391 0
 Address: 811 WASHINGTON ST
 Land Use: 031
 Zoning: CBD
 Building Type: STORE
 Stories: 2
 Exterior Construction: VINYL
 Interior Construction: PLASTER
 Building Age: 1930
 Assessed Value: \$345,000
 Building Condition: Fair
 Ownership YAITANES PHILLIP N
 YATANES BRIGET A
 Commercial/Residential: C
 Storefront Construction:
 Vacant: yes no other: Both - Naguya just opened but other half is abandoned antique store

<u>Component</u>	<u>Condition</u>
Roofing	
Windows and Doors	
Exterior Walls	
Porch/Stairs/Deck	
Foundation	
Storefront & Signage	
Parking Lots	
Environmental	Probable lead paint based on age of building
Other:	Abandoned shop contents in ground floor space
Overall Property Rating: (Excellent / Good / Fair / Poor)	
briefly state why.

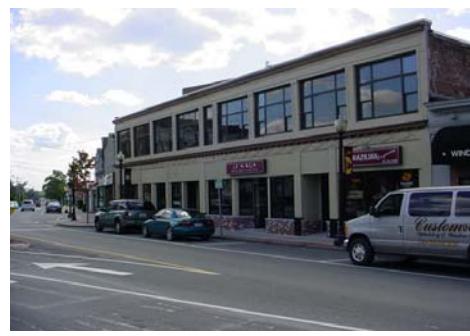
Parcel ID: 054 392 0
 Address: 797 WASHINGTON ST
 Land Use: 362
 Zoning: CBD
 Building Type: STORE
 Stories: 1
 Exterior Construction: BRICK
 Interior Construction: PLASTER
 Building Age: 1900
 Assessed Value: \$537,600
 Building Condition: Fair
 Ownership: VIEN KEVIN TRUSTEE
 C & V INVESTMENT REALTY TR
 Commercial/Residential: C
 Storefront Construction:
 Vacant: yes no other: J&J Thrift, Aquarium Store, BUT vacant State Theatre

<u>Component</u>	<u>Condition</u>
Roofing	
Windows and Doors	
Exterior Walls	
Porch/Stairs/Deck	
Foundation	
Storefront & Signage	
Parking Lots	Has driveway access to Wyman Street
Environmental	Probable lead paint based on age of building
Other:	State Theatre portion of building in poor condition inside and outside
Overall Property Rating: (Excellent / Good / Fair / Poor)	
briefly state why.

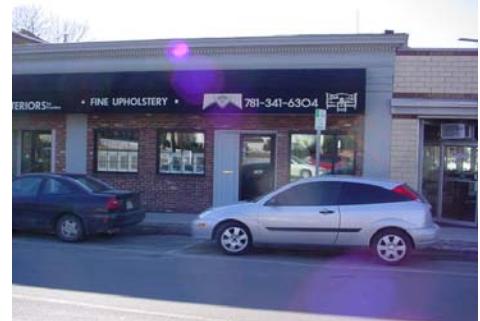
Parcel ID: 054 393 0
 Address: 793 WASHINGTON ST
 Land Use: 325
 Zoning: CBD
 Building Type: STORE
 Stories: 1
 Exterior Construction: BRICK
 Interior Construction: PLASTER
 Building Age: 1900
 Assessed Value: \$291,400
 Building Condition: Good
 Ownership: FRONTINO DOMENICO
 FRONTINO ANTONIETTA
 Commercial/Residential: C
 Storefront Construction:
 Vacant: yes no other: Upholstery Store on ground floor

<u>Component</u>	<u>Condition</u>
Roofing	
Windows and Doors	
Exterior Walls	
Porch/Stairs/Deck	
Foundation	
Storefront & Signage	
Parking Lots	
Environmental	Probable lead paint based on age of building
Other:	MassDEP: Closed (see <i>Existing Conditions Memorandum</i> , April 2015)
Overall Property Rating: (Excellent / Good / Fair / Poor)	
briefly state why.

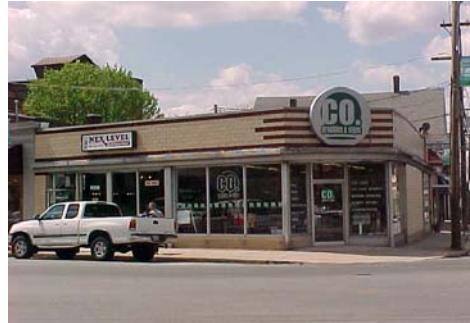
Parcel ID: 054 394 0
 Address: 785 WASHINGTON ST
 Land Use: 325
 Zoning: CBD
 Building Type: SHOP CTR N
 Stories: 1
 Exterior Construction: BRICK
 Interior Construction: PLASTER
 Building Age: 1950
 Assessed Value: \$320,600
 Building Condition: Good
 Ownership: RITTENBERG J & TUCK J TRSTS
 BUICK REALTY TRUST II
 Commercial/Residential: C
 Storefront Construction:
 Vacant: yes no other: No

<u>Component</u>	<u>Condition</u>
Roofing	
Windows and Doors	
Exterior Walls	Minor repairs needed
Porch/Stairs/Deck	
Foundation	
Storefront & Signage	
Parking Lots	
Environmental	Probable lead paint based on age of building
Other:	
Overall Property Rating: (Excellent / Good / Fair / Poor)	
briefly state why.

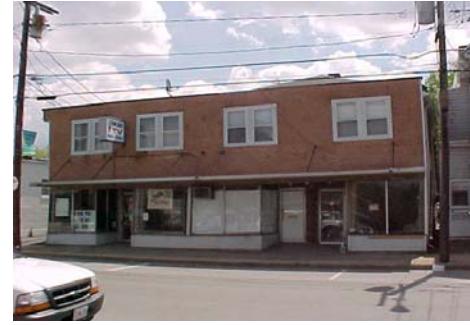
Parcel ID: 054 395 0
 Address: 10 WYMAN ST
 Land Use: 031
 Zoning: CBD
 Building Type: STORE
 Stories: 2
 Exterior Construction: VINYL
 Interior Construction: PLASTER
 Building Age: 1930
 Assessed Value: \$294,000
 Building Condition: Fair-Avg
 Ownership: PANICO STEVEN M & LINDA S
 TRUSTEES OF S & L REALTY TRUST
 Commercial/Residential: C
 Storefront Construction:
 Vacant: yes no other: No

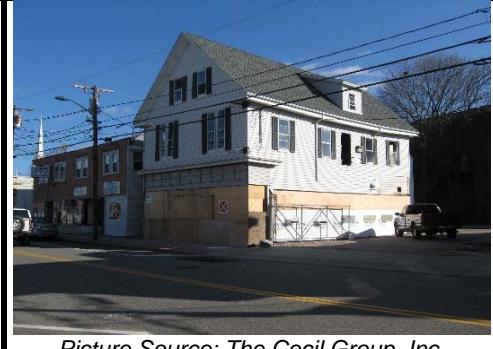
Parcel ID: 054 396 0
 Address: 16 WYMAN ST
 Land Use: 325
 Zoning: CBD
 Building Type: STORE
 Stories: 2A
 Exterior Construction: VINYL
 Interior Construction: PLASTER
 Building Age: 1930
 Assessed Value: \$288,600
 Building Condition: Fair
 Ownership: DYKEMAN LOUIS E
 Commercial/Residential: C
 Storefront Construction:
 Vacant: yes no other: Yes - demolition x on building

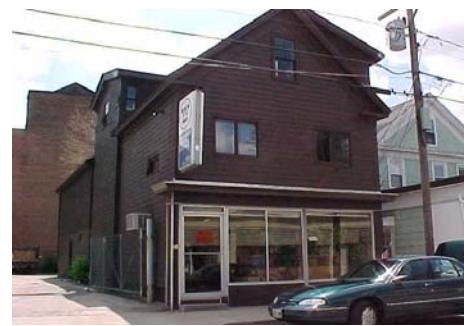
Parcel ID: 054 397 0
Address: 24 WYMAN ST
Land Use: 325
Zoning: CBD
Building Type: STORE
Stories: 2T
Exterior Construction: WOOD SHING
Interior Construction: PLASTER
Building Age: 1900
Assessed Value: \$247,600
Building Condition: Fair
Ownership: DYKEMAN ELEC CO INC
Commercial/Residential: C
Storefront Construction:
Vacant: yes no other: No

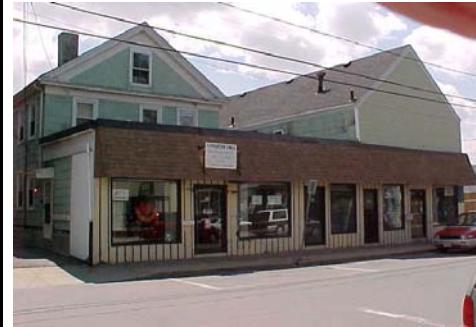
Parcel ID: 054 398 0
 Address: 26 WYMAN ST
 Land Use: 013
 Zoning: CBD
 Building Type: MIXED OLD
 Stories: 2A
 Exterior Construction: VINYL
 Interior Construction: PLASTER
 Building Age: 1920
 Assessed Value: \$486,500
 Building Condition: Average
 Ownership: FERNANDES AVELINO A
 Commercial/Residential: C
 Storefront Construction:
 Vacant: yes no other: No - fully occupied

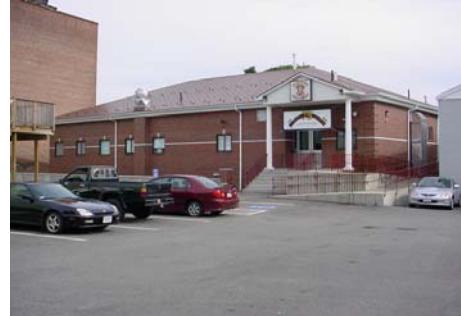
Parcel ID: 054 399 0
Address: 21 RAILROAD AV
Land Use: 353
Zoning: CBD
Building Type: CLUBHOUSE
Stories: 1A
Exterior Construction: BRICK
Interior Construction: DRYWALL
Building Age: 2005
Assessed Value: \$478,700
Building Condition: Average
Ownership: PORTUGUESE NATL CLUB
OF STOUGHTON, INC
Commercial/Residential: Nonprofit
Storefront Construction:
Vacant: yes no other: No

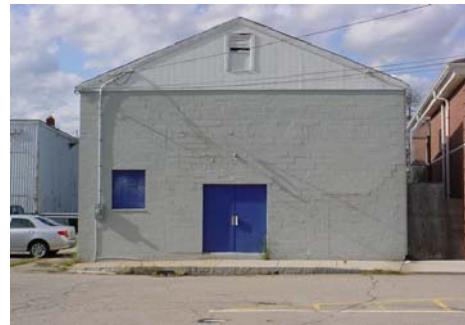
Parcel ID: 054 400 0
 Address: 27 RAILROAD AV
 Land Use: 316
 Zoning: CBD
 Building Type: GARAGE
 Stories: 1
 Exterior Construction: CONC BLOCK
 Interior Construction: MINIMUM
 Building Age: 1950
 Assessed Value: \$86,000
 Building Condition: Fair
 Ownership: DUBOIS RICHARD L & DELORES
 TRSTS DUBOIS FAMILY NOM TRUST
 Commercial/Residential: C
 Storefront Construction:
 Vacant: yes no other: Unclear

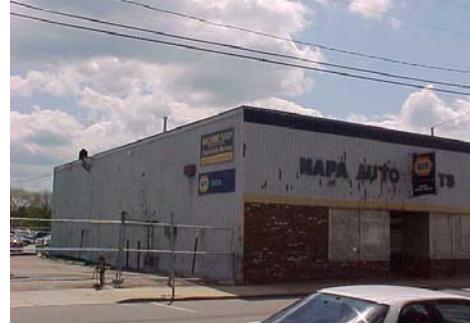
Parcel ID: 054 401 0
 Address: 48 WYMAN ST
 Land Use: 316
 Zoning: CBD
 Building Type: WAREHOUSE
 Stories: 1
 Exterior Construction: CORREG STL
 Interior Construction: MINIMUM
 Building Age: 1960
 Assessed Value: \$187,800
 Building Condition: Poor
 Ownership: BOLT FACILITY CASE CORPORATION
 Commercial/Residential: C
 Storefront Construction:
 Vacant: yes no other: Yes - new owner

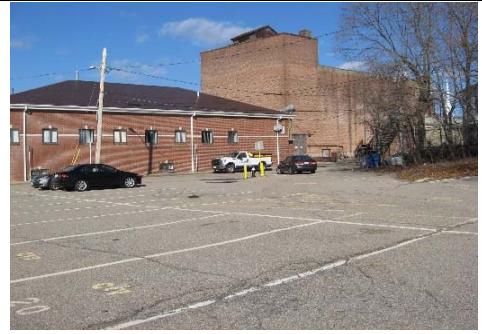
Parcel ID: 054 402 0
Address: RAILROAD AV
Land Use: 930
Zoning: CBD
Building Type: VACNT LAND
Stories:
Exterior Construction:
Interior Construction:
Building Age:
Assessed Value: \$49,400
Building Condition:
Ownership TOWN OF STOUGHTON
Commercial/Residential: Municipal
Storefront Construction:
Vacant: yes no other: No - parking lot - for commuters and generates revenue

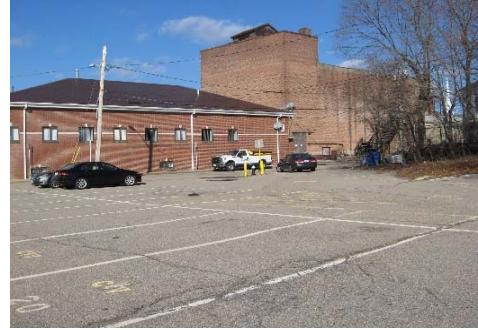
Parcel ID: 054 403 0
Address: RAILROAD AV
Land Use: 930
Zoning: CBD
Building Type: VACNT LAND
Stories:
Exterior Construction:
Interior Construction:
Building Age:
Assessed Value: \$18,500
Building Condition: Average
Ownership: TOWN OF STOUGHTON
Commercial/Residential: Municipal
Storefront Construction:
Vacant: yes no other: No - parking lot - for commuters and generates revenue

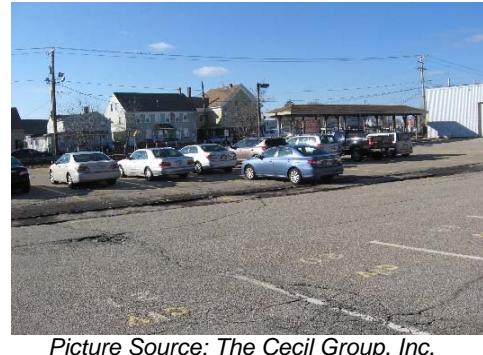
Parcel ID: 054 404 0
Address: WYMAN ST
Land Use: 901
Zoning: CBD
Building Type: VACNT LAND
Stories:
Exterior Construction:
Interior Construction:
Building Age:
Assessed Value: \$52,200
Building Condition:
Ownership MASS BAY TRANS AUTHORITY
Commercial/Residential: State agency
Storefront Construction:
Vacant: yes no other: No - commuter rail parking

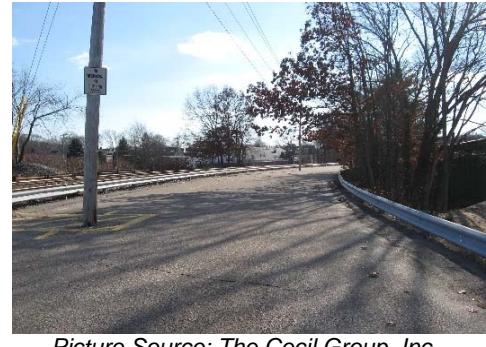
Parcel ID: 054 405 0
Address: WYMAN ST
Land Use: 901
Zoning: I
Building Type: VACNT LAND
Stories:
Exterior Construction:
Interior Construction:
Building Age:
Assessed Value: \$51,200
Building Condition:
Ownership MASS BAY TRANS AUTHORITY
Commercial/Residential: State agency
Storefront Construction:
Vacant: yes no other: No - commuter rail parking

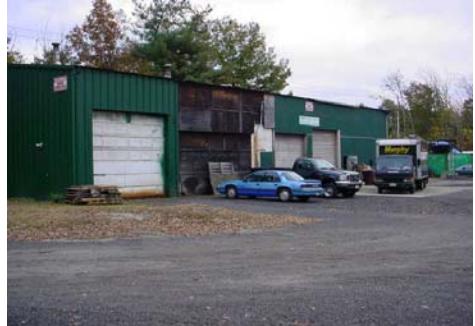
Parcel ID: 054 406 0
 Address: MORTON SQ
 Land Use: 332
 Zoning: I
 Building Type: REPAIR GAR
 Stories: 1
 Exterior Construction: ALUMINUM
 Interior Construction: MINIMUM
 Building Age: 1950
 Assessed Value: \$169,300
 Building Condition: Fair
 Ownership: MURPHY COAL CO INC
 Commercial/Residential: C
 Storefront Construction:
 Vacant: yes no other: No - active and used for storage of materials

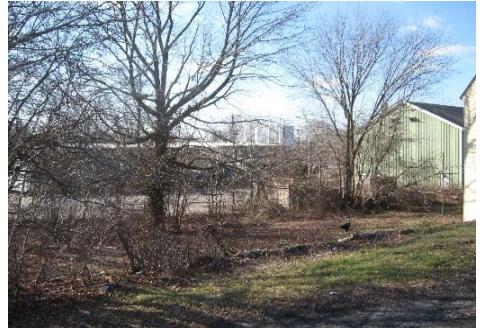
Parcel ID: 054 407 0
 Address: MORTON ST
 Land Use: 131
 Zoning: I
 Building Type: VACNT LAND
 Stories:
 Exterior Construction:
 Interior Construction:
 Building Age:
 Assessed Value: \$43,000
 Building Condition:
 Ownership GOUVEIA NELSON E & KENNETH
 HOBSON EILEEN
 Commercial/Residential:
 Storefront Construction:
 Vacant: yes no other: Yes - empty overgrown lot

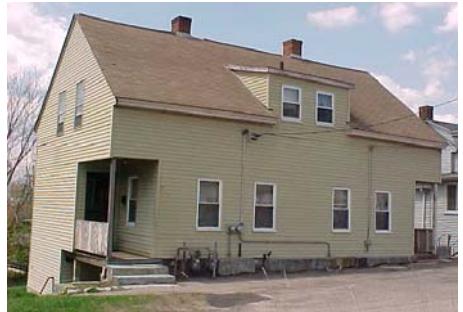
Parcel ID: 054 408 0
 Address: 15 MORTON SQ
 Land Use: 104
 Zoning: I
 Building Type: MULTI-CONV
 Stories: 1T
 Exterior Construction: ALUMINUM
 Interior Construction: PLASTER
 Building Age: 1940
 Assessed Value: \$195,500
 Building Condition: Average
 Ownership: GOUVEIA NELSON E & KENNETH
 HOBSON EILEEN
 Commercial/Residential: R
 Storefront Construction:
 Vacant: yes no other: No

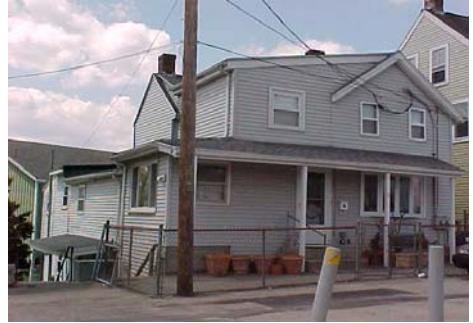
<u>Component</u>	<u>Condition</u>
Roofing	
Windows and Doors	
Exterior Walls	Peeling paint
Porch/Stairs/Deck	
Foundation	
Storefront & Signage	
Parking Lots	
Environmental	Probable lead paint based on age of building
Other:	
Overall Property Rating: (Excellent / Good / Fair / Poor)	
briefly state why.

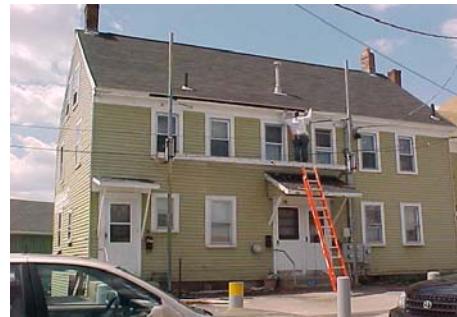
<u>Component</u>	<u>Condition</u>
Roofing	
Windows and Doors	
Exterior Walls	Minor repairs
Porch/Stairs/Deck	
Foundation	
Storefront & Signage	
Parking Lots	
Environmental	Probable lead paint based on age of building
Other:	
Overall Property Rating: (Excellent / Good / Fair / Poor) briefly state why.

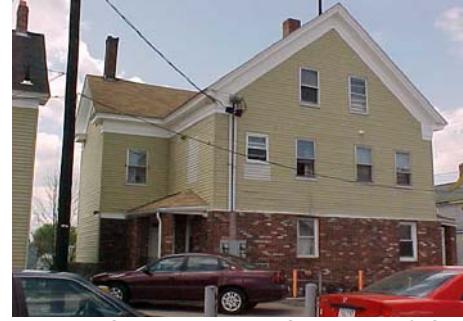
<u>Component</u>	<u>Condition</u>
Roofing	
Windows and Doors	
Exterior Walls	Minor repairs
Porch/Stairs/Deck	
Foundation	
Storefront & Signage	
Parking Lots	
Environmental	Probable lead paint based on age of building
Other:	
Overall Property Rating: (Excellent / Good / Fair / Poor)	
briefly state why.

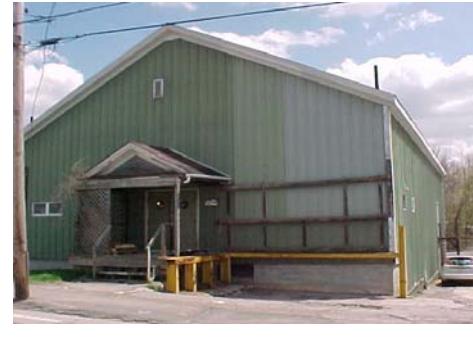
<u>Component</u>	<u>Condition</u>
Roofing	
Windows and Doors	
Exterior Walls	Needs paint
Porch/Stairs/Deck	Porch roof needs repairs
Foundation	
Storefront & Signage	
Parking Lots	Need repairs
Environmental	Probable lead paint based on age of building
Other:	
Overall Property Rating: (Excellent / Good / Fair / Poor)	
briefly state why.

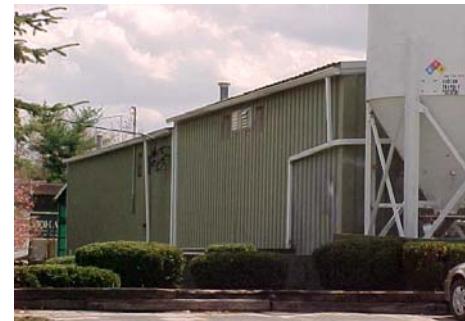
MassDEP: Closed (see *Existing Conditions Memorandum* , April 2015)

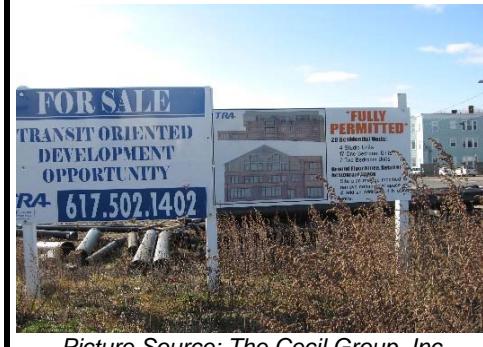
Component	Condition
Roofing	
Windows and Doors	
Exterior Walls	
Porch/Stairs/Deck	
Foundation	
Storefront & Signage	
Parking Lots	
Environmental	
Other:	Lot has been cleared but materials have been dumped on site

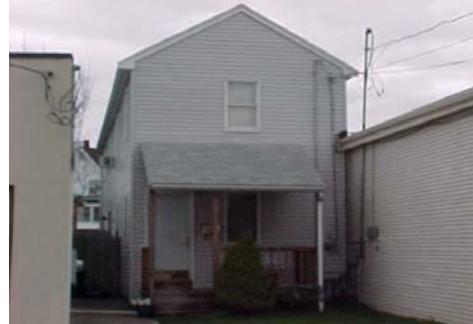
<u>Component</u>	<u>Condition</u>
Roofing	
Windows and Doors	
Exterior Walls	
Porch/Stairs/Deck	
Foundation	
Storefront & Signage	
Parking Lots	
Environmental	Probable lead paint based on age of building
Other:	
Overall Property Rating: (Excellent / Good / Fair / Poor)	
briefly state why.

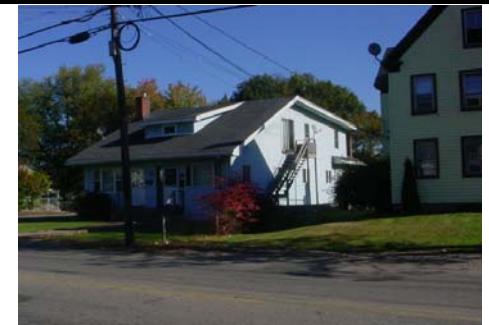
<u>Component</u>	<u>Condition</u>
Roofing	
Windows and Doors	
Exterior Walls	
Porch/Stairs/Deck	
Foundation	
Storefront & Signage	
Parking Lots	
Environmental	Probable lead paint based on age of building
Other:	
Overall Property Rating: (Excellent / Good / Fair / Poor)	
briefly state why.

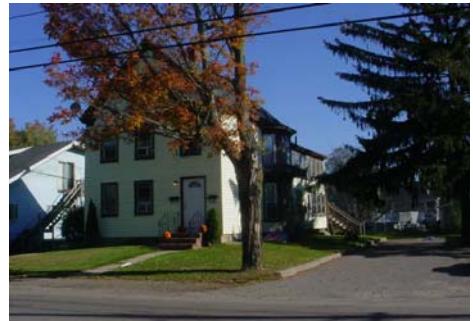
<u>Component</u>	<u>Condition</u>
Roofing	
Windows and Doors	
Exterior Walls	
Porch/Stairs/Deck	
Foundation	
Storefront & Signage	
Parking Lots	
Environmental	Probable lead paint based on age of building
Other:	
Overall Property Rating: (Excellent / Good / Fair / Poor)	
briefly state why.

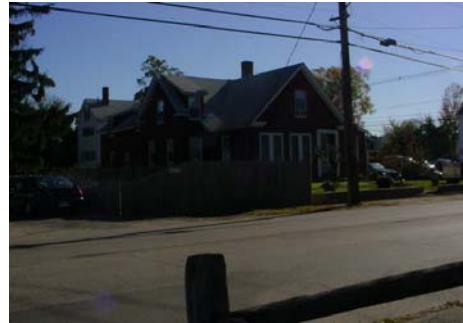
<u>Component</u>	<u>Condition</u>
Roofing	
Windows and Doors	
Exterior Walls	
Porch/Stairs/Deck	
Foundation	
Storefront & Signage	
Parking Lots	Needs repairs
Environmental	Probable lead paint based on age of building
Other:	
Overall Property Rating: (Excellent / Good / Fair / Poor)	
briefly state why.

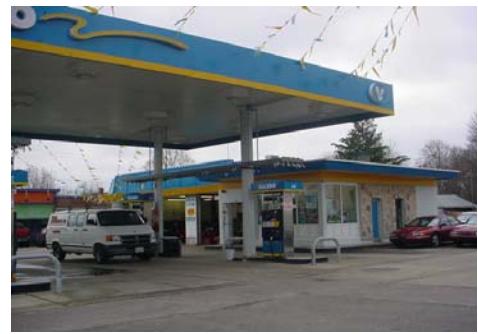
Parcel ID: 055 069 0
 Address: 645 WASHINGTON ST
 Land Use: 334
 Zoning: GB
 Building Type: SERVICE ST
 Stories: 1
 Exterior Construction: CORREG STL
 Interior Construction: MINIMUM
 Building Age: 1950
 Assessed Value: \$628,100
 Building Condition: Good
 Ownership: 645 WASHINGTON STREET RLTY LLC
 Commercial/Residential: C
 Storefront Construction:
 Vacant: yes no other: No - service station and auto sales

<u>Component</u>	<u>Condition</u>
Roofing	
Windows and Doors	
Exterior Walls	
Porch/Stairs/Deck	
Foundation	
Storefront & Signage	
Parking Lots	Lot is fully paved
Environmental	Probable lead paint based on age of building
Other:	MassDEP: Closed (see <i>Existing Conditions Memorandum</i> , April 2015)
Overall Property Rating: (Excellent / Good / Fair / Poor)	
briefly state why.

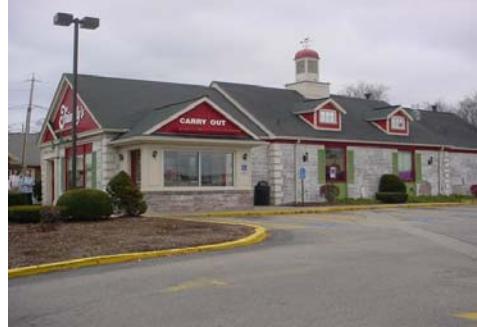
Parcel ID: 055 166 0
 Address: 630 WASHINGTON ST
 Land Use: 326
 Zoning: GB
 Building Type: RESTAURANT
 Stories: 1
 Exterior Construction: BRICK
 Interior Construction: DRYWALL
 Building Age: 1972
 Assessed Value: \$303,700
 Building Condition: Fair-Avg
 Ownership: TRI-TOWN COMMONS II LLC
 C/O WINSTANLEY ENTERPRISES LLC
 Commercial/Residential: C
 Storefront Construction:
 Vacant: yes no other: Yes - Surrey Equities 888-320-3470

Component	Condition
Roofing	
Windows and Doors	
Exterior Walls	
Porch/Stairs/Deck	
Foundation	
Storefront & Signage	
Parking Lots	
Environmental	Probable lead paint based on age of building
Other:	
Overall Property Rating: (Excellent / Good / Fair / Poor)	
briefly state why.

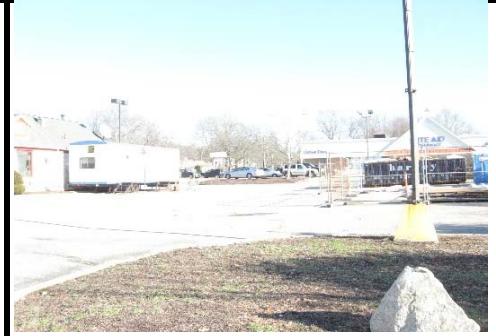
Parcel ID: 055 167 0
 Address: WASHINGTON ST
 Land Use: 337
 Zoning: GB
 Building Type:
 Stories:
 Exterior Construction:
 Interior Construction:
 Building Age:
 Assessed Value: \$225,800
 Building Condition:
 Ownership: TRI-TOWN COMMONS II LLC
 C/O WINSTANLEY ENTERPRISES LLC
 Commercial/Residential: C
 Storefront Construction:
 Vacant: yes no other: No - parking lot used for 055 166

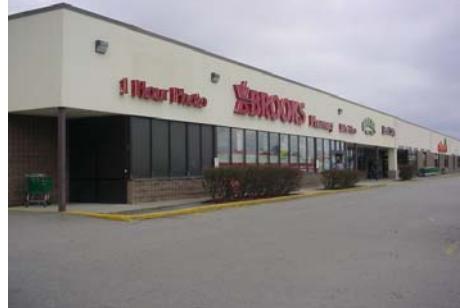
Parcel ID: 055 168 0
 Address: 638 WASHINGTON ST
 Land Use: 323
 Zoning: GB
 Building Type: SHOP CTR N
 Stories: 1
 Exterior Construction: CONC BLOCK
 Interior Construction: DRYWALL
 Building Age: 1981
 Assessed Value: \$6,494,600
 Building Condition: Average
 Ownership: TRI-TOWN COMMONS LLC
 C/O WINSTANLEY ENTERPRISES LLC
 Commercial/Residential: C
 Storefront Construction:
 Vacant: yes no other: Partially vacant while new supermarket moves in

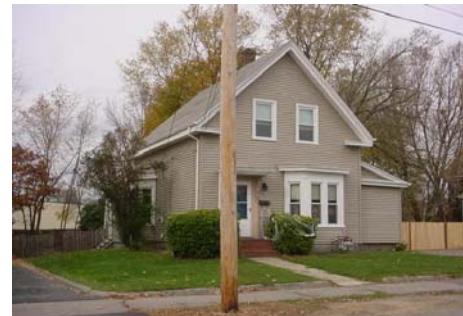
Parcel ID: 055 169 0
Address: 96 MONK ST
Land Use: 104
Zoning: GB
Building Type: MULTI-CONV
Stories: 1T
Exterior Construction: VINYL
Interior Construction: PLASTER
Building Age: 1900
Assessed Value: \$228,400
Building Condition: Average
Ownership: DANNA PAUL F
CULLEN KIMBERLY ANN
Commercial/Residential: R
Storefront Construction:
Vacant: yes no other: No - could be removed from redevelopment area

<u>Component</u>	<u>Condition</u>
Roofing	
Windows and Doors	
Exterior Walls	
Porch/Stairs/Deck	
Foundation	
Storefront & Signage	
Parking Lots	
Environmental	Probable lead paint based on age of building
Other:	
Overall Property Rating: (Excellent / Good / Fair / Poor)	
briefly state why.

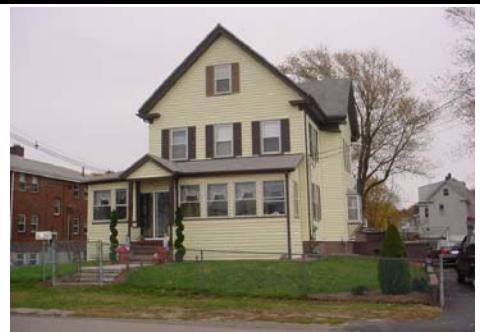
Parcel ID: 055 181 0
Address: 67 MONK ST
Land Use: 104
Zoning: RU
Building Type: MULTI-CONV
Stories: 2
Exterior Construction: VINYL
Interior Construction: PLASTER
Building Age: 1900
Assessed Value: \$232,200
Building Condition: Average
Ownership: MORAIS JOSE M & MARIA C L/E
ANTONIO M MORAIS REMAINDER
Commercial/Residential: R
Storefront Construction:
Vacant: yes no other: No

<u>Component</u>	<u>Condition</u>
Roofing	
Windows and Doors	
Exterior Walls	
Porch/Stairs/Deck	
Foundation	
Storefront & Signage	
Parking Lots	
Environmental	Probable lead paint based on age of building
Other:	
Overall Property Rating: (Excellent / Good / Fair / Poor)	
briefly state why.

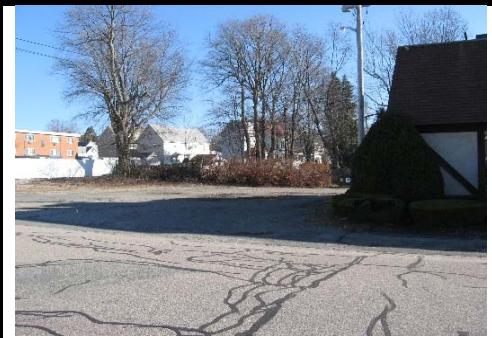
Parcel ID: 055 182 0
 Address: MONK ST
 Land Use: 337
 Zoning: GB
 Building Type:
 Stories:
 Exterior Construction:
 Interior Construction:
 Building Age:
 Assessed Value: \$95,700
 Building Condition:
 Ownership KAMPANELAS CHARLES
 KAMPANELAS PARIS
 Commercial/Residential: C
 Storefront Construction:
 Vacant: yes no other: No - parking lot for 054 241
