# STOUGHTON DOWNTOWN REDEVELOPMENT PLAN

## Volume III: Existing Conditions Memorandum

## Appendices

Stoughton, Massachusetts April 2015

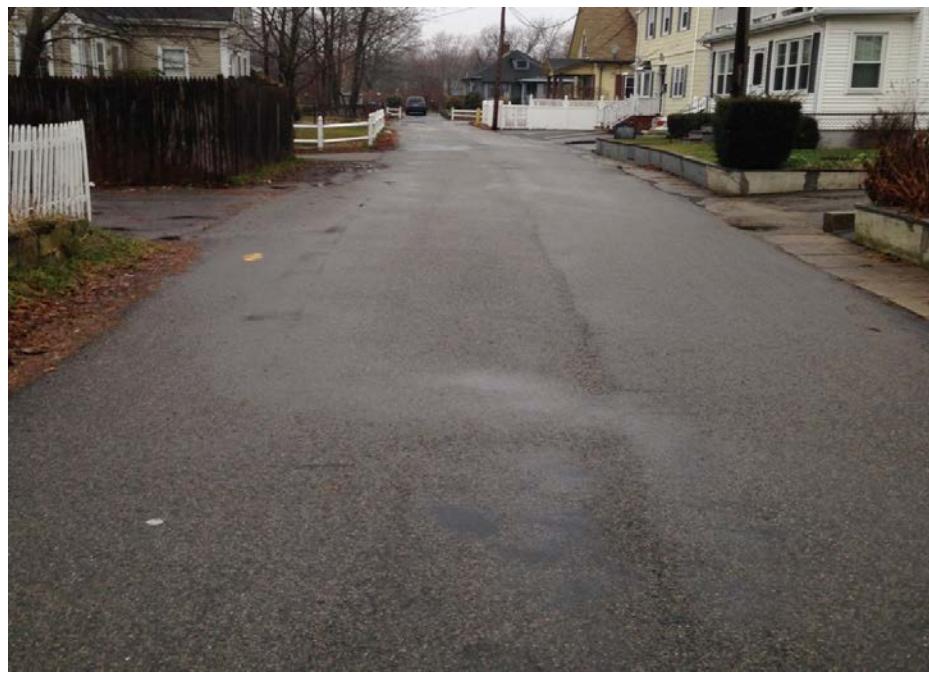
<table><tr> <th><b>Component</b></th> <th><b>Condition</b></th> <th><b>Comments</b></th> </tr><tr> <td>Road Surface</td> <td>Poor</td> <td>Severe cracking and patching along road surface</td> </tr></table>

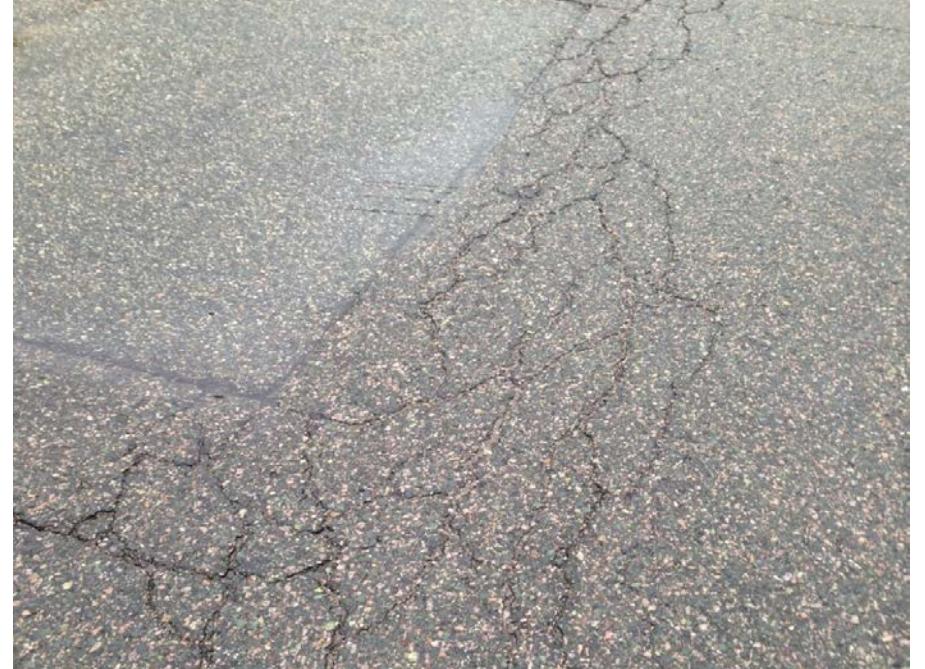
<table><tr> <th><b>Component</b></th> <th><b>Condition</b></th> <th><b>Comments</b></th> </tr><tr> <td>Road Surface</td> <td>Poor</td> <td>Severe cracking and patching along road surface, alligator cracking</td> </tr><tr> <td>Existing Sidewalk</td> <td>Fair</td> <td>South side of street sidewalk in great condition, north side non existant in some spots</td> </tr></table>

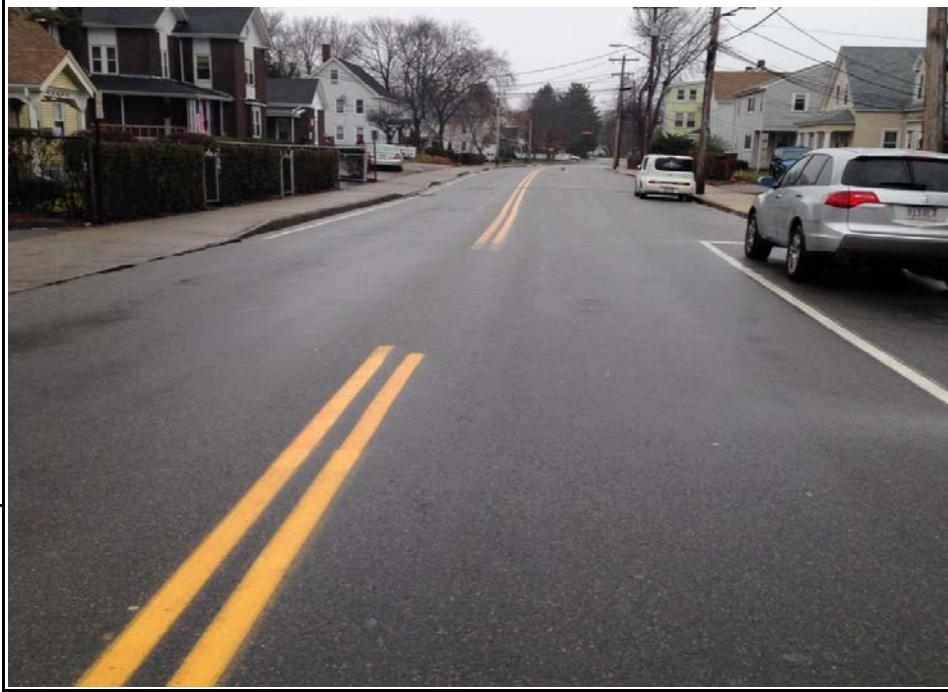
<u>Component</u>	<u>Condition</u>	<u>Comments</u>
Road Surface	Good	Minor patching south of School Street, water main trench patch north of School Street
Water Lines	Poor	6" CI, installed 1922
Sewer Lines	Poor	8" VC gravity line, installed 1936 south of school street, installed 1962 north of school street
Existing Sidewalk	Good	Asphalt sidewalk on west, concrete on east. Overall in very good condition, some areas may not be ADA compliant
Curbing	Good	Granite VB curb on west side of street, monolithic curb on east side until ending at School Street Intersection
Drainage	Excellent	No ponding issues anywhere on street
Gas Lines	Good	6" CS-HP Installed 1980, 8" P-HP Installed 2005,
Parking Lot:		
Lighting:		
Trees/Landscaping:		
Park/Playground:		
Other:		
<b>Overall Rating:</b>	Good

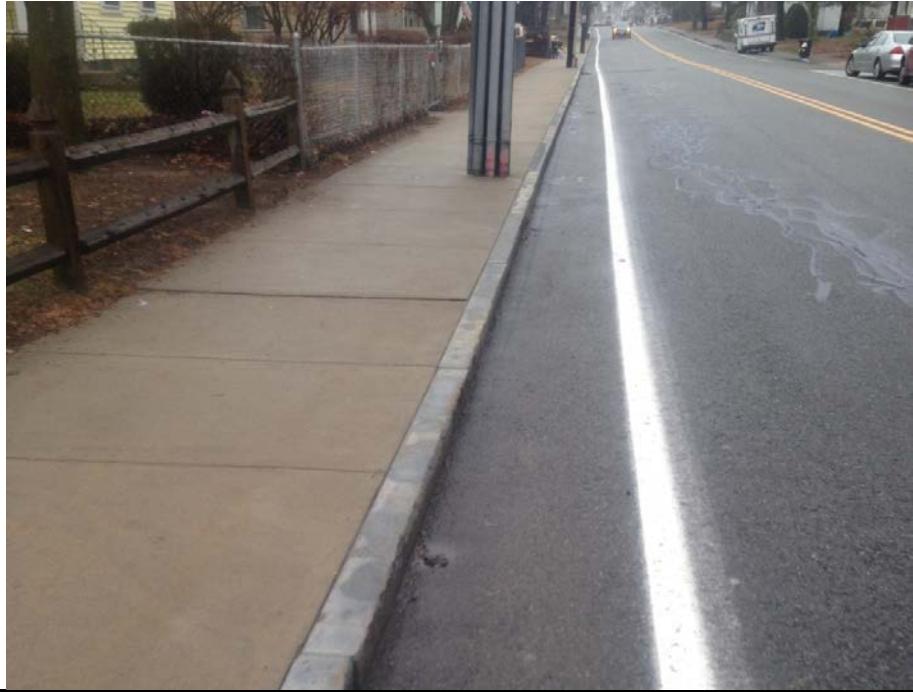
<b><u>Component</u></b>	<b><u>Condition</u></b>	<b><u>Comments</u></b>
Road Surface	Good	Road surface in good condition with some minor patching in some areas
Water Lines	Fair	10" CICL, installed 1970
Sewer Lines	Poor	Unknown diameter and size, installed 1936
Existing Sidewalk	Good	Concrete side walk on both sides with minor cracking in some areas
Curbing	Good	Ganite curb on north side and monolific on south side
Drainage	Good	No ponding issues on street
Gas Lines	Good	4" CS-HP Installed 1980, 4" CS-HP Installed 1981
Parking Lot:		
Lighting:		
Trees/Landscaping:		
Park/Playground:		
Other:		
<b>Overall Rating:</b>	Good

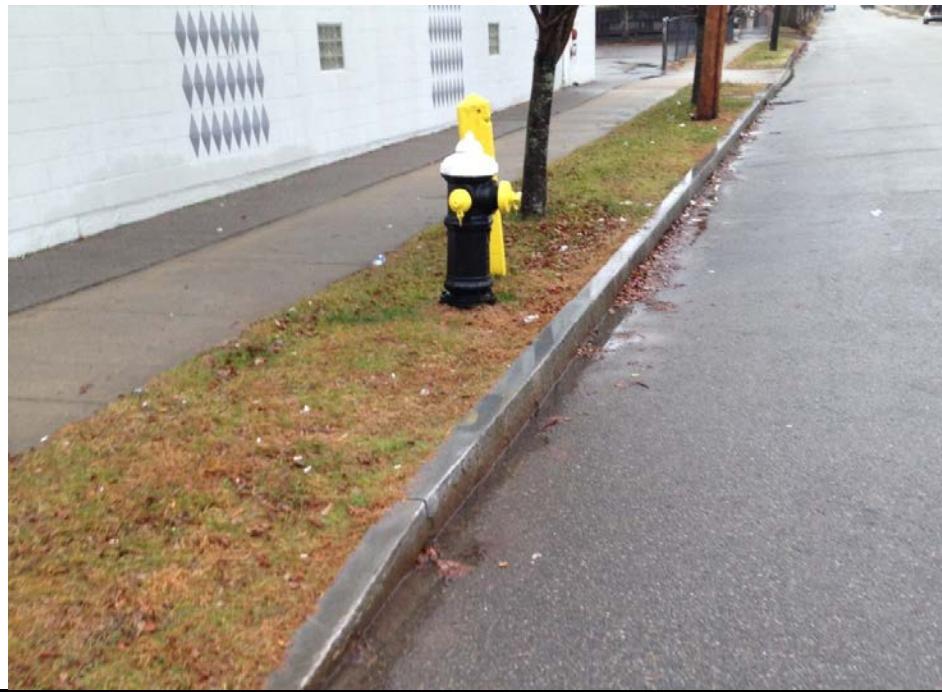
<b><u>Component</u></b>	<b><u>Condition</u></b>	<b><u>Comments</u></b>
Road Surface	Excellent	Newly paved road in great condition
Water Lines	Poor	6" CI, installed 1922 (east of washington) 12" CICL installed 1970 (west of washington)
Sewer Lines	Poor	8", 10", 12" VC gravity lines, installed 1935-1937
Existing Sidewalk	Good	South sidewalk has some moderate cracking, everywhere else is in great condition
Curbing	Good	Granite curb on north side, monolithic on south side. East of washington st. both curbs granite VB in great condition
Drainage	Good	Minor ponding on curb east of Washington Street
Gas Lines	Good	2" P-HP Installed 1991, 4" CS-HP Installed 1977
Parking Lot:		
Lighting:		
Trees/Landscaping:		
Park/Playground:		
Other:		
<b>Overall Rating:</b>	Good

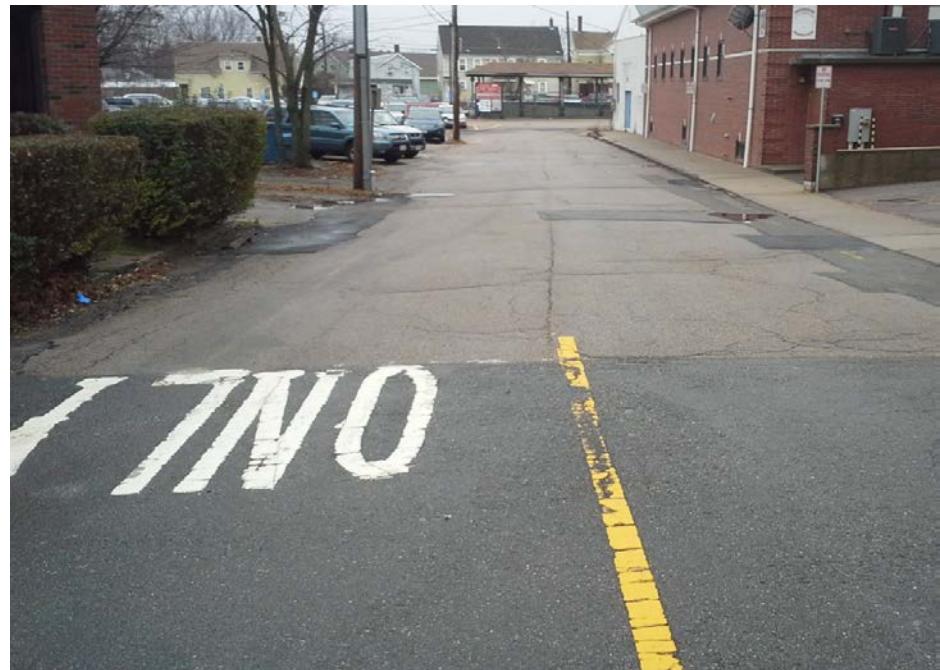
<b>Component</b>	<b>Condition</b>	<b>Comments</b>
Road Surface	Poor	Moderate cracking in pavement surface within lanes and shoulders. Alligator cracking in shoulder where no curb is present, and at westerly end of road. No crack sealing has been done.
Water Lines	Poor	6" CI, installed 1922
Sewer Lines		None shown on GIS
Existing Sidewalk	Fair	Cement concrete sidewalk on northerly side. Surface in good condition. Drives, WCRs and placement of sign post do not comply. Walkway at easterly end of southerly side too narrow to be considered a sidewalk.
Curbing	Good	Granite curb, Type VB, in good condition on northerly side and easterly end of southerly side.
Drainage	Fair	No ponding observed. Older castings on some drain structures.
Gas Lines	Good	2" P-HP Installed 2006, 2" CS-HP Installed 1980
Parking Lot:		
Lighting:		
Trees/Landscaping:		
Park/Playground:		
Other:		
<b>Overall Rating:</b>	Fair

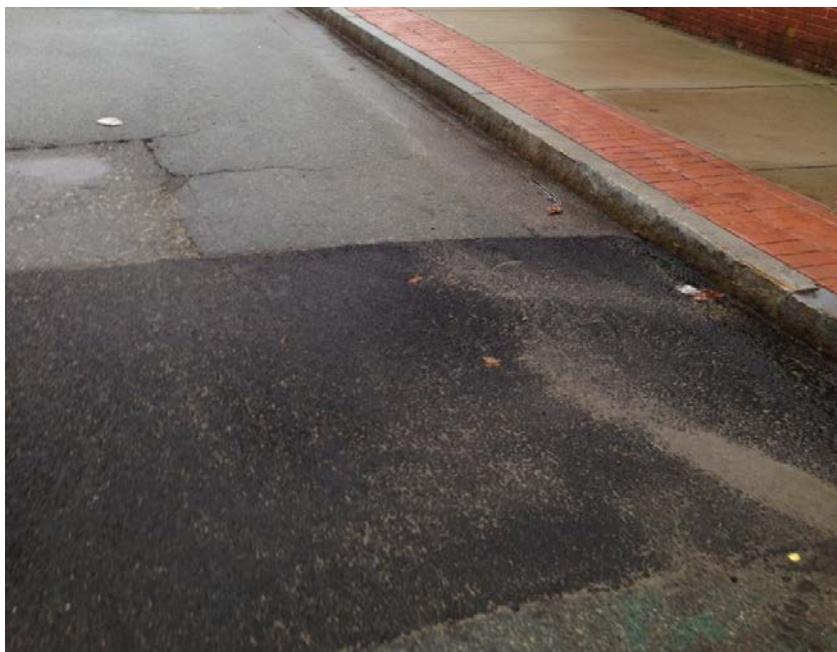
<u>Component</u>	<u>Condition</u>	<u>Comments</u>
Road Surface	Fair	Severe Cracking and patching to road surface
Water Lines	Poor	6" CI, installed 1922
Sewer Lines	Poor	10" VC gravity line, installed 1935
Existing Sidewalk	Fair	some areas on concrete sidewalk with accessibility issues, and all sidewalks end after police station
Curbing	Poor	Granite VB curb on both sides, util sidewalk ends after police station
Drainage	Good	minor ponding on both sides of street
Gas Lines	Good	2" CS-HP Installed 1976
Parking Lot:		
Lighting:		
Trees/Landscaping:		
Park/Playground:		
Other:		
<b>Overall Rating:</b>	Fair

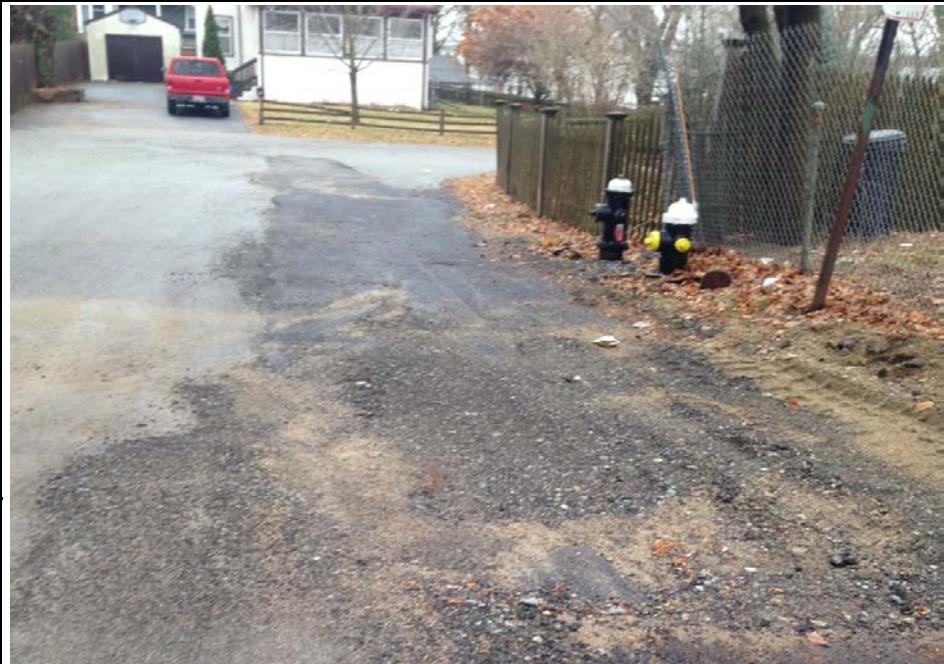
<b>Component</b>	<b>Condition</b>	<b>Comments</b>
Road Surface	Poor	Utility trench patch on westerly side of road. Moderate to heavy alligator cracking in remaining pavement surface. Some crack sealing has been done.
Water Lines	Poor	6" CI, installed 1922
Sewer Lines	Fair	8" VC, gravity line, installed 1972
Existing Sidewalk	Poor	None present.
Curbing	Poor	None present.
Drainage	Poor	No drain structures present.
Gas Lines	Good	2" CS-HP Installed 1973
Parking Lot:		
Lighting:		
Trees/Landscaping:		
Park/Playground:		
Other:		
<b>Overall Rating:</b>	Poor

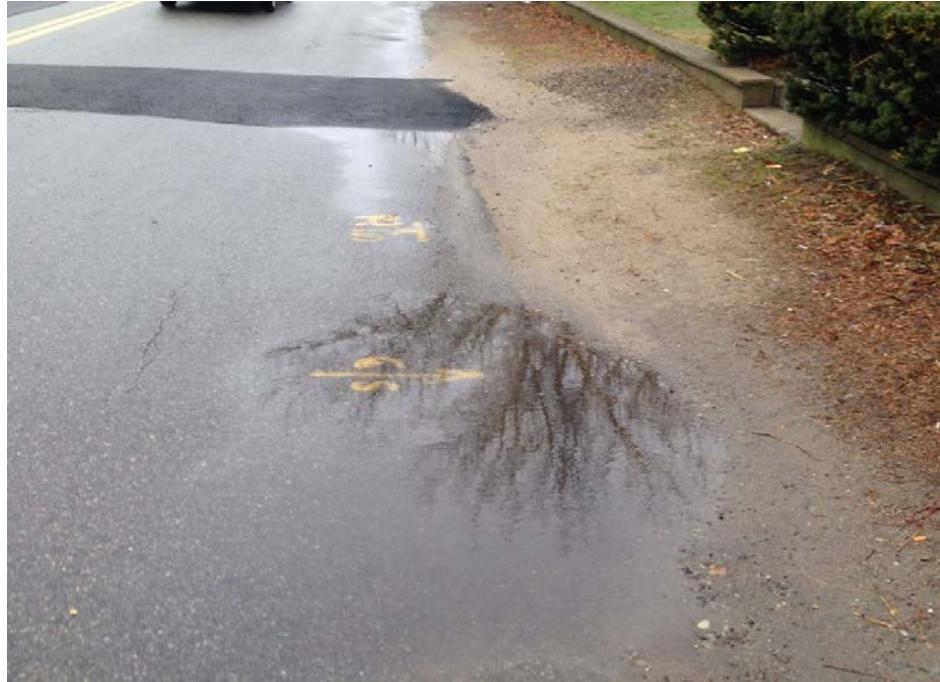
<b>Component</b>	<b>Condition</b>	<b>Comments</b>
Road Surface	Good	Water main trench patch throughout road, several locations of smaller patching
Water Lines	Poor	6" CI, installed 1922
Sewer Lines	Fair	8" gravity line, material unknown
Existing Sidewalk	Fair	South side of street has asphalt sidewalk in good condition, northside has no existing sidewalk
Curbing	Fair	Granite VB curb on south side of street, no existing curb on north side of street
Drainage	Good	Minor ponding in areas where curb is non existant
Gas Lines	Good	2" CS-HP Installed 1982, 2" P-HP Installed 1986, 2006
Parking Lot:		
Lighting:		
Trees/Landscaping:		
Park/Playground:		
Other:		
<b>Overall Rating:</b>	Fair

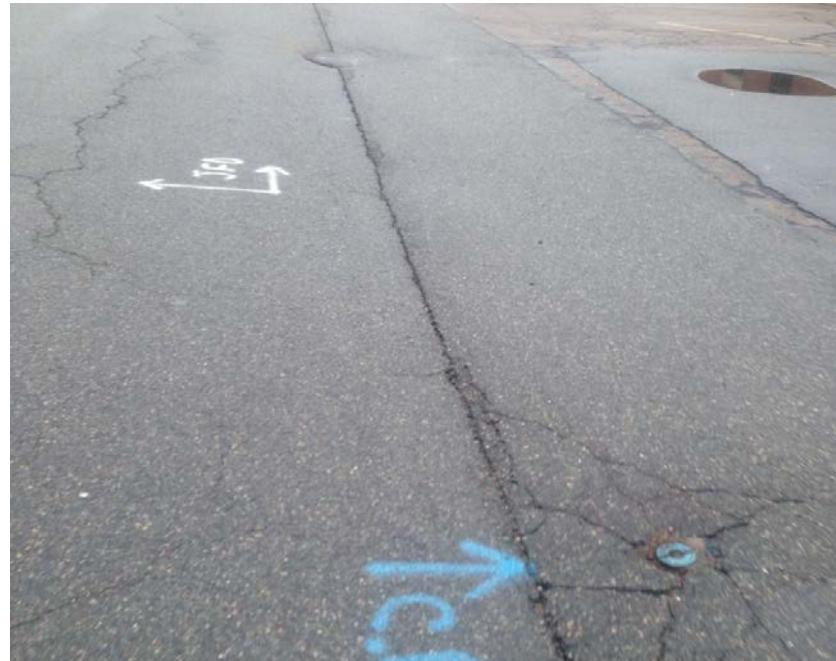
<b>Component</b>	<b>Condition</b>	<b>Comments</b>
Road Surface	Fair	Some moderate cracking in areas, with patching in others, but majority of road is in good condition
Water Lines	Poor	6" CI, installed 1922
Sewer Lines	Good	8" PVC gravity line, installed 1998
Existing Sidewalk	Fair	Ashpalt on south side in good condition, rollover on north side
Curbing	Fair	Granite VB curb on south side in good condition, north side has no curb
Drainage	Fair	Minor ponding in some areas
Gas Lines	Good	4" P-HP Installed 1996
Parking Lot:		
Lighting:		
Trees/Landscaping:		
Park/Playground:		
Other:		
<b>Overall Rating:</b>	Fair

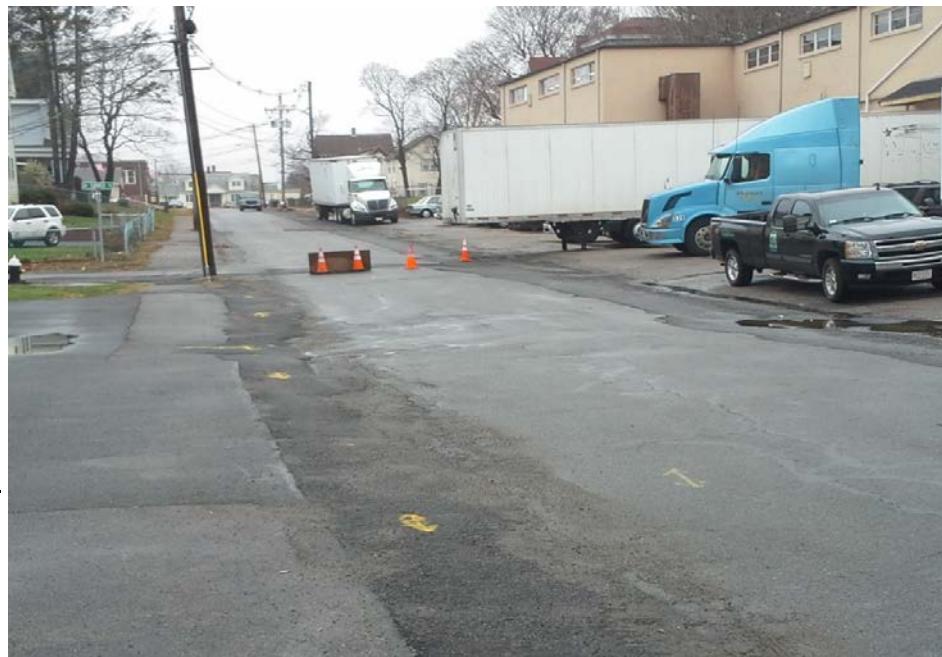
<b>Component</b>	<b>Condition</b>	<b>Comments</b>
Road Surface	Poor	Moderate to heavy cracking in pavement surface within lanes. New utility trench patches in shoulders. Some crack sealing has been done. Road needs reclamation or full depth reconstruction.
Water Lines	Fair	10" DI, installed 1922
Sewer Lines	Poor	15" VC gravity line, installed 1935 - 8" VC gravity line, installed 1953, installed in 1972 running north-south
Existing Sidewalk	Poor	No sidewalk on westerly side. Intermittent sidewalk (monolithic concrete and rollover HMA) on southerly side. Rollover HMA on northerly/easterly side. Sidewalks do not comply with current accessibility standards.
Curbing	Poor	Short run of Type VA-1 granite curb on northerly side in fair condition. Rollover sidewalks do not prevent vehicles from parking on sidewalk.
Drainage	Poor	No drain structures observed west of Summer Ave. East of Summer Ave, some structures (including a Bradley Head) were present. All had older castings.

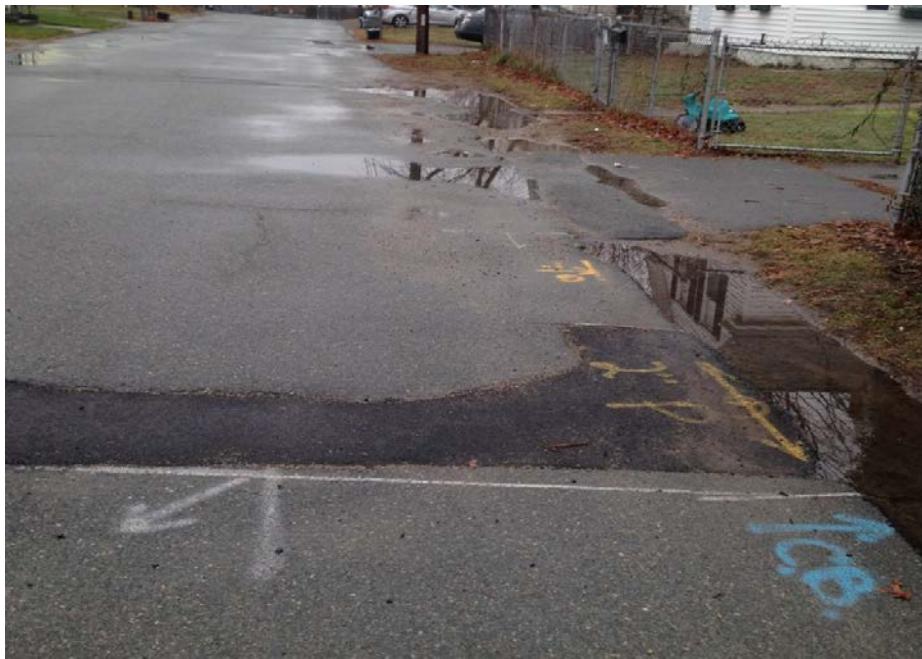
<u>Component</u>	<u>Condition</u>	<u>Comments</u>
Road Surface	Poor	Severe Cracking on road surface. Alligator cracking
Water Lines	Fair	2 listed on GIS, 1-8", 1-6" no materials given
Sewer Lines	Poor	8" VC gravity line
Existing Sidewalk	Poor	None on either side of street
Curbing	Poor	No curbing on either side of street
Drainage	Poor	Severe ponding on both sides of street
Gas Lines	Good	2" P-HP Installed 1997
Parking Lot:		
Lighting:		
Trees/Landscaping:		
Park/Playground:		
Other:		
<b>Overall Rating:</b>	Poor

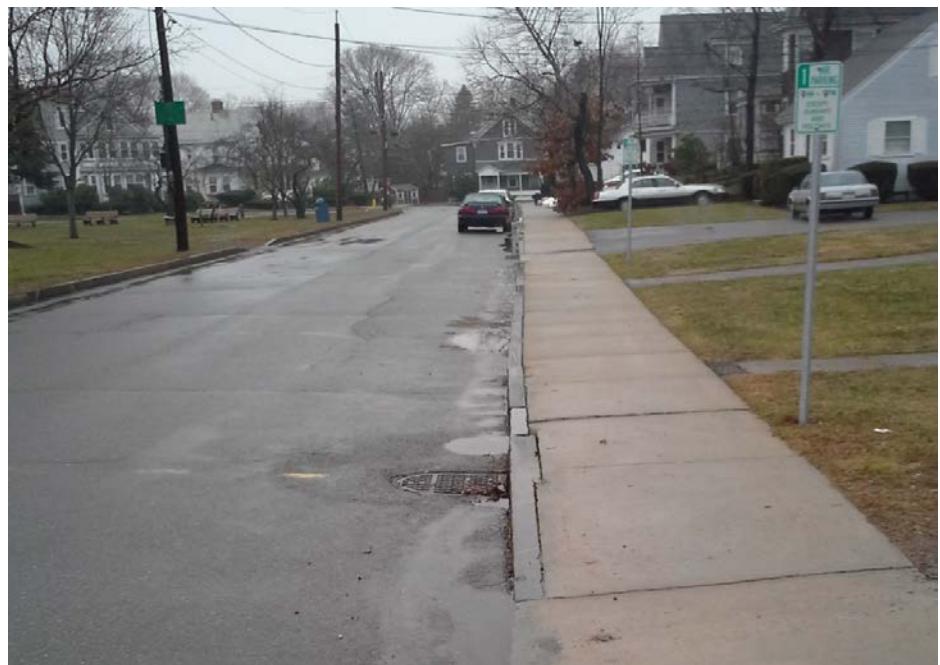
<b>Component</b>	<b>Condition</b>	<b>Comments</b>
Road Surface	Fair	Moderate cracking in pavement surface within lanes, heavier cracking in shoulders. No crack sealing has been done.
Water Lines	Poor	6" CI, installed 1922
Sewer Lines	Fair	8" VC gravity line, installed 1961
Existing Sidewalk	Fair	Cement concrete sidewalk on westerly side. Walk surface is in good condition. Drives and WCRs do not comply with current accessibility standards.
Curbing	Good	Granite curb, Type VB, in good condition on both sides.
Drainage	Fair	Some low spots and ponding in the gutters. Minor settlement at some catch basins. Older castings on catch basins and manholes.
Gas Lines	Good	2" CS-HP Installed 1959
Parking Lot:		
Lighting:		
Trees/Landscaping:		
Park/Playground:		
Other:		
<b>Overall Rating:</b>	Fair

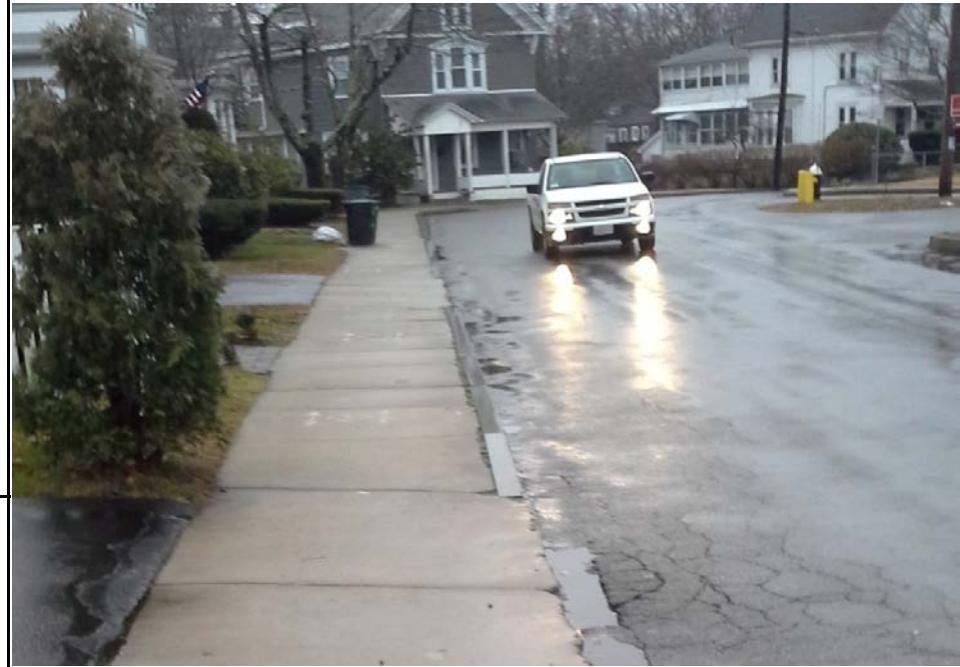
<b>Component</b>	<b>Condition</b>	<b>Comments</b>
Road Surface	Fair	Light to moderate cracking in pavement surface within lanes, heavier cracking in shoulders. Alligator cracking in some locations. No crack sealing has been done.
Water Lines	Poor	6" CI, installed 1922
Sewer Lines	Fair	8" VC gravity line, installed 1961
Existing Sidewalk	Fair	Cement concrete sidewalk on southerly side and on northerly side, west of Walnut Ave. Walk surface is in generally good condition. Drives and WCRs do not comply with current accessibility standards.
Curbing	Good	Granite curb, Type VB, in good condition on both sides.
Drainage	Fair	No significant ponding in the gutters. Some settlement a manhole within travel lane. Older castings on some drain structures.
Gas Lines	Good	2" P-HP Installed 1987
Parking Lot:		
Lighting:		
Trees/Landscaping:		
Park/Playground:		
Other:		
<b>Overall Rating:</b>	Fair

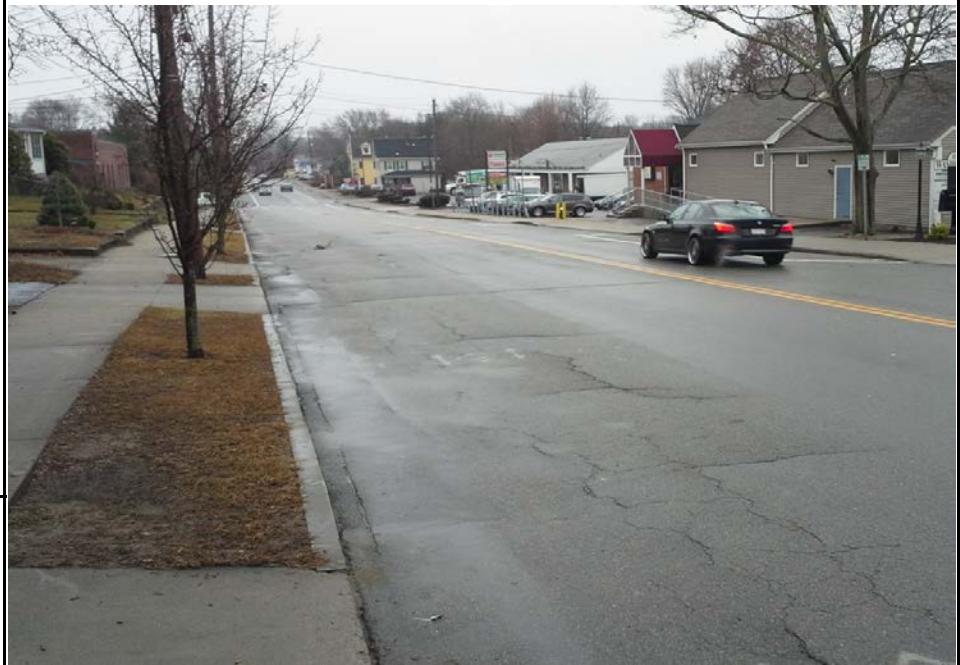
<b>Component</b>	<b>Condition</b>	<b>Comments</b>
Road Surface	Fair	Moderate cracking in pavement surface within lanes and shoulders. Alligator cracking in some locations. No crack sealing has been done.
Water Lines	Poor	6" CI, installed 1922
Sewer Lines	Fair	8" VC gravity main, installed 1961
Existing Sidewalk	Fair	Cement concrete sidewalk on north of Walnut St, HMA sidewalk south, both sides. Walk surface is in generally good condition. Drives, WCRs and cross slope do not comply with current accessibility standards.
Curbing	Good	Granite curb, Type VB, in good condition on both sides.
Drainage	Good	Minor ponding in gutter. Cascade grate at low point on westerly side is broken and about 2/3 clogged with debris.
Gas Lines	Good	8" CS-HP Installed 1980, 8" CS-HP Installed 1971
Parking Lot:		
Lighting:		
Trees/Landscaping:		
Park/Playground:		
Other:		
<b>Overall Rating:</b>	Fair

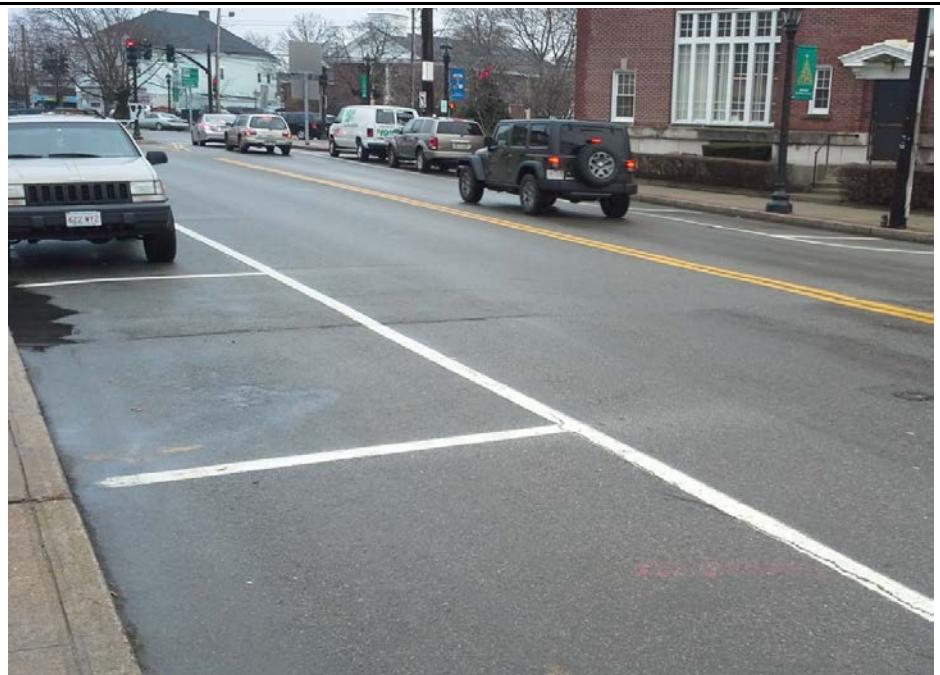
<b>Component</b>	<b>Condition</b>	<b>Comments</b>
Road Surface	Good	This section appears to have been overlaid within the last 5 years. Minor cracking observed.
Water Lines	Fair	10"-12" CICL, installed 1970
Sewer Lines	Poor	10" dia., unknown material gravity line
Existing Sidewalk	Good	Cement concrete sidewalk with brick banding on both sides. Walk surface is in good condition and, with the exception of no detectable warning panels, appears to comply with current accessibility standards.
Curbing	Good	Granite curb, Type VB, in good condition on both sides.
Drainage	Fair	Moderate to heavy ponding observed in parking lanes on westerly side north of Railroad Ave.
Gas Lines	Good	8" CS-HP Installed 1980
Parking Lot:		
Lighting:		
Trees/Landscaping:		
Park/Playground:		
Other:		
<b>Overall Rating:</b>	Good

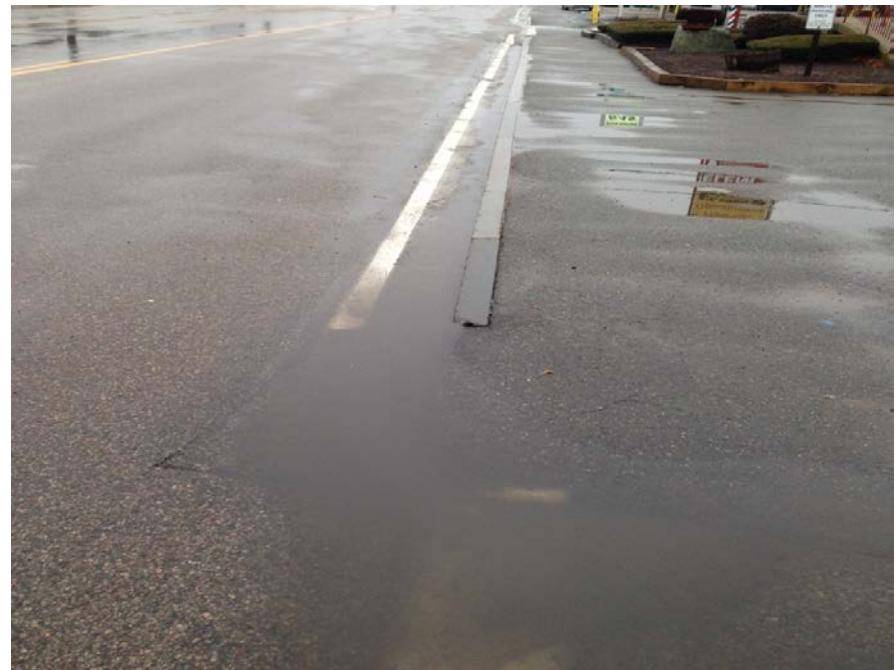
<b>Component</b>	<b>Condition</b>	<b>Comments</b>
Road Surface	Good	This section appears to have been overlaid within the last 5 years. Very minor ponding and cracking observed.
Water Lines	Good	12" DI on West side (1970), 8" CI on east side (1922, Old)
Sewer Lines		8" VC gravity sewer
Existing Sidewalk	Good	East sidewalk in poor condition with sever cracking, west sidewalk new and in exelent condition.
Curbing	Good	Granite curb, Type VB, in good condition on west side, east side is cracked and/or missing.
Drainage	Good	Moderate ponding observed in some intersections, Mostly "D" catch basins
Gas Lines	Good	3" BS-HP Installed 1915, 4" P-HP Installed 2006, 8" CS-HP Installed 1980
Parking Lot:		
Lighting:		
Trees/Landscaping:		
Park/Playground:		
Other:		
<b>Overall Rating:</b>	Good

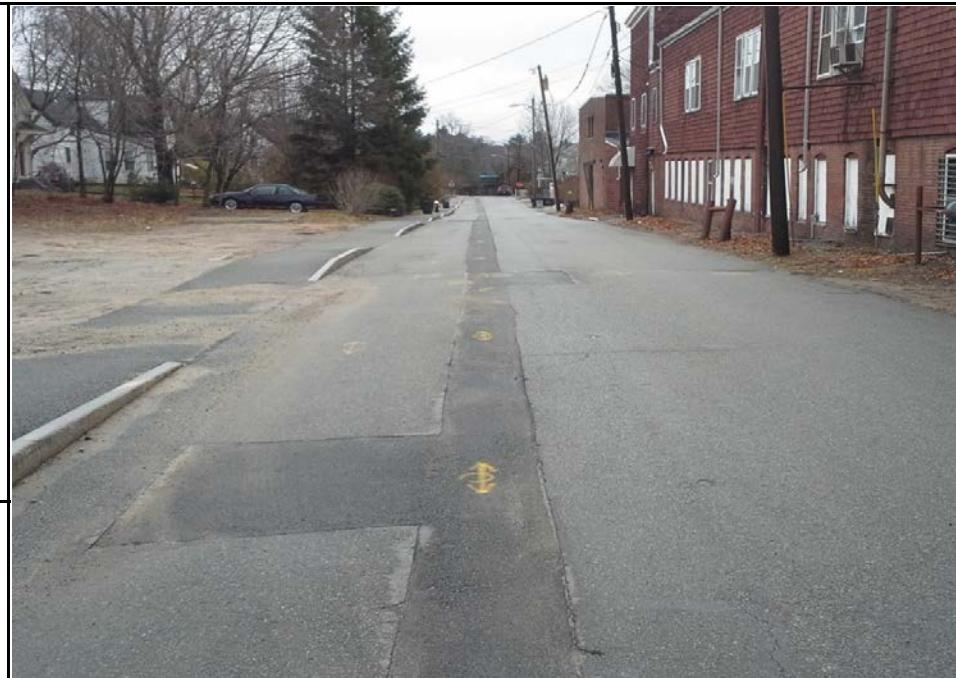
<b>Component</b>	<b>Condition</b>	<b>Comments</b>
Road Surface	Fair	Utility trench patch in lane on easterly side of road. Light to moderate cracking in pavement surface. Some crack sealing has been done.
Water Lines	Poor	6" CI, installed 1922
Sewer Lines	Fair	8" VC gravity line, installed 1961
Existing Sidewalk	Fair	No sidewalk on westerly side. HMA sidewalk on easterly side. Walk terminates (on Summer St.) without WCR.
Curbing	Good	No curbing on westerly side. Granite curb, type VB, in good condition on easterly side.
Drainage	Poor	No drain structures present.
Gas Lines	Good	2" P-HP Installed 2013
Parking Lot:		
Lighting:		
Trees/Landscaping:		
Park/Playground:		
Other:		
<b>Overall Rating:</b>	Fair

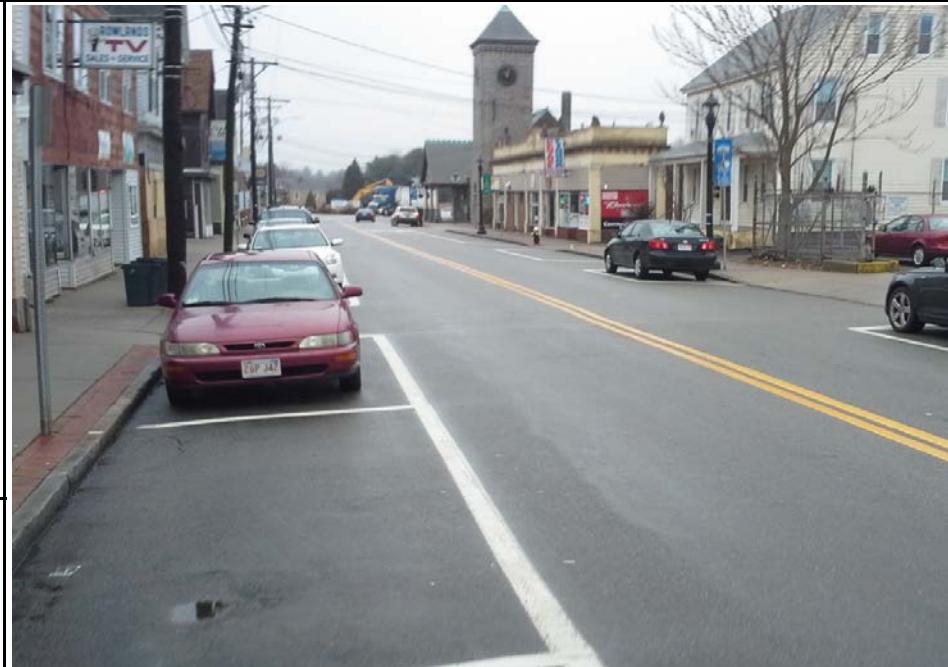
<b>Component</b>	<b>Condition</b>	<b>Comments</b>
Road Surface	Good	Minor cracking observed in travel lanes. Minor to moderate cracking and some settlement in parking lane. Insufficient horizontal clearance to utility poles on southerly side.
Water Lines	Poor	10" CI, installed 1922
Sewer Lines	Poor	10" dia. Gravity line, unknown material, installed in 1936
Existing Sidewalk	Fair	Cement concrete, with brick banding near Washington St. and stamped & colored concrete banding farther west, both sides. Surface is in good condition. Drives and WCRs do not comply with current standards.
Curbing	Good	Granite curb, type VB, in good condition on both sides.
Drainage	Fair	No significant ponding observed on either side. Catch basin located within crosswalk does not comply with accessibility standards. Older castings on drain structures.
Gas Lines	Good	4" CS-HP Installed 1980, 4" P-HP Installed 1997
Parking Lot:

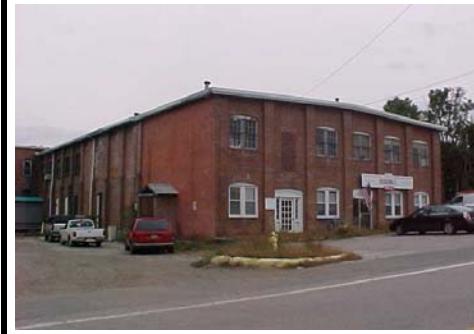
Front yard paved; side yard gravel to materials storage in rear

Probable lead paint based on age of building

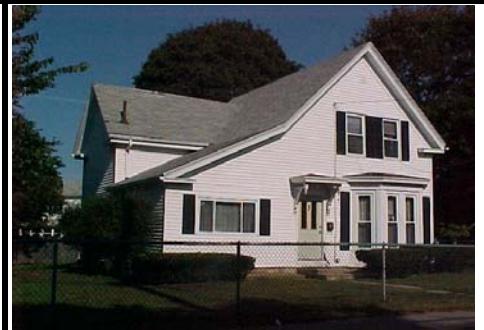
<u>Component</u>	<u>Condition</u>
Roofing	
Windows and Doors	
Exterior Walls	
Porch/Stairs/Deck	New front stoop
Foundation	
Storefront & Signage	
Parking Lots	
Environmental	Probable lead paint based on age of building
Other:	
Overall Property Rating: (Excellent / Good / Fair / Poor)	
briefly state why.

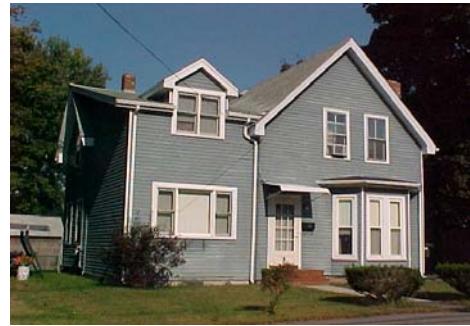
<u>Component</u>	<u>Condition</u>
Roofing	
Windows and Doors	
Exterior Walls	
Porch/Stairs/Deck	
Foundation	
Storefront & Signage	
Parking Lots	
Environmental	Probable lead paint based on age of building
Other:	
Overall Property Rating: (Excellent / Good / Fair / Poor)	
briefly state why.

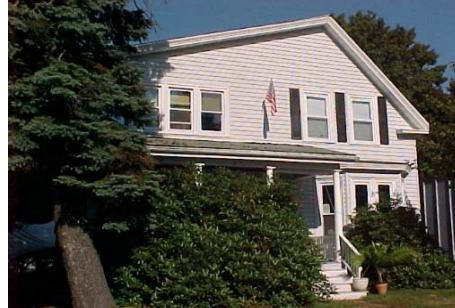
<u>Component</u>	<u>Condition</u>
Roofing	
Windows and Doors	
Exterior Walls	
Porch/Stairs/Deck	
Foundation	
Storefront & Signage	
Parking Lots	half of front yard is paved
Environmental	Probable lead paint based on age of building
Other:	
Overall Property Rating: (Excellent / Good / Fair / Poor)	
briefly state why.

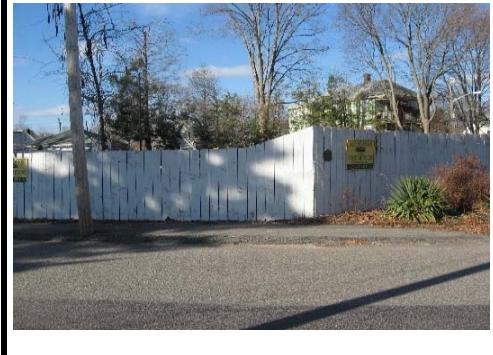
<u>Component</u>	<u>Condition</u>
Roofing	
Windows and Doors	
Exterior Walls	
Porch/Stairs/Deck	
Foundation	
Storefront & Signage	
Parking Lots	
Environmental	
Other:	Fence needs paint
Overall Property Rating: (Excellent / Good / Fair / Poor)	
briefly state why.

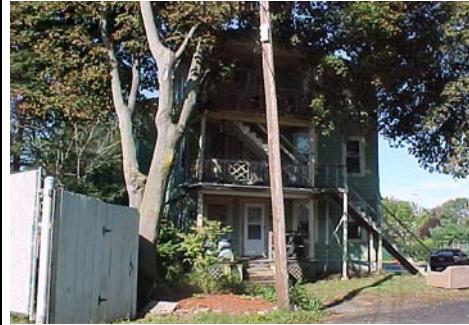
<u>Component</u>	<u>Condition</u>
Roofing	
Windows and Doors	
Exterior Walls	
Porch/Stairs/Deck	
Foundation	
Storefront & Signage	
Parking Lots	
Environmental	Probable lead paint based on age of building
Other:	
Overall Property Rating: (Excellent / Good / Fair / Poor)	
briefly state why.

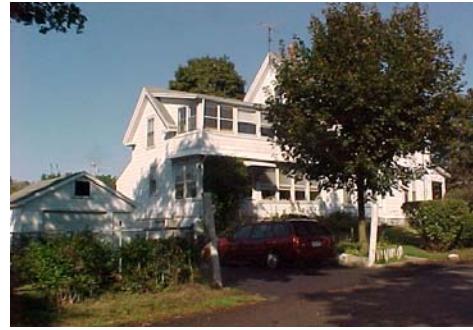
<u>Component</u>	<u>Condition</u>
Roofing	
Windows and Doors	
Exterior Walls	
Porch/Stairs/Deck	
Foundation	
Storefront & Signage	
Parking Lots	
Environmental	Probable lead paint based on age of building
Other:	
Overall Property Rating: (Excellent / Good / Fair / Poor)	
briefly state why.

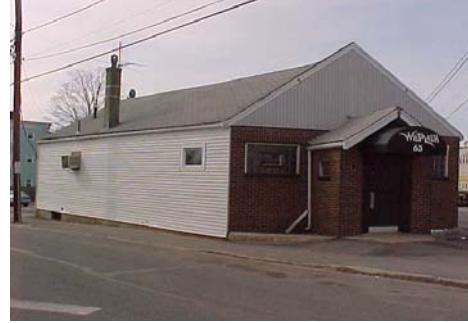
<u>Component</u>	<u>Condition</u>
Roofing	
Windows and Doors	
Exterior Walls	
Porch/Stairs/Deck	
Foundation	
Storefront & Signage	
Parking Lots	
Environmental	Probable lead paint based on age of building
Other:	
Overall Property Rating: (Excellent / Good / Fair / Poor)	
briefly state why.

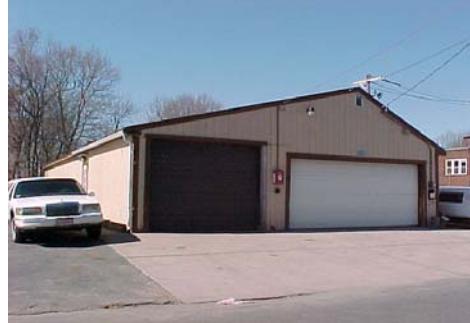
<u>Component</u>	<u>Condition</u>
Roofing	
Windows and Doors	
Exterior Walls	
Porch/Stairs/Deck	
Foundation	
Storefront & Signage	
Parking Lots	Front and side yards both paved
Environmental	Probable lead paint based on age of building
Other:	
Overall Property Rating: (Excellent / Good / Fair / Poor)	
briefly state why.

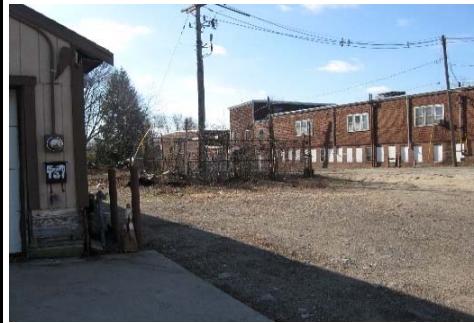
<u>Component</u>	<u>Condition</u>
Roofing	
Windows and Doors	
Exterior Walls	
Porch/Stairs/Deck	
Foundation	
Storefront & Signage	
Parking Lots	
Environmental	
Other:	Check previous use if possible - between repair garage and mill
Overall Property Rating: (Excellent / Good / Fair / Poor)	
briefly state why.

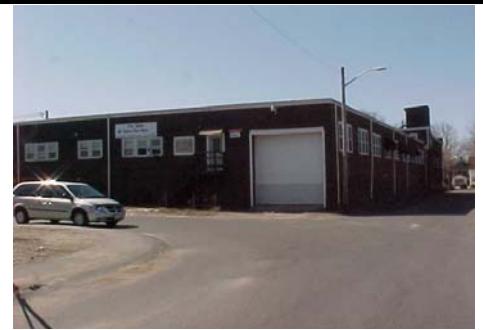
<u>Component</u>	<u>Condition</u>
Roofing	
Windows and Doors	
Exterior Walls	Singificant paint needed and siding repairs
Porch/Stairs/Deck	
Foundation	
Storefront & Signage	
Parking Lots	
Environmental	Probable lead paint based on age of building
Other:	
Overall Property Rating: (Excellent / Good / Fair / Poor)	briefly state why.

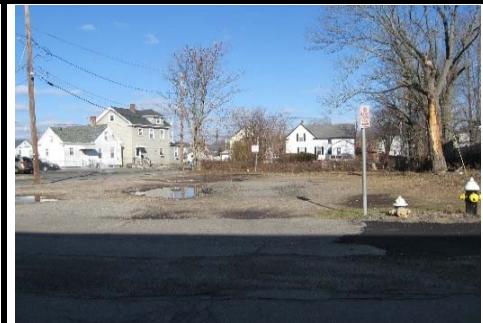
<u>Component</u>	<u>Condition</u>
Roofing	
Windows and Doors	
Exterior Walls	
Porch/Stairs/Deck	
Foundation	
Storefront & Signage	
Parking Lots	Gravel lot with significant potholes
Environmental	
Other:	Check previous use if possible - across from mill
Overall Property Rating: (Excellent / Good / Fair / Poor)	
briefly state why.

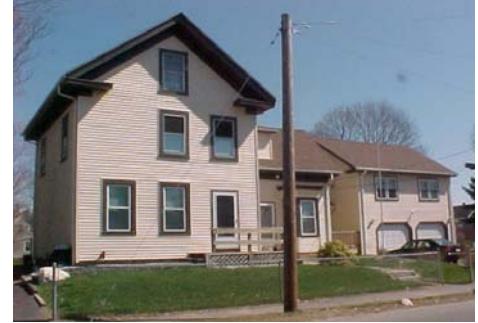
<u>Component</u>	<u>Condition</u>
Roofing	
Windows and Doors	
Exterior Walls	
Porch/Stairs/Deck	
Foundation	
Storefront & Signage	
Parking Lots	
Environmental	Probable lead paint based on age of building
Other:	
Overall Property Rating: (Excellent / Good / Fair / Poor)	
briefly state why.

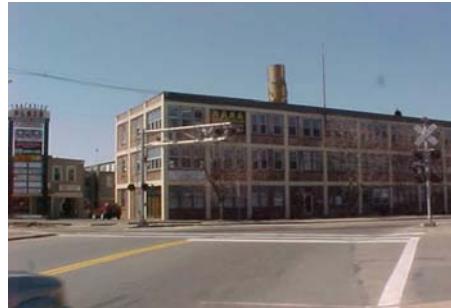
Parcel ID: 054 110 0  
 Address: 2 CANTON ST  
 Land Use: 401  
 Zoning: GB  
 Building Type: MILL  
 Stories: 3  
 Exterior Construction: BRICK  
 Interior Construction: DRYWALL  
 Building Age: 1910  
 Assessed Value: \$1,752,800  
 Building Condition: Fair-Avg  
 Ownership: STOUGHTON CTR BUSINESS PK LLC  
 Commercial/Residential: C  
 Storefront Construction:  
 Vacant: yes no other: No - 50 businesses on site

<u>Component</u>	<u>Condition</u>
Roofing	
Windows and Doors	
Exterior Walls	
Porch/Stairs/Deck	
Foundation	
Storefront & Signage	
Parking Lots	
Environmental	Probable lead paint based on age of building
Other:	MassDEP: Closed (see <i>Existing Conditions Memorandum</i> , April 2015)
Overall Property Rating: (Excellent / Good / Fair / Poor)	
briefly state why.

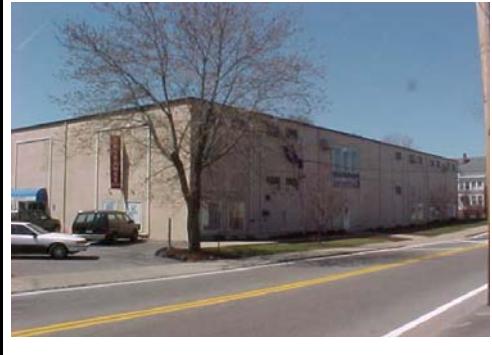
Parcel ID: 054 111 0  
Address: 18 CANTON ST  
Land Use: 957  
Zoning: I  
Building Type: WAREHOUSE  
Stories: 2  
Exterior Construction: CONC BLOCK  
Interior Construction: MINIMUM  
Building Age: 1910  
Assessed Value: \$1,729,700  
Building Condition: Average  
Ownership: SOCIETY OF ST VINCENT DE PAUL  
Commercial/Residential: Non-profit  
Storefront Construction:  
Vacant: yes no other: No - Society of St. Vincent de Paul

<u>Component</u>	<u>Condition</u>
Roofing	
Windows and Doors	
Exterior Walls	
Porch/Stairs/Deck	
Foundation	
Storefront & Signage	
Parking Lots	
Environmental	Probable lead paint based on age of building
Other:	
Overall Property Rating: (Excellent / Good / Fair / Poor)	
briefly state why.

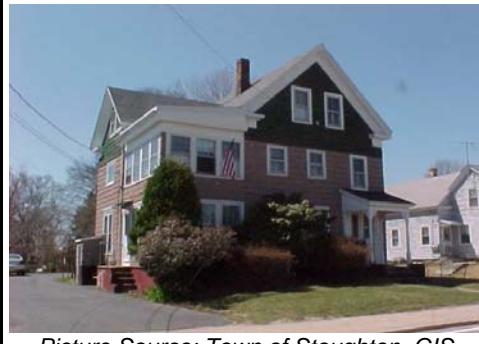
Parcel ID: 054 112 0  
Address: 46 CANTON ST  
Land Use: 104  
Zoning: RU  
Building Type: MULTI-CONV  
Stories: 2A  
Exterior Construction: VINYL  
Interior Construction: PLASTER  
Building Age: 1930  
Assessed Value: \$245,900  
Building Condition: Average  
Ownership: LOPES MARIA R  
Commercial/Residential: R  
Storefront Construction:  
Vacant: yes no other: No

<b>Component</b>	<b>Condition</b>
Roofing	
Windows and Doors	
Exterior Walls	
Porch/Stairs/Deck	
Foundation	
Storefront & Signage	
Parking Lots	
Environmental	Probable lead paint based on age of building
Other:	Recently re-sided
Overall Property Rating: (Excellent / Good / Fair / Poor)	
briefly state why.

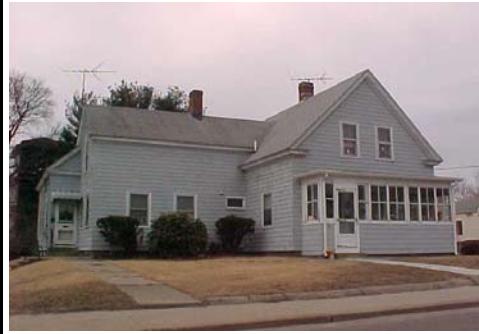
Parcel ID: 054 113 0  
Address: 54 CANTON ST  
Land Use: 104  
Zoning: RU  
Building Type: MULTI-CONV  
Stories: 1H  
Exterior Construction: WOOD SHING  
Interior Construction: PLASTER  
Building Age: 1930  
Assessed Value: \$227,300  
Building Condition: Average  
Ownership: MACROGIANIS NICHOLAS  
MACROGIANIS EVELYN  
Commercial/Residential: R  
Storefront Construction:  
Vacant: yes no other: No

<u>Component</u>	<u>Condition</u>
Roofing	
Windows and Doors	
Exterior Walls	
Porch/Stairs/Deck	
Foundation	
Storefront & Signage	
Parking Lots	
Environmental	Probable lead paint based on age of building
Other:	
Overall Property Rating: (Excellent / Good / Fair / Poor)	
briefly state why.

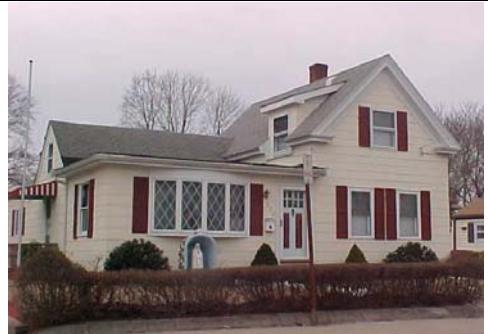
Parcel ID: 054 114 0  
Address: 60 CANTON ST  
Land Use: 101  
Zoning: RU  
Building Type: OLD STYLE  
Stories: 2  
Exterior Construction: ASBESTOS  
Interior Construction: PLASTER  
Building Age: 1930  
Assessed Value: \$203,300  
Building Condition: Average  
Ownership: DEALMEIDA ANGELO G  
DEALMEIDA MARIA F  
Commercial/Residential: R  
Storefront Construction:  
Vacant: yes no other: No

<u>Component</u>	<u>Condition</u>
Roofing	
Windows and Doors	
Exterior Walls	
Porch/Stairs/Deck	
Foundation	
Storefront & Signage	
Parking Lots	
Environmental	Probable lead paint based on age of building
Other:	
Overall Property Rating: (Excellent / Good / Fair / Poor)	
briefly state why.
