STOUGHTON BUILDING AUDITS

KMA audited the following municipal buildings:

TOWN HALL

AUDITED ON: MAY 1, 2024

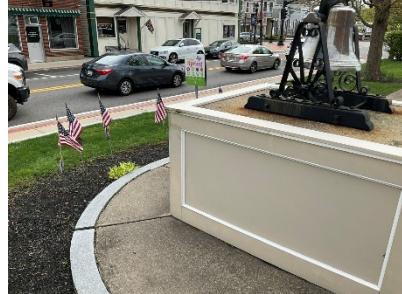
3.	Memorial There is no accessible route to all sides of the memorial, including the memorial plaque facing Pearl Street.	2010 ADAS 206.1

Provide an accessible route to the memorial. Additional study required. Unit Cost: \$5,000 ea. Quantity: 1	\$5,000
4.	Drop Box The afterhours drop box is not located on an accessible route due to the curb and has a cross slopes >2%, @ up to 5%.	2010 ADAS 206.1

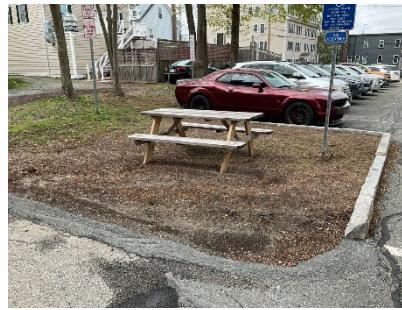
Relocate the drop box to an accessible location. Unit Cost: \$250 Quantity: 1	\$250
5.	Picnic Table The table lacks the required knee and toe clearance, clear floor space, and is not on an accessible route due to the mulch surface.	2010 ADAS 206.1 2010 ADAS 305.2 2010 ADAS 902.4.1

Provide an accessible picnic table located on an accessible route. Unit Cost: \$250 ea. Quantity: 1	\$250

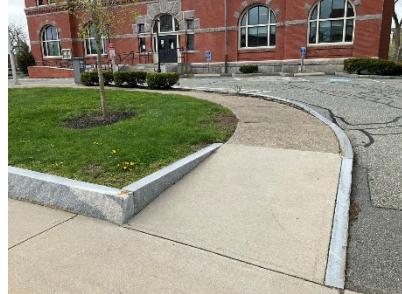
6.	Exterior Accessible Route The walkway between Pearl Street and the main entrance has running slopes >5%, @ up to 13%. The walkway has cross slopes >2%, @ up to 3%.	2010 ADAS 302.1 2010 ADAS 403.3

Regrade the walkway. Unit Cost: \$25/SF Est. Quantity: 100 SF	\$2,500
7.	Ramp to Front Entrance (East Side) The lower landing of the ramp has a slope >2%, @ 2.7%. The lower ramp has running slopes >8.3% @ up to 9.7%. The intermediate landing of the ramp has a width >60", @ 55".	2010 ADAS 502.2

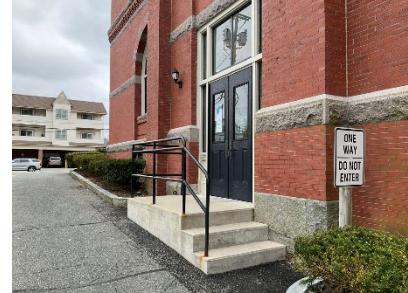
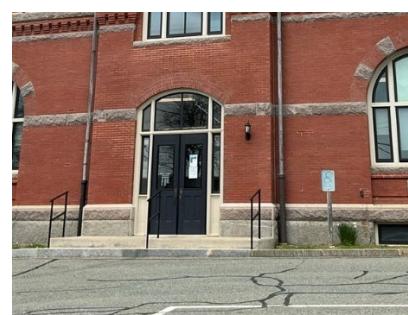
8.	<p>Side Entrances (North/South Sides)</p> <p>The entrances are not accessible due to the step.</p> <p>The stairs lack the required handrails on both sides.</p>	<p>2010 ADAS 505.2 2010 ADAS 216.6</p>

<p>Install signage at all non-accessible entrances indicating the nearest accessible entrance/exit.</p> <p>Unit Cost: \$150 ea.</p> <p>Quantity: 2</p> <p>Install compliant handrails on both sides of the stairs.</p> <p>Unit Cost: \$50/LF</p> <p>Est. Quantity: 16 LF</p>	\$1,100
9.	<p>Rear Entrance (West Side)</p> <p>The entrance door is located in a recess >8" and lacks a level landing, @ 7.1%.</p>	<p>2010 ADAS 404.2.4.3 2010 ADAS 404.2.4.4</p>

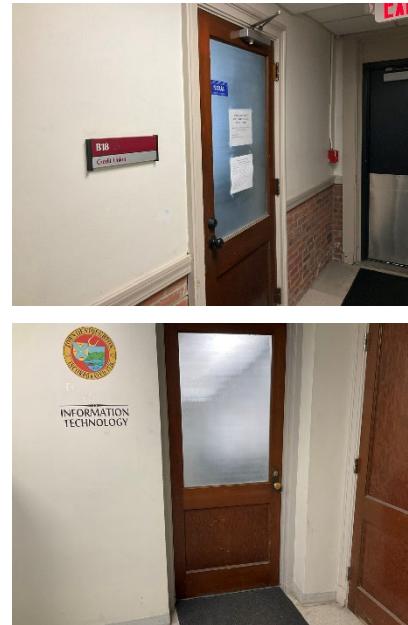
<p>Install a cane detectable object below the box.</p> <p>Unit Cost: \$250 ea.</p> <p>Quantity: 1</p> <p>Install a cane detectable object below the televisions.</p> <p>Unit Cost: \$250 ea.</p> <p>Quantity: 2</p>	\$750
13.	<p>Door Hardware (Typical)</p> <p>The door hardware of the Credit Union and IT Department on the basement level require tight grasping, pinching, or twisting of the wrist to operate.</p>	2010 ADAS 404.2.7

<p>Replace the door hardware with lever types.</p> <p>Unit Cost: \$300</p> <p>Quantity: 2</p>	\$600

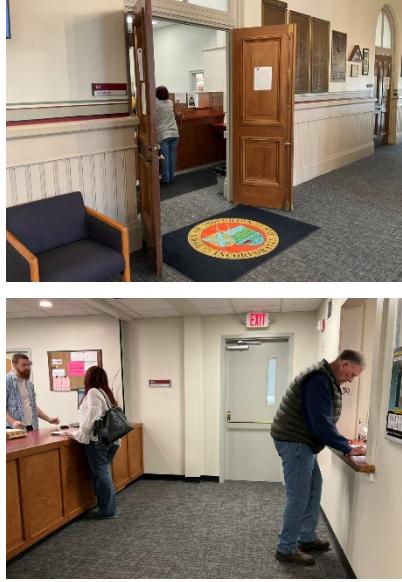
16.	<p>Counters (Typical)</p> <p>The counters serving the Tax Collector and Clerk's Office on the first floor and the Visiting Nurse Office and Engineering Department on the second floor are >36" AFF, @ 44 1/4"</p>	2010 ADAS 904.4

<p>Lower a 36" wide portion of the counter to 36" max. AFF. Unit Cost: \$3,000 ea. Quantity: 4</p>	\$12,000
17.	<p>Desks in Great Hall (Third Floor)</p> <p>The knee clearance at the desk is <27" AFF, @ 26".</p>	2010 ADAS 306.2 & 306.3

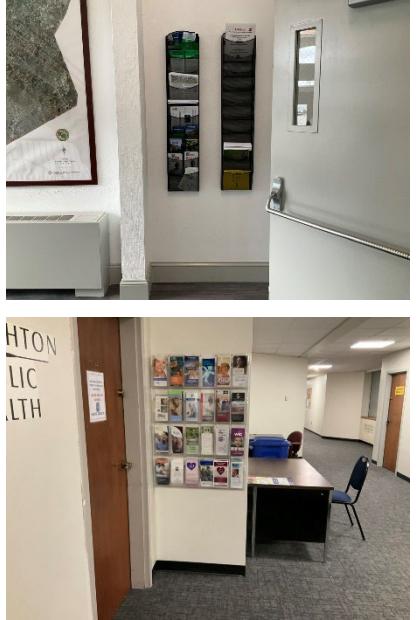
19.	<p>Bulletin Boards (Typical)</p> <p>Materials displayed on the bulletin boards inside the stairwell (South Side) and near the Visiting Nurse Office are >48".</p>	2010 ADAS 308.2 & 308.3

<p>Relocate the materials to an accessible reach range. Unit Cost: \$50 ea. Quantity: 2</p>	\$100
20.	<p>Drinking Fountain (Third Floor)</p> <p>A drinking fountain for standing users is not provided.</p>	2010 ADAS 211.2

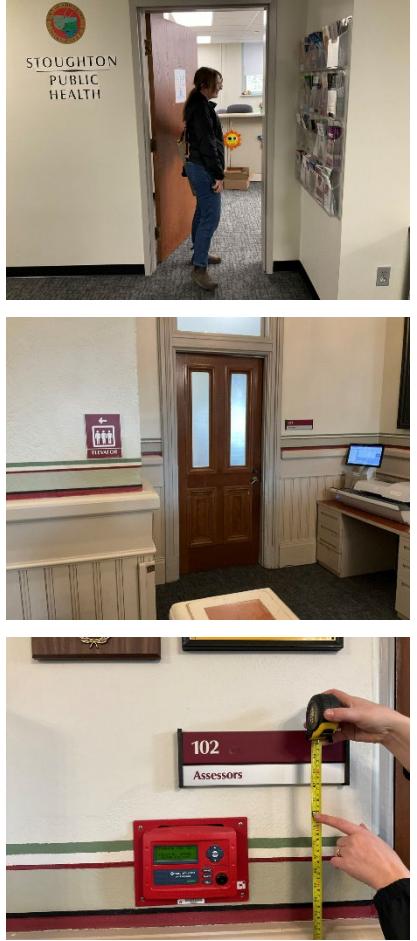
21.	<p>Signage (Typical)</p> <p>The doors to the IT Department on the basement level, the Conference Room on the first floor, and Visiting Nurse Office and Building & Zoning on the second floor lack tactile/braille signage mounted 60" max. on the latch side of the door.</p> <p>The sign of the Assessor's Office, Tax Collector, Clerk's Office, Treasurer Office, HR/Payroll on the first floor and the Great Hall on the third floor are located >60", measured from the baseline of the highest tactile character, up to 64".</p>	<p>2010 ADAS 216.2 2010 ADAS 703.4.1</p>

<p>Install and reinstall tactile/ Braille signage on the latch side of the door at 60" AFF maximum. Coordinate with location and height requirements.</p> <p>Unit Cost: \$100 per sign Quantity: 10</p>	\$1,000
-----	---	--	--	---	---------

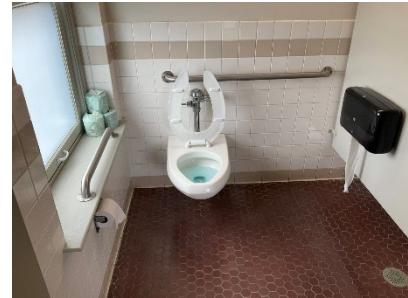
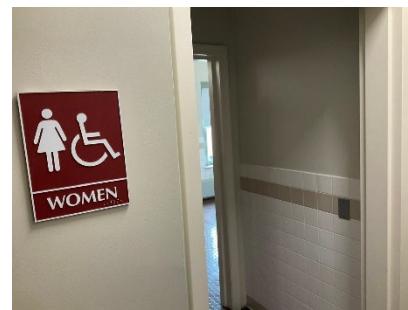
24.	<p>Men's & Women's Multi-User Toilet Rooms (Third Floor)</p> <p>The door to the lacks tactile/Braille signage mounted 60" max. on the latch side (Women's).</p> <p>The bottom of the reflective surface of the mirror is >40" AFF, @ 42" (Men's/Women's).</p> <p>The toilet centerline is not between 16"-18" from the nearest adjacent side wall, @ 20" (Men's/Women's).</p> <p>Toilet flush controls are not mounted on the open side of the toilet (Women's).</p> <p>The toilet paper (TP) dispenser is located <7"- 9" from the front of the toilet, @ 5" (Women's).</p> <p>The accessible toilet stalls are <60" wide, @ up to 58 1/2" (Men's/Women's).</p> <p>The rear grab bars are mounted >6" from the interior corner of the wall, @13" (Men's/Women's).</p> <p>The side grab bar extends <54" from the rear wall, @ 44" (Men's).</p> <p>The side grab bar is not mounted on the wall (Women's).</p> <p>The coat hooks are mounted >48", @ 50" (Men's/Women's).</p>

<p>Install tactile/ Braille signage on the latch side of the door at 60" AFF maximum.</p> <p>Unit Cost: \$100 per sign Quantity: 1</p> <p>Lower the mirror.</p> <p>Unit cost: \$50 ea. Quantity: 2</p> <p>Reposition the toilet.</p> <p>Unit cost: \$1,500 ea. Est. Quantity: 1</p> <p>Reposition the flush valve or install an automatic flush control.</p> <p>Unit cost: \$1,500 Est. Quantity: 1</p> <p>Relocate the TP dispenser.</p> <p>Unit cost: \$50 ea. Est. Quantity: 1</p> <p>Reconfigure the toilet stall.</p> <p>Unit cost: \$5,000 ea. Quantity: 2</p> <p>Add a partition above the window sill and relocate the grab bar.</p> <p>Unit cost: \$250 ea. Quantity: 2</p> <p>Relocate the grab bars.</p> <p>Unit cost: \$50 ea. Quantity: 2</p> <p>Install a coat hook mounted no higher than 48" AFF.</p> <p>Unit Cost: \$50 ea. Quantity: 2</p>	\$13,950

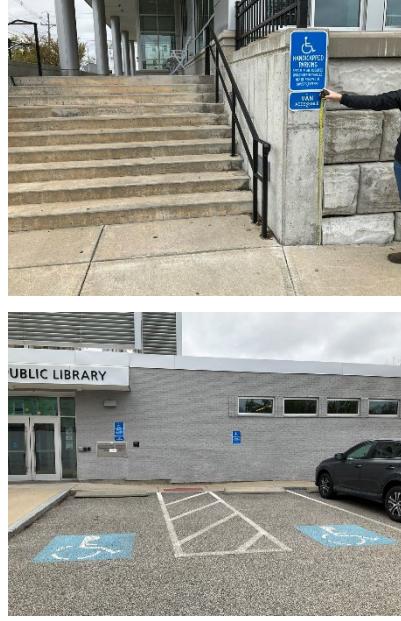
#	<i>Barrier Statement</i>	<i>Code References</i>	<i>Photo</i>	<i>Proposed Mitigation</i>	<i>Cost</i>
1.	<p>Parking</p> <p>The van parking space signage on the parking lot off Park Street is <60" AFF measured to the bottom of the sign, @ 55".</p> <p>The van parking space closest to the rear entrance (off Walnut Street) is <96" wide, @ 60", measured centerline to centerline.</p>	<p>2010 ADAS 502.6</p> <p>2010 ADAS 502.2</p>

<p>Install a van accessible sign with the International Symbol of Accessibility at 60" AFF minimum, measured to the bottom of the sign.</p> <p>Unit Cost: \$100 ea.</p> <p>Quantity: 1</p> <p>Restripe a portion of the parking to add the required number of van spaces, as well as their associated signs and access aisles.</p> <p>Unit Cost: \$150 ea.</p> <p>Quantity: 3 (2 spaces, 1 aisle)</p>	\$550

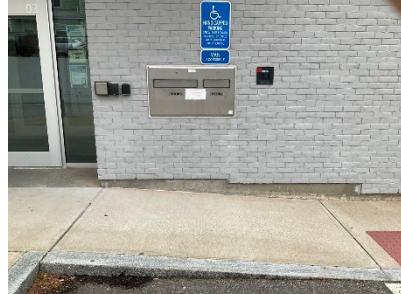
2.	<p>Drop Box</p> <p>The afterhours drop box is not located on an accessible route due to its placement along the ramp and with slopes >2%, @ 8%.</p>	2010 ADAS 206.1

<p>Relocate the drop box to an accessible location.</p> <p>Unit Cost: \$250</p> <p>Quantity: 1</p>	\$250

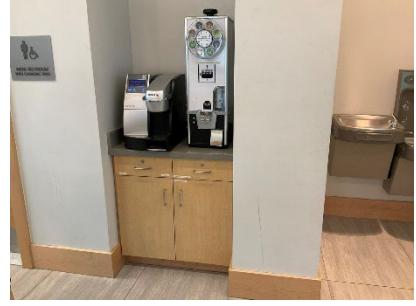
<p>Raise the drinking fountain. Unit Cost: \$750 ea. Quantity: 1</p> <p>Relocate the drinking fountain. Unit Cost: \$1,500 ea. Quantity: 1</p>	\$2,250
7.	<p>K-cup Dispenser</p> <p>The knob at the top of the K-cup dispenser on the second-floor lobby is mounted >48" AFF, @ 66", and requires tight grasping, pinching, and/or twisting of the wrist to operate.</p>	2010 ADAS 308.2 & 308.3 2010 ADAS 309.4

<p>Lower the K-cup dispenser. Unit Cost: \$50 ea. Quantity: 1</p>	\$50

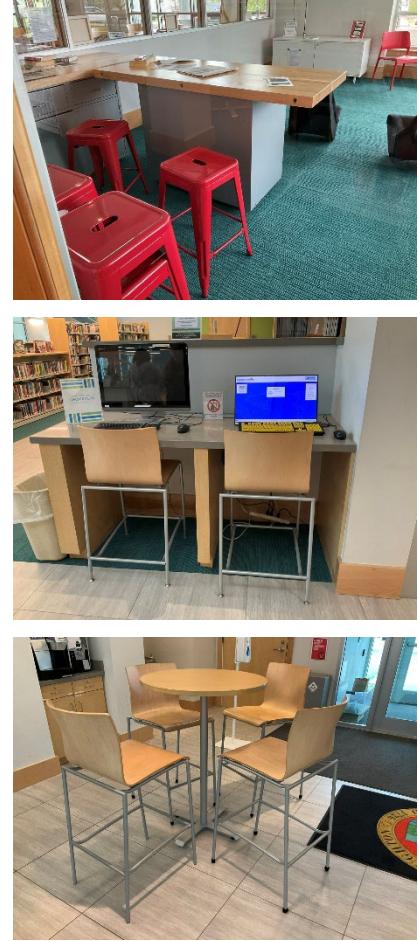
8.	<p>Work Surfaces (Typical)</p> <p>The table inside 115 Young Adult and the computer desk at the Teen Space on the first floor and the tall table on the second-floor lobby are >34" AFF, @ 36", 35 ¾", and 42", respectively.</p> <p>The computer desks on the first floor lacks the required knee and toe clearance for a forward approach.</p>	<p>2010 ADAS 902.3</p> <p>2010 ADAS 306.2 & 306.3</p>

<p>Provide at least one table and computer desk, and no less than 5% of the total number of tables and desks, that provides compliant knee and toe clearance.</p> <p>Unit Cost: \$250 ea.</p> <p>Est. Quantity: 3</p>	\$750
----	--	---	---	---	-------

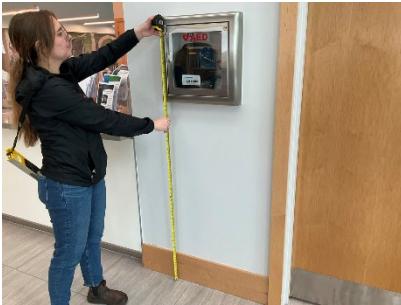
9.	AED Cabinet The pull of the AED box on the first-floor lobby is mounted >48" AFF, @ 58".	2010 ADAS 308.2 & 308.3

Relocate the AED box. Unit Cost: \$50 ea. Quantity: 1	\$50
10.	Protruding Objects The shelving near the elevator lobby on the second floor protrude >4" into the circulation space, @ 20".	2010 ADAS 307.2

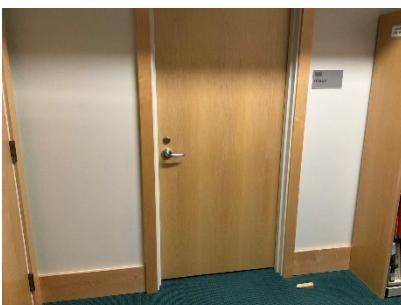
Install wing walls on the ends of the lower shelving. Unit Cost: \$250 ea. Quantity: 2	\$500
11.	Signage (108 Storage, First Floor) There is no tactile/ Braille signage mounted on the latch side of the door.	ADAS 703.4.2

Install tactile/ Braille signage on the latch side of the door. Coordinate with location and height requirements. Unit Cost: \$100 ea. Est. Quantity: 1	\$100

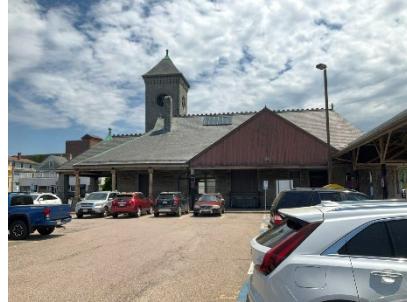
TRAIN DEPOT					
#	<i>Barrier Statement</i>	<i>Code References</i>	<i>Photo</i>	<i>Proposed Mitigation</i>	<i>Cost</i>
1.	Parking There is an insufficient number of accessible parking spaces.	2010 ADAS 208.2

Restripe a portion of the parking to add the required number of accessible parking spaces, including van spaces, as well as their associated signs and access aisles. Unit Cost: \$150 ea. Est. Quantity: 1	\$150
2.	Building There is no accessible route to and within the building. The building interior lacks multiple accessible spaces and elements, including toilet rooms.	2010 ADAS 206

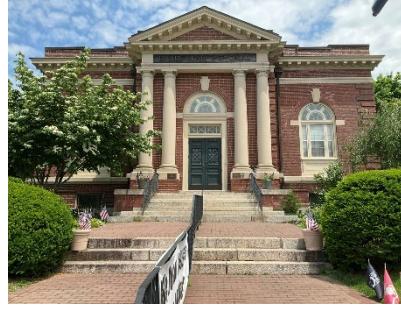
HISTORICAL SOCIETY					
#	<i>Barrier Statement</i>	<i>Code References</i>	<i>Photo</i>	<i>Proposed Mitigation</i>	<i>Cost</i>
1.	<p>Outdoor Stairs</p> <p>The bottom section and some sections at the top of the staircase lack continuous handrails on both sides.</p> <p>At the top section of stairs, the bottom handrails extend <12".</p>	2010 ADAS 505

<p>Install compliant handrail extensions on both sides of the stairs.</p> <p>Unit Cost: \$80/LF Est. Quantity: 100 LF</p>	\$8,000

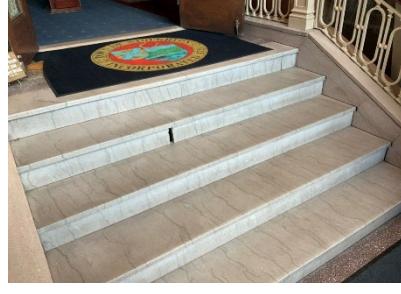
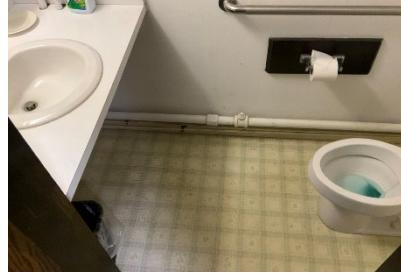
2.	<p>Building</p> <p>There is no accessible route into and throughout the building due to stairs. The building interior lacks multiple accessible spaces and elements, including toilet rooms.</p>	2010 ADAS 206 2010 ADAS 604.3.1

<p>When designing the building renovation, provide an accessible route to and within the building and ensure that the building is fully accessible. Further design study is required.</p> <p>Unit Cost: \$100,000 ea. Quantity: 1</p>	\$100,000

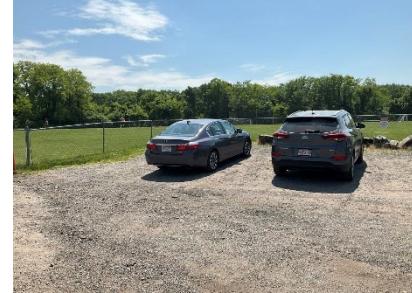
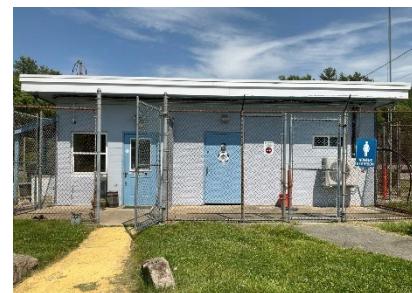
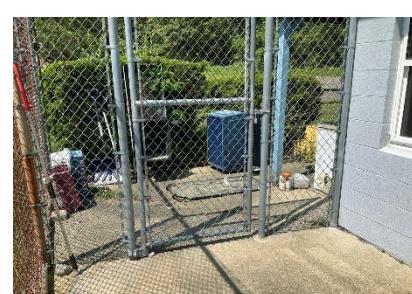
3.	<p>Walkway to Entrance</p> <p>The walkway leading to the entrance is >36" and has a change in level > 1/2" AFF, @ 1 1/2", at the fenced entry point.</p> <p>The gate lacks the minimum 10" of vertical smooth surface.</p>	<p>2010 ADAS 404.2.10</p> <p>2010 ADAS 403</p>

<p>Repave the walkway from the parking lot to the main entrance.</p> <p>Unit Cost: \$50/LF</p> <p>Est. Quantity: 22 LF</p> <p>Replace the gate with a compliant type.</p> <p>Unit Cost: \$1,000 ea.</p> <p>Est. Quantity: 1</p>	\$2,100
----	---	--	---	---	---------

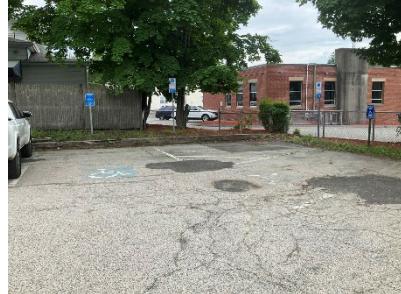
#	<i>Barrier Statement</i>	<i>Code References</i>	<i>Photo</i>	<i>Proposed Mitigation</i>	<i>Cost</i>
1.	<p>Parking</p> <p>The width of the access aisle measured <60" wide from centerline to centerline.</p> <p>The designated accessible parking spaces and their associated access aisles have slopes >2%.</p> <p>The designated accessible parking space signs are mounted >60" @ 44", measured to the bottom of the sign.</p>	<p>2010 ADAS 502.6</p> <p>2010 ADAS 502.4</p>

<p>Regrade and restripe the existing designated parking spaces and their associated access aisles.</p> <p>Unit Cost: \$1,500 ea.</p> <p>Quantity: 3 (2 spaces, 1 aisle)</p> <p>Install a sign with the International Symbol of Accessibility at 60" AFF minimum, measured to the bottom of the sign. Include a van accessible sign where applicable.</p> <p>Unit Cost: \$100 ea.</p> <p>Quantity: 2</p>	\$4,700

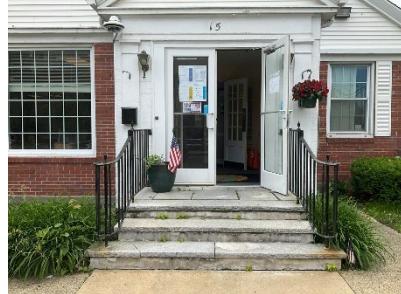
2.	<p>Front Entrance</p> <p>The facility lacks directional signage identifying the location of the accessible entrance located at the rear of the building.</p>	2010 ADAS 216.6

<p>Install tactile/braille signage with the International Symbol of Accessibility (ISA) where required.</p> <p>Unit Cost: \$100 ea.</p> <p>Est. Quantity: 1</p>	\$100

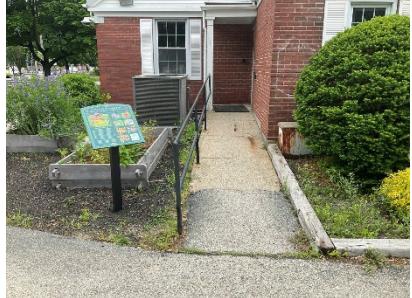
3.	<p>Exterior Ramp</p> <p>The ramp leading to the accessible entrance had slopes >8.3%, @ up to 9.2%.</p> <p>The ramp lacks continuous handrails on both sides. In addition, at the one handrail that is provided, it extends <12".</p> <p>There are changes in level at the bottom of the ramp > 1/2" and are not beveled with a maximum 1:2 slope.</p>	<p>2010 ADAS 405.2 2010 ADAS 303 2010 ADAS 505</p>

<p>Rebuild the ramp, including installing compliant handrails on both sides of the ramp.</p> <p>Unit Cost: \$15,000 ea.</p> <p>Quantity: 1</p>	\$15,000

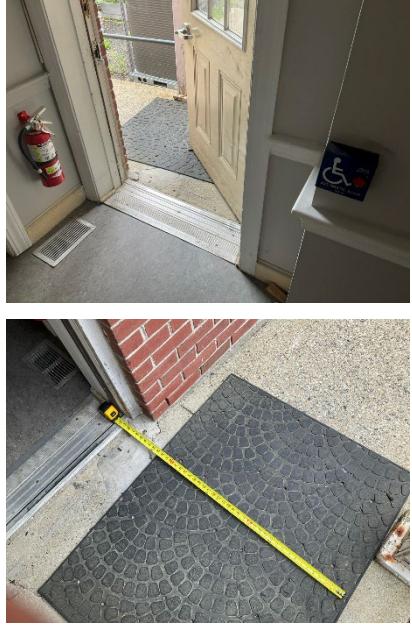
4.	<p>Rear Entrance</p> <p>The pull side door maneuvering on the latch side perpendicular to the door measured <60", @ 40" to the opposing post. Note: an automatic door opener is provided on both sides of the door, however at the time of the audit, both door openers were malfunctioning.</p>	<p>2010 ADAS 404</p>

<p>Fix automatic door opener.</p> <p>Unit Cost: \$1,000 ea.</p> <p>Quantity: 1</p>	\$1,000

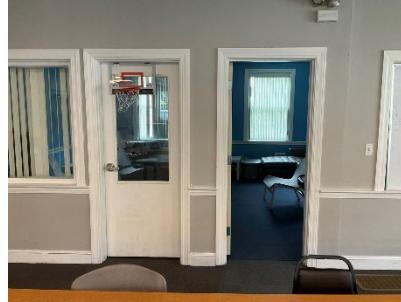
5.	<p>Signage</p> <p>All the rooms open to the public lack permanent signage mounted on the latch side of the door.</p>	2010 ADAS 703

<p>Install tactile/Braille signage on the latch side of the door. Coordinate with location and height requirements. Unit Cost: \$100 ea. Est. Quantity: 6</p>	\$600

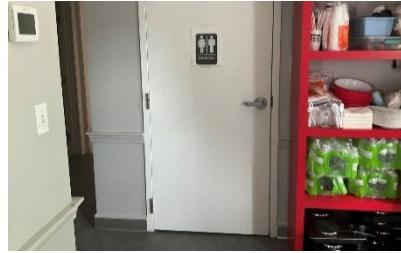
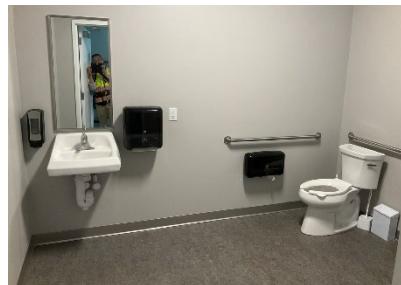
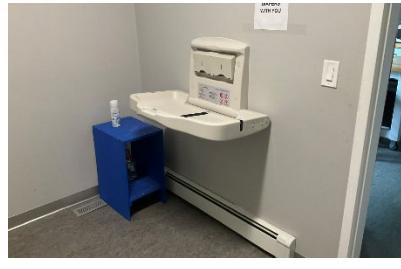
6.	<p>Single-User Toilet Room</p> <p>The signage is not mounted on the latch side of the door.</p> <p>The pull side door maneuvering clearance for a forward approach scaled <12", @ 5" due to fire shelving obstruction.</p> <p>The toilet centerline is not 16"-18" from the side wall, @ 18 1/2".</p> <p>The top of the baby changing work surface measured >34" AFF, @ 39". In addition, the handle is not within reach range.</p>	2010 ADAS 703 2010 ADAS 404 2010 ADAS 604

<p>Relocate the signage. Unit Cost: \$100 ea. Quantity: 1</p> <p>Reposition the toilet Unit Cost: \$1,500 ea. Quantity: 1</p> <p>Provide a compliant baby changing table. Unit Cost: \$100 ea. Quantity: 1</p>	\$1,700
TOTAL FOR RECREATION CENTER:					\$23,100

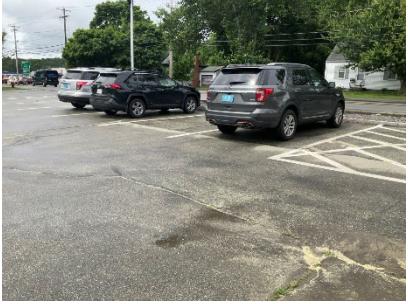
#	<i>Barrier Statement</i>	<i>Code References</i>	<i>Photo</i>	<i>Proposed Mitigation</i>	<i>Cost</i>
1.	<p>Parking</p> <p>There is an insufficient number of accessible parking spaces provided.</p>	2010 ADAS 208.2

<p>Restripe a portion of the parking to add the required number of accessible parking spaces, including van spaces, as well as their associated signs and access aisles.</p> <p>Unit Cost: \$1,500 ea.</p> <p>Est. Quantity: 1</p>	\$1,500

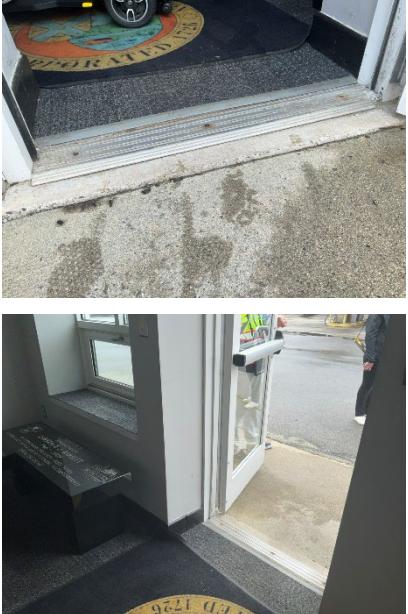
2.	<p>Entrance</p> <p>The exterior threshold measured > 1/2" AFF, @ 5/8".</p> <p>The door is located is a recess >8" deep, @ 11" on the push side and therefore does not provide the required door maneuvering clearance.</p> <p>The hand sanitizer dispenser is mounted >48" AFF, @ 53".</p>	2010 ADAS 404

<p>Replace the threshold.</p> <p>Unit Cost: \$250 ea.</p> <p>Quantity: 1</p> <p>Install an automatic door opener.</p> <p>Unit Cost: \$2,500 ea.</p> <p>Quantity: 1</p> <p>Lower the hand sanitizer.</p> <p>Unit Cost: \$50</p> <p>Quantity: 1</p>	\$2,800

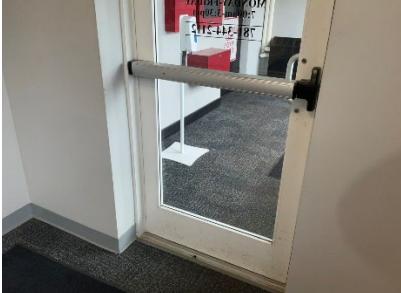
3.	Vestibule Door The vestibule's interior door is located is a recess >8" deep, @ 9" on the push side and therefore does not provide the required door maneuvering clearance.	2010 ADAS 404

Install an automatic door opener. Unit Cost: \$2,500 ea. Quantity: 1	\$2,500

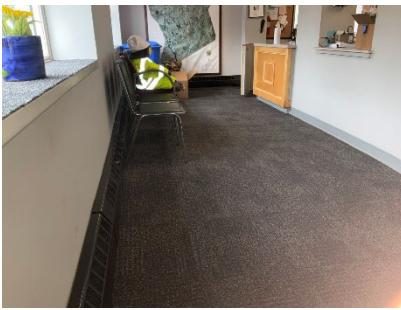
4.	Counters The height of the counters dedicated to different departments measured >36", @ 42". The water/sewer counter lacks a level clear floor space due to the location of the ramp.	2010 ADAS 305 2010 ADAS 606

Lower the counters. Unit Cost: \$2,500 ea. Quantity: 2 Remove the counter over the ramp. Unit Cost: \$50 ea. Quantity: 1	\$5,050

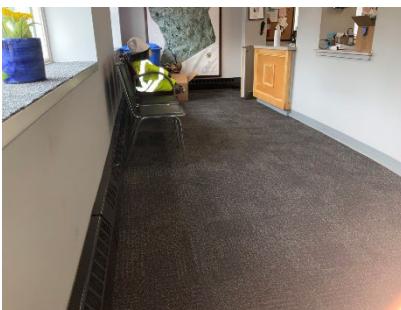
5.	Ramp The walkway through the front office has slopes >5%, @ 8.2% and is not treated as a ramp. The ramp lacks a level landing <60" long, @ 48".	2010 ADAS 405

Rebuild the ramp, including installing compliant handrails on both sides of the ramp. Further design study is required. Unit Cost: \$5,000 ea. Quantity: 1	\$5,000
TOTAL FOR DPW BUILDING:					\$16,850

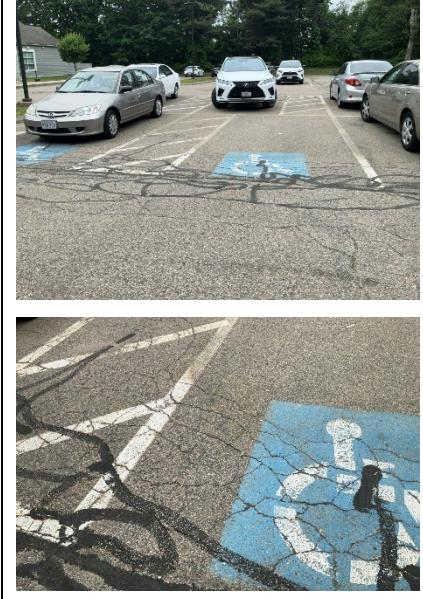
2.	<p>Parking Near Building</p> <p>Some of the designated accessible parking spaces had slopes >2%, @ up to 3.1%.</p> <p>The width of the access aisles measured <60" wide from centerline to centerline, @ 56".</p> <p>All four accessible spaces lack signage indicating they are accessible.</p>	<p>2010 ADAS 502.4 2010 ADAS 502.3.1 2010 ADAS 502.6</p>

<p>Regrade and restripe the existing designated parking spaces and their associated access aisles.</p> <p>Unit Cost: \$1,500 ea.</p> <p>Quantity: 3 (2 spaces, 1 aisle)</p> <p>Install a sign with the International Symbol of Accessibility at 60" AFF minimum, measured to the bottom of the sign. Include a van accessible sign where applicable.</p> <p>Unit Cost: \$100 ea.</p> <p>Quantity: 4</p> <p>Restripe the pavement markings in the parking spaces and associated access aisles.</p> <p>Unit Cost: \$150 ea.</p> <p>Quantity: 4</p>	\$5,500

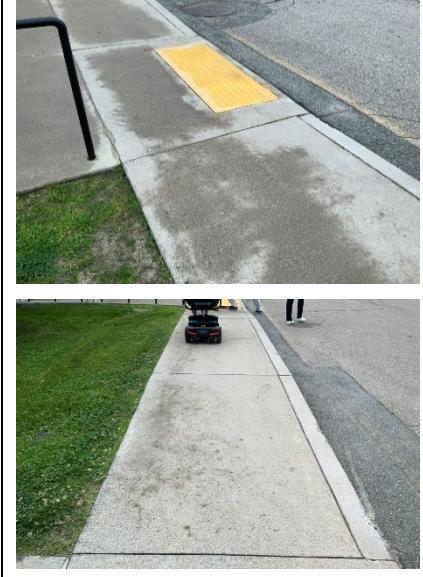
3.	<p>Walkway Between Parking and Entrance</p> <p>The ramp lacks a level landing <2%, @ up to 7.6%.</p> <p>The sidewalk has cross slopes >2%, @ up to 4.9%.</p>	<p>2010 ADAS 405.7 2010 ADAS 403.3</p>

<p>Rebuild the curb ramp.</p> <p>Unit cost: \$1,250 ea.</p> <p>Quantity: 1</p> <p>Regrade the walkway.</p> <p>Unit Cost: \$25/SF</p> <p>Est. Quantity: 150 SF</p>	\$5,000

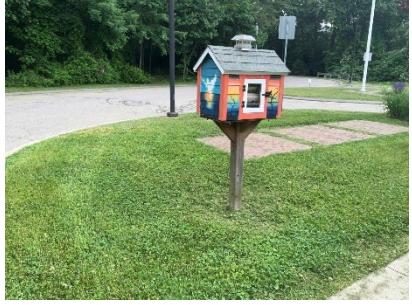
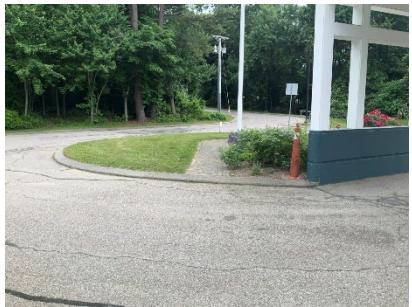
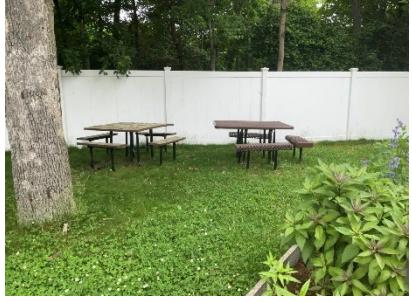
4.	<p>Site Amenities</p> <p>Some site amenities (i.e. book box, flagpole, picnic tables, gardens) are not located along an accessible route due to the grass surface.</p> <p>The topmost controls at the donation bin located on the parking lot measured >48" AFF, @ 60".</p>	<p>2010 ADAS 206.1</p> <p>2010 ADAS 308.2.1</p>

<p>Provide an accessible route to at least one of each type of site amenity.</p> <p>Unit Cost: \$25/SF Est. Quantity: 200 SF</p> <p>Provide a bin with controls within reach range.</p> <p>Unit Cost: \$500 ea. Quantity: 1</p>	\$5,500
----	---	---	--	---	---------

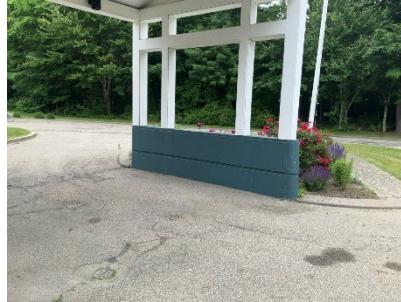
5.	<p>Drop-off within Carport The access aisle serving the vehicle pull-up space is not marked.</p>	2010 ADAS 503.3.3

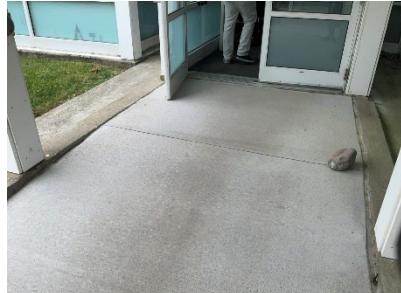
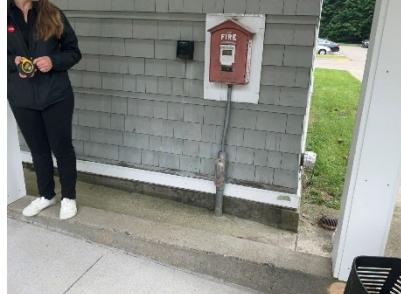
<p>Provide markings at the access aisle to discourage parking. Unit Cost: \$300 ea. Quantity: 1</p>	\$300
6.	<p>Main Entrance The walkway leading to the main entrance has running slopes >5%, @ 6.7%, and is not treated as a ramp. The push button of the automatic door opener is not located on an accessible route due to its placement along the ramp. The pull station is not located on an accessible route due to its placement along the ramp and is mounted >44" AFF over a 20"-25" obstruction.</p>	<p>2010 ADAS 405.3 2010 ADAS 405 2010 ADAS 206.1</p>

<p>Rebuild the curb ramp. Unit cost: \$1,250 ea. Quantity: 1</p> <p>Relocate both the push button and the pull station to an accessible location. Unit Cost: \$250 ea. Quantity: 2</p>	\$1,750

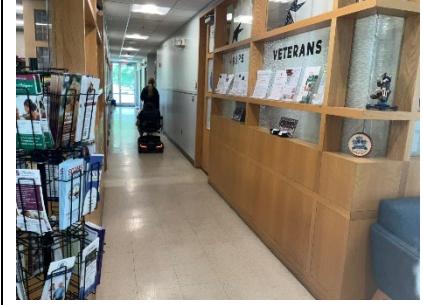
7.	<p>Entry Lobby</p> <p>The topmost rows at the brochure shelf are mounted > 48" AFF.</p>	<p>2010 ADAS 308.2 & 308.3</p>

<p>Lower the brochure shelf. Unit Cost: \$50 ea. Quantity: 1</p>	\$50

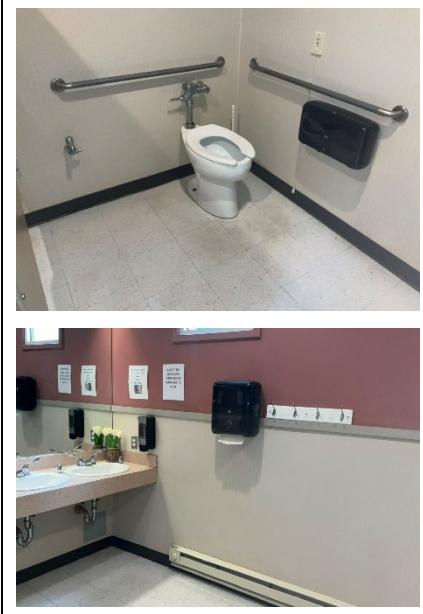
8.	<p>Women's Toilet Room</p> <p>The pipes underneath the lavatory are not insulated.</p> <p>The side grab bar extends <54" from the rear wall, @48".</p> <p>The toilet centerline is not 16"-18" from the nearest adjacent side wall, @ 18 1/2".</p> <p>The coat hook is >48" AFF, @ 64".</p> <p>The paper towel dispenser protrudes >4" into the circulation space.</p>	<p>2010 ADAS 606.5 2010 ADAS 604.5.1 2010 ADAS 604.2 2010 ADAS 604.8.3 2010 ADAS 307.2</p>

<p>Insulate the pipes. Unit Cost: \$50 ea. Quantity: 1</p> <p>Relocate the grab bar. Unit Cost: \$50 ea. Quantity: 1</p> <p>Reposition the toilet. Unit Cost: \$500 ea. Quantity: 1</p> <p>Provide a coat hook mounted no higher than 48" AFF. Unit Cost: \$50 ea. Quantity: 1</p> <p>Relocate paper towel dispenser. Unit Cost: \$50 ea. Quantity: 1</p>	\$700

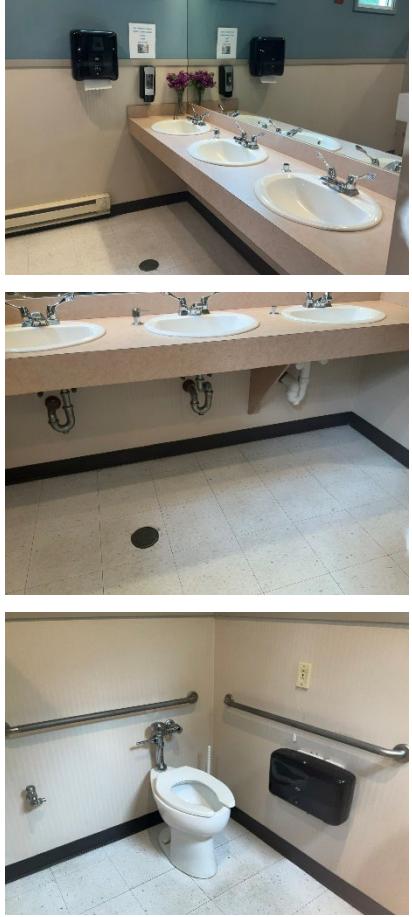
9.	<p>Men's Toilet Room</p> <p>The pipes underneath the lavatory are not insulated.</p> <p>The lavatory is mounted >34" AFF, @34 3/4".</p> <p>The paper towel dispenser is mounted >48" AFF, @ 54", to the highest operable part.</p> <p>The side grab bar extends <54" from the rear wall, @49".</p> <p>The toilet centerline is not 16"-18" from the nearest adjacent side wall, @ 18 1/4".</p> <p>The coat hook is >48" AFF, @ 64".</p> <p>The urinal does not provide the required clear floor space in front of it, @ 29".</p>	<p>2010 ADAS 606.5</p> <p>2010 ADAS 606.3</p> <p>2010 ADAS 308.3</p> <p>2010 ADAS 604.5.1</p> <p>2010 ADAS 604.2</p> <p>2010 ADAS 604.8.3</p> <p>2010 ADAS 605.3</p>

<p>Insulate the pipes. Unit Cost: \$50 ea. Quantity: 1</p> <p>Lower the lavatory. Unit Cost: \$750 ea. Quantity: 1</p> <p>Relocate paper towel dispenser. Unit Cost: \$50 ea. Quantity: 1</p> <p>Relocate the grab bar. Unit Cost: \$50 ea. Quantity: 1</p> <p>Reposition the toilet. Unit Cost: \$500 ea. Quantity: 1</p> <p>Provide a coat hook mounted no higher than 48" AFF. Unit Cost: \$50 ea. Quantity: 1</p> <p>Relocate the urinal partitions. Unit Cost: \$250 ea. Quantity: 1</p>	\$1,800

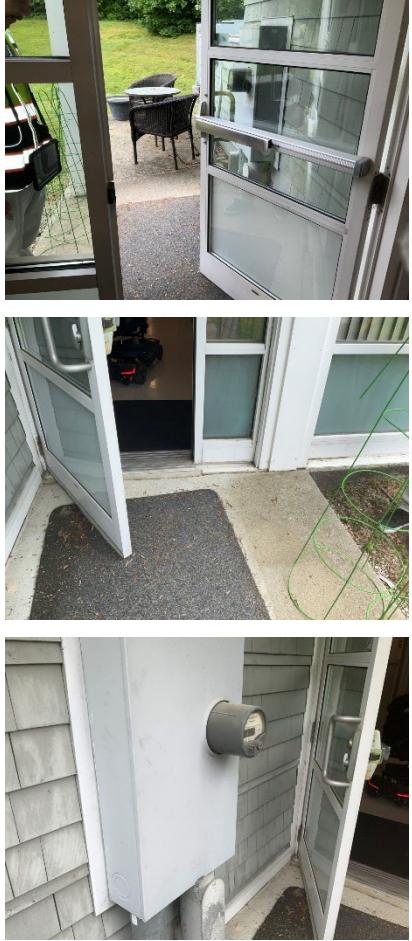
10.	<p>Rear Patio</p> <p>The entry door gets stuck on the rug and lacks the required minimum 18" of maneuvering clearance on the latch push side for a forward approach, due to electric meter @ 45".</p> <p>Electric meter protrudes >4" into the circulation space, @ 12".</p> <p>The table lacks the required knee and toe clearance for a forward approach due to its pedestal base.</p>	<p>2010 ADAS 404.2.3</p> <p>2010 ADAS 307.2</p> <p>2010 ADAS 902.4.1</p>

<p>Install an automatic door opener. Unit Cost: \$2,500 ea. Quantity: 1</p> <p>Install a cane detectable object below the electric meter. Unit Cost: \$250 ea. Quantity: 1</p> <p>Provide at least one table, and no less than 5% of the total number of tables, that provides compliant knee and toe clearance. Unit Cost: \$250 ea. Est. Quantity: 1</p>	\$3,000
-----	--	--	--	--	---------

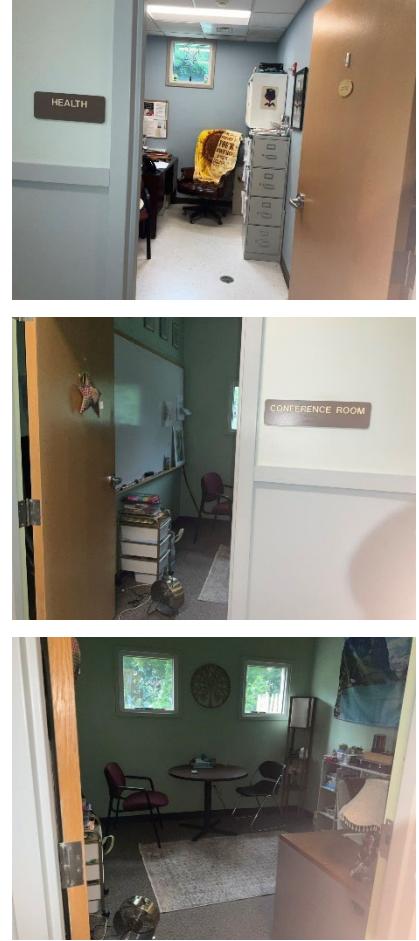
11.	<p>Health Office and Conference Room</p> <p>The maneuvering clearance at the doors are <18" on the latch pull-side, obstructed by furniture.</p> <p>The tables lack the required knee and toe clearance for a forward approach due to their pedestal base.</p>	<p>2010 ADAS 404.2.4</p> <p>2010 ADAS 902.4.1</p>

<p>Relocate the furniture. Unit Cost: \$50 ea. Quantity: 2</p> <p>Provide at least one table, and no less than 5% of the total number of tables, that provides compliant knee and toe clearance. Unit Cost: \$250 ea. Est. Quantity: 2</p>	\$600
-----	--	---	---	--	-------

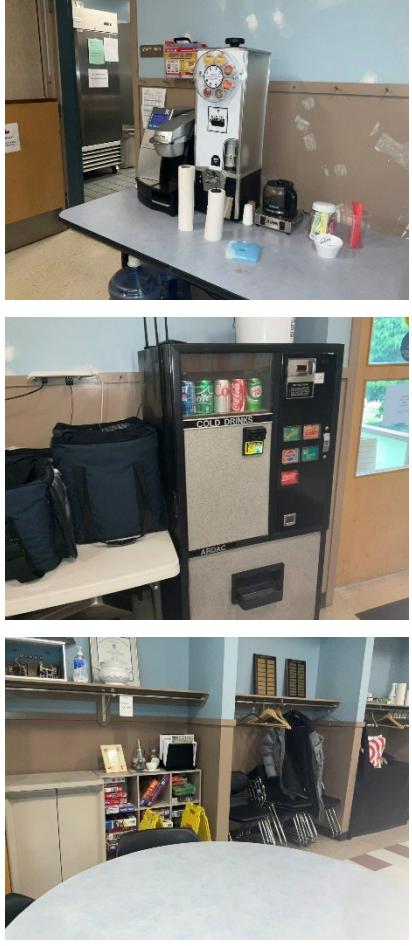
12.	<p>Community Room</p> <p>The door maneuvering clearance is <12" on the latch, push side for a front approach, @ 9".</p> <p>The knob at the top of the coffee cup dispenser is mounted >48" AFF, @ 54",</p> <p>The coin slot of the vending machine is mounted >48" AFF, @ 54".</p> <p>The coat rack is mounted >48" AFF, @ 61".</p> <p>The table lacks the required knee and toe clearance for a forward approach due to the lack of 30" clearance between legs.</p>	<p>2010 ADAS 404.2.4.1</p> <p>2010 ADAS 308.2.1</p> <p>2010 ADAS 902.4.1</p>

<p>Install an automatic door opener. Unit Cost: \$2,500 ea. Quantity: 1</p> <p>Lower the coffee cup dispenser and the coat rack. Unit Cost: \$50 ea. Quantity: 2</p> <p>Replace the vending machine. Unit Cost: \$250 ea. Quantity: 1</p> <p>Provide at least one table, and no less than 5% of the total number of tables, that provides compliant knee and toe clearance. Unit Cost: \$250 ea. Est. Quantity: 1</p>	\$3,100

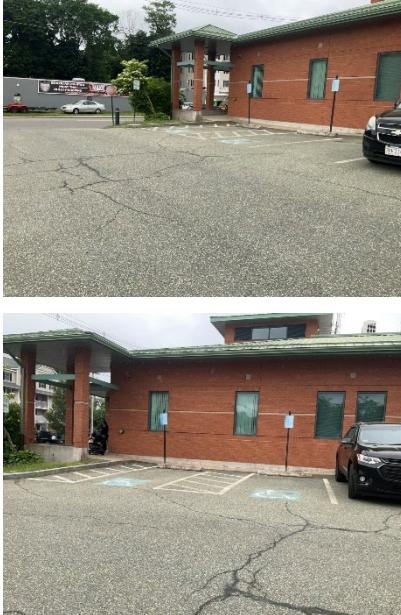
#	<i>Barrier Statement</i>	<i>Code References</i>	<i>Photo</i>	<i>Proposed Mitigation</i>	<i>Cost</i>
1.	<p>Parking</p> <p>The accessible parking spaces have slopes >2%, @ up to 5.2%.</p> <p>The designated van accessible access aisle is <96" wide, @ 60", measured centerline to centerline.</p> <p>The van accessible parking space lacks the required signage.</p>	<p>2010 ADAS 502.4</p> <p>2010 ADAS 502.2</p> <p>2010 ADAS 502.6</p>

<p>Regrade and restripe the existing designated parking spaces, including one van accessible parking space, and their associated signs and access aisles.</p> <p>Unit Cost: \$1,500 ea.</p> <p>Quantity: 3 (2 spaces + 1 aisle)</p>	\$4,500

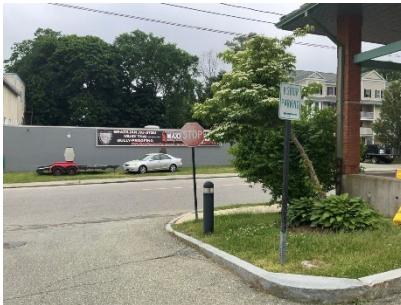
2.	<p>Walkway Between Street and Accessible Entrance</p> <p>The walkway between Rose Street and the accessible entrance has running slopes >5%, @ up to 11.8%, due to the steep vehicular ramp to the parking lot.</p>	2010 ADAS 206.1

<p>Construct a new ramp leading to the accessible entrance. Further design study required.</p> <p>Unit Cost: \$15,000 ea.</p> <p>Quantity: 1</p>	\$15,000

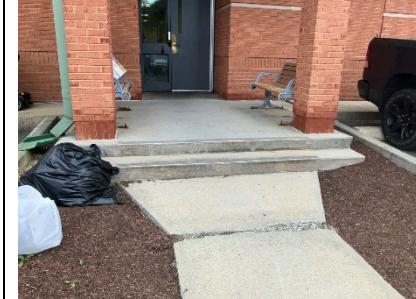
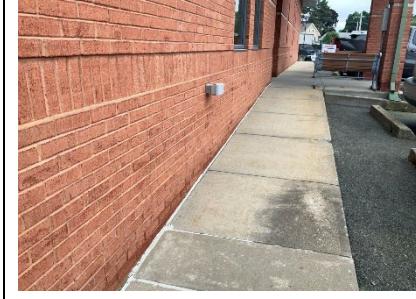
4.	<p>Walkway Between Parking and Employee Entrance</p> <p>The stairs leading to the employee entrance do not have handrails on both sides.</p> <p>The walkway has running slopes $>5\%$ and is not treated as a ramp, @ up to 5.7%.</p> <p>The outdoor outlet protrudes $>4"$ into the circulation space, @ 5 1/2".</p>	<p>2010 ADAS 505.2 2010 ADAS 403.3 2010 ADAS 307.2</p>

<p>Install compliant handrails on both sides of the stairs. Unit Cost: \$50/LF Quantity: 8 LF</p> <p>Provide compliant handrails on both sides of the walkway. Unit Cost: \$50/LF Quantity: 60 LF</p> <p>Install a cane detectable object below the outlet. Unit Cost: \$250 ea. Quantity: 1</p>	\$3,650

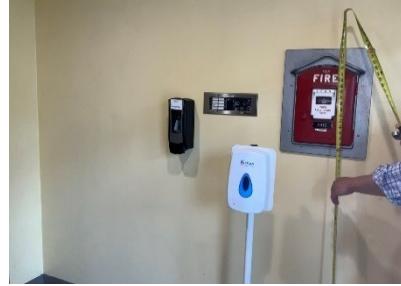
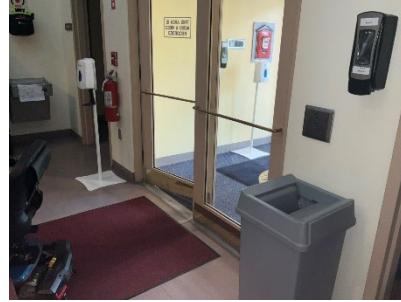
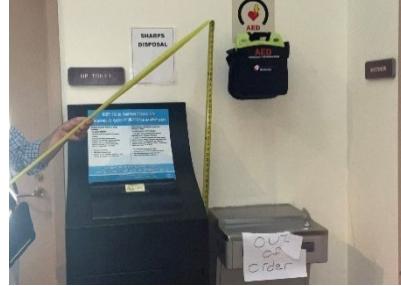
5.	<p>Entry Lobby</p> <p>The pull station is mounted >48" AFF, @ 58 1/2".</p> <p>The entry doors provide a smooth surface <10" AFF on the push side, @ up to 7 1/2".</p> <p>The AED box is mounted >48" AFF, @ 68", and its clear floor is obstructed by the drinking fountain.</p> <p>Materials displayed on the bulletin board are >48", @ 70".</p> <p>The clear floor space of the hand sanitizer is obstructed by the trash can.</p> <p>A drinking fountain for standing persons not provided.</p> <p>The doors lack tactile/Braille signage mounted 60" max. on the latch side.</p>	<p>2010 ADAS 308.2.1</p> <p>2010 ADAS 404.2.10</p> <p>2010 ADAS 305</p> <p>2010 ADAS 211.2</p> <p>2010 ADAS 703.4.2</p>

<p>Relocate the pull station. Unit Cost: \$150 ea. Quantity: 1</p> <p>Replace the door with a door with a bottom rail at least 10" min. AFF. Unit Cost: \$1,000 ea. Quantity: 2</p> <p>Relocate the AED box. Unit Cost: \$50 ea. Quantity: 1</p> <p>Relocate the materials to an accessible reach range. Unit Cost: \$50 ea. Quantity: 1</p> <p>Relocate the trash can. Unit Cost: \$50 Quantity: 1</p> <p>Add a high drinking fountain. Unit Cost: \$1,500 ea. Quantity: 1</p> <p>Install tactile/Braille signage on the latch side of the door. Coordinate with location and height requirements. Unit Cost: \$150 ea. Quantity: 1</p>	\$3,950

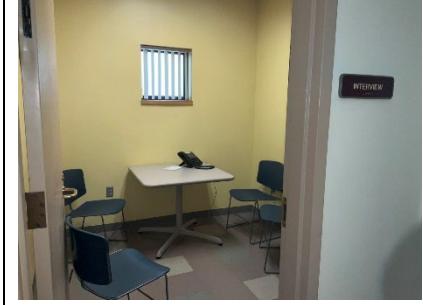
6.	<p>Interview Room at Lobby</p> <p>The table lacks the required knee and toe clearance for a forward approach due to its pedestal base.</p> <p>An audible/visual fire alarm is not provided.</p>	<p>2010 ADAS 306.1 2010 ADA 215</p>

<p>Provide at least one table, and no less than 5% of the total number of tables, that provides compliant knee and toe clearance.</p> <p>Unit Cost: \$250 ea.</p> <p>Est. Quantity: 1</p> <p>Install a visual/audible alarm.</p> <p>Unit Cost: \$750</p> <p>Quantity: 1</p>	\$1,000

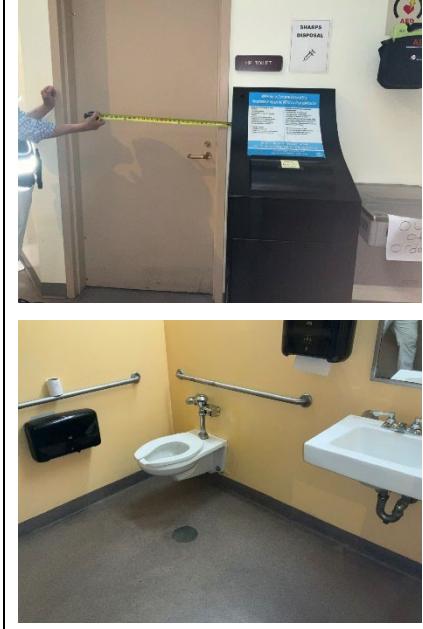
7.	<p>Single-user Toilet Room at Lobby</p> <p>The push side door maneuvering clearance is <12" on the latch side for a front approach, @ 4", due to the sharp container disposal.</p> <p>Sink pipes are not insulated.</p> <p>The bottom of the reflective surface of the mirror is >40" AFF, @ 41".</p> <p>The paper towel dispenser protrudes >4" into the circulation area, @ 8".</p> <p>The coat hook is mounted >48" AFF, @ 65".</p> <p>The side grab bar extends <54" from the rear wall, @ 48".</p>	<p>2010 ADAS 404.2.4.1 2010 ADAS 606.5 2010 ADAS 603.3 2010 ADA 307.2 2010 ADAS 604.8.3 2010 ADAS 604.5.1</p>

<p>Relocate the sharp container disposal.</p> <p>Unit Cost: \$50 ea.</p> <p>Quantity: 1</p> <p>Insulate the pipes underneath the sink.</p> <p>Unit Cost: \$50 ea.</p> <p>Quantity: 1</p> <p>Lower the mirror.</p> <p>Unit Cost: \$50</p> <p>Quantity: 1</p> <p>Relocate the dispenser.</p> <p>Unit Cost: \$50</p> <p>Quantity: 1</p> <p>Install a coat hook mounted no higher than 48" AFF.</p> <p>Unit Cost: \$50</p> <p>Quantity: 1</p> <p>Relocate the grab bar.</p> <p>Unit Cost: \$50</p> <p>Quantity: 1</p>	\$300

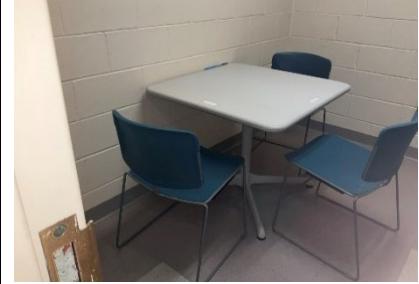
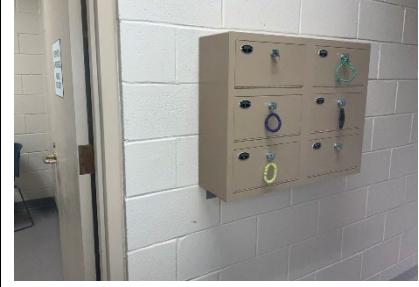
11.	<p>Interrogation Room</p> <p>The table lacks the required knee and toe clearance for a forward approach due to its pedestal base.</p> <p>The gun locker protrudes >4" into the circulation space, @ 8".</p> <p>An audible/visual fire alarm is not provided.</p>	<p>2010 ADAS 902.4.1</p> <p>2010 ADAS 307.2</p> <p>2010 ADAS 215</p>

<p>Provide at least one table, and no less than 5% of the total number of tables, that provides compliant knee and toe clearance.</p> <p>Unit Cost: \$250 ea.</p> <p>Est. Quantity: 1</p> <p>Install a cane detectable object below the standpipe.</p> <p>Unit Cost: \$250 ea.</p> <p>Quantity: 1</p> <p>Install a visual/audible alarm.</p> <p>Unit Cost: \$750</p> <p>Quantity: 1</p>	\$1,250

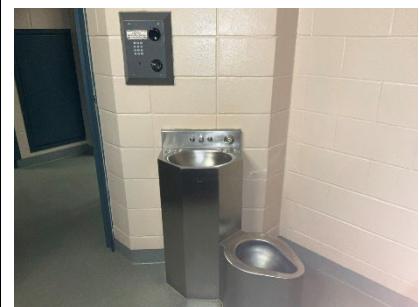
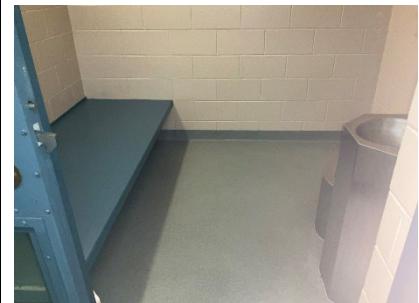
12.	<p>Detention Cells</p> <p>The sink/toilet combination fixture inside each type of cell is not ADA compliant.</p> <p>The telephone is mounted >48" AFF, @ 54", and its clear floor is obstructed by the sink.</p>	<p>2010 ADAS 604 & 606</p> <p>2010 ADAS 308.2.1</p>

<p>Replace the sink/toilet combination fixture with an ADA-compliant fixture in one of each type of cell (male, female, and juvenile).</p> <p>Unit Cost: \$5,000 ea.</p> <p>Est. Quantity: 3</p> <p>Relocate the telephone.</p> <p>Unit Cost: \$150 ea.</p> <p>Quantity: 1</p>	\$1,650

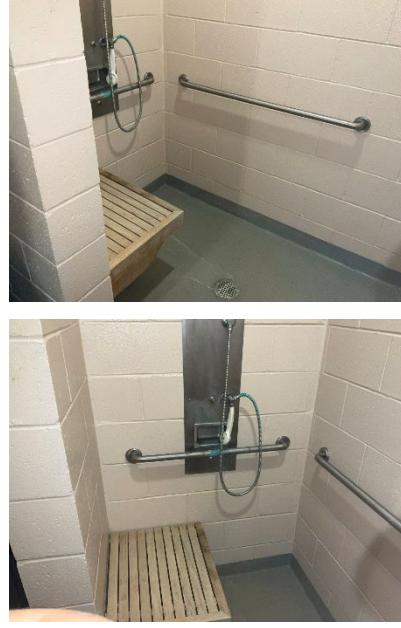
13.	<p>Shower Room</p> <p>The shower stall does not meet the dimensional requirements for an alternative roll-in shower, @ 42" deep.</p>	2010 ADA 608.2.3

<p>Rebuild the existing shower. Unit Cost: \$2,200 ea. Quantity: 1</p>	\$2,200
TOTAL FOR POLICE STATION:					\$53,050

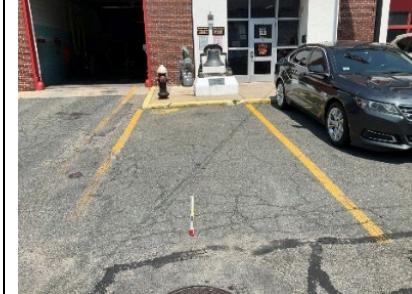
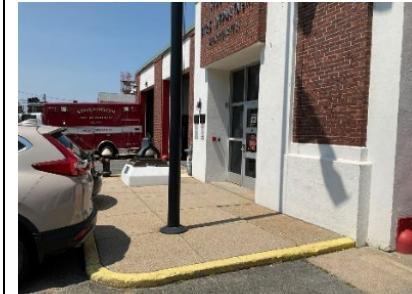
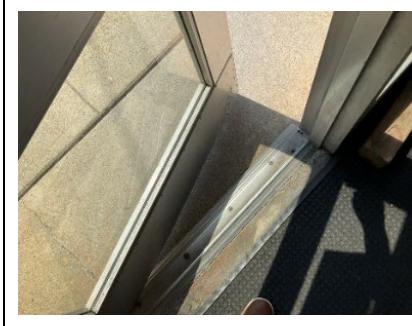
#	<i>Barrier Statement</i>	<i>Code References</i>	<i>Photo</i>	<i>Proposed Mitigation</i>	<i>Cost</i>
1.	<p>Entrance</p> <p>There is no accessible route into the building as well the apparatus bays, memorial, flagpole, doorbell and emergency phone due to the 4" curb. Further, the walkway between the street and the entrance has running slopes >5%, up to 10%.</p> <p>The exterior threshold measured > 1/2" AFF, @ 1", and not beveled at 1:2.</p> <p>The door lacks a level landing, @ 2.5%, and has a change in level > 1/2" AFF, @ 1", due to the control joint.</p>	<p>2010 ADAS 206</p> <p>2010 ADAS 403.4</p> <p>2010 ADAS 404.2.5</p> <p>2010 ADAS 404.2.4.4</p>

<p>Provide an accessible route to the building entrance, apparatus bays, memorial, and flagpole. Additional study required.</p> <p>Unit Cost: \$50,000 ea.</p> <p>Quantity: 1</p>	\$50,000

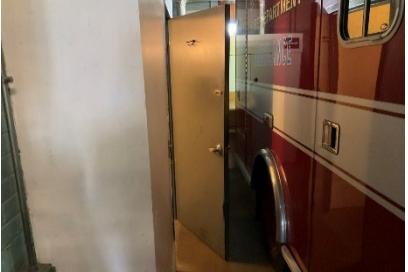
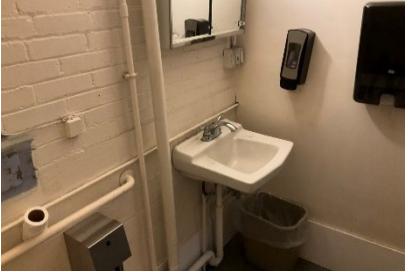
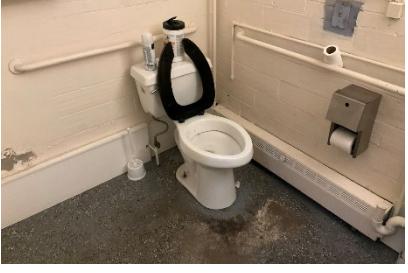
4.	<p>Single-user Toilet Room inside Apparatus Bay</p> <p>There is no tactile/Braille signage mounted on the latch side of the door.</p> <p>The pull side door maneuvering clearance is <42" on the latch side for a hinge side approach, @ obstructed by the fire truck.</p> <p>The sink/lavatory lacks the required 27" high min. knee clearance, @ obstructed by the trash can.</p> <p>Toilet clearance obstructed by the heater and exposed pipes.</p> <p>The coat hook is mounted >48" AFF, @ 72".</p>	<p>2010 ADAS 703.4.2</p> <p>2010 ADAS 404.2.4.1</p> <p>2010 ADAS 306.3.5</p> <p>2010 ADAS 604.3</p> <p>2010 ADAS 604.8.3</p>

<p>Install tactile/Braille signage on the latch side of the door. Coordinate with location and height requirements.</p> <p>Unit Cost: \$100 ea.</p> <p>Quantity: 1</p> <p>Relocate the fire truck. Additional study required.</p> <p>Unit Cost: \$1,000 ea.</p> <p>Quantity: 1</p> <p>Relocate the trash can.</p> <p>Unit Cost: \$50 ea.</p> <p>Quantity: 1</p> <p>Install insulation around the sink pipes.</p> <p>Unit Cost: \$100</p> <p>Quantity: 1</p> <p>Modify the heater and exposed pipes.</p> <p>Unit Cost: \$750 ea.</p> <p>Quantity: 2</p> <p>Install a coat hook mounted no higher than 48" AFF.</p> <p>Unit Cost: \$50 ea.</p> <p>Quantity: 1</p>	10,000

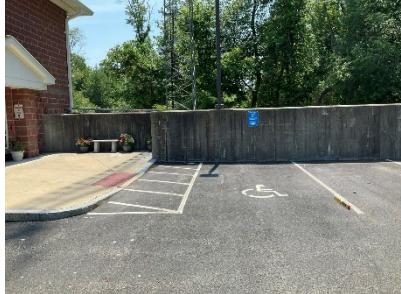
#	<i>Barrier Statement</i>	<i>Code References</i>	<i>Photo</i>	<i>Proposed Mitigation</i>	<i>Cost</i>
1.	<p>Parking</p> <p>The designated accessible parking signs are mounted <60", @ 42 1/2", measured to the bottom of the sign.</p> <p>There is an insufficient number of van accessible parking spaces. The existing accessible parking space does not meet the dimensional requirements for a van space.</p> <p>The designated van accessible access aisle is <96" wide, @ 60", measured centerline to centerline.</p>	<p>2010 ADAS 502.6</p> <p>2010 ADAS 208.2.4</p> <p>2010 ADAS 502.2</p>

<p>Install signs at 60" min. AFF, measured to the bottom of the sign.</p> <p>Unit Cost: \$100 ea.</p> <p>Quantity: 1</p> <p>Restripe a portion of the parking to add the required number of accessible parking spaces, including van spaces, as well as their associated signs and access aisles.</p> <p>Unit Cost: \$150 ea.</p> <p>Quantity: 1</p>	\$250

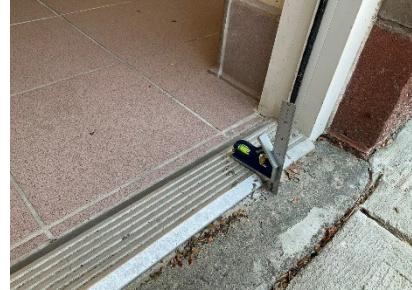
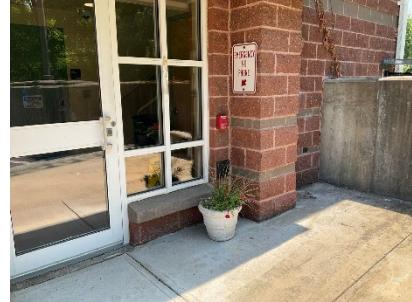
2.	<p>Entrance</p> <p>The threshold is >1/2", @1".</p> <p>The door is located in a recess >8", @ 8.5".</p> <p>The emergency phone is obstructed by the planter.</p>	<p>2010 ADAS 404.2.5</p> <p>2010 ADAS 404.2.4.3</p> <p>2010 ADAS 308.2.1</p>

<p>Replace the threshold. Unit cost: \$250 ea. Quantity: 1</p> <p>Install an automatic door opener. Unit Cost: 2,500 ea. Quantity: 1</p> <p>Relocate the planter. Unit Cost: \$150 ea. Quantity: 1</p>	\$2,900
3.	<p>Rear Exit</p> <p>The running slope of the curb ramp is >8.3%, @ 10.2%.</p> <p>The emergency phone is not located on an accessible route due to its placement along the ramp and is mounted >48" AFF, @ 53".</p>	<p>2010 ADAS 405.2</p> <p>2010 ADAS 206.1</p> <p>2010 ADAS 308.2.1</p>

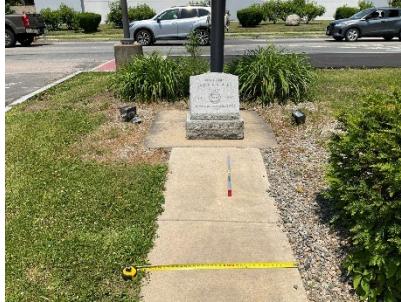
4.	<p>Memorial and Flagpole</p> <p>The walkway to the memorial and the flagpole has running slopes >5%, @ 5.2%</p> <p>The rope hook is obstructed by the memorial.</p>	<p>2010 ADAS 403.3 2010 ADAS 308.2</p>

<p>Regrade the walkway and reconfigure the memorial and flagpole. Additional study required. Unit Cost: \$5,000 ea. Quantity: 1</p>	\$5,000
5.	<p>Counter</p> <p>The counter is >36" AFF, @ 42".</p>	<p>2010 ADAS 904.4.1</p>

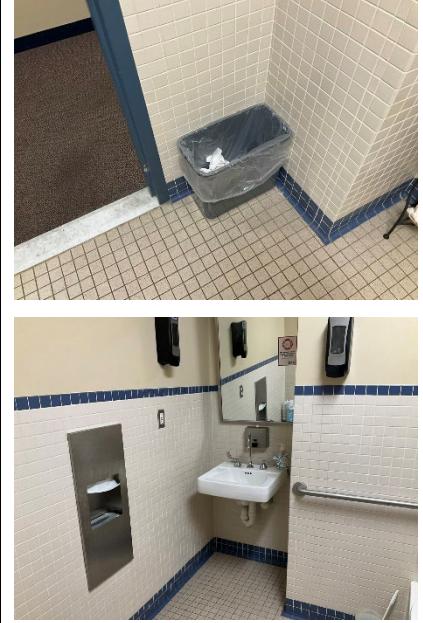
6.	<p>Men's Toilet Room</p> <p>The pull side maneuvering clearance at the door is <18", @ obstructed by the trash can.</p> <p>The bottom of the reflective surface of the mirror is >40" AFF, @ 46 1/2".</p> <p>The soap dispenser is >48" AFF, @ 62".</p>	<p>2010 ADAS 404.2.4.1</p> <p>2010 ADA 603.3</p> <p>2010 AAS 308.2.1</p>

<p>Relocate the trash can. Unit Cost \$50 ea. Quantity: 1</p> <p>Lower the mirror. Unit Cost: \$50 Quantity: 1</p> <p>Relocate the dispenser. Unit Cost: \$50 Quantity: 1</p>	\$150
----	---	--	--	---	-------
