STOUGHTON BUILDING AUDITS

KMA audited the following municipal buildings:

TOWN HALL

AUDITED ON: MAY 1, 2024

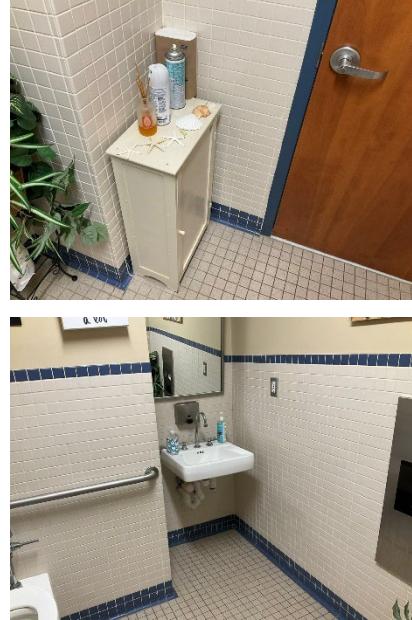
7.	<p>Women's Toilet Room</p> <p>The pull side maneuvering clearance at the door is <18", @ obstructed by the cabinet.</p> <p>The bottom of the reflective surface of the mirror is >40" AFF, @ 57 1/4".</p> <p>The soap dispenser is >48" AFF, @ 62".</p> <p>The toilet lacks the required clearance around it, @ due to the chair.</p>	<p>2010 ADAS 404.2.4.1</p> <p>2010 ADA 603.3</p> <p>2010 AAS 604.3</p>

<p>Relocate the trash can. Unit Cost \$50 ea. Quantity: 1</p> <p>Lower the mirror. Unit Cost: \$50 Quantity: 1</p> <p>Relocate the chair. Unit Cost: \$50 Quantity: 1</p>	\$150
8.	<p>Drinking Fountain</p> <p>A drinking fountain for standing persons is not provided.</p>	200 ADAS 211.2

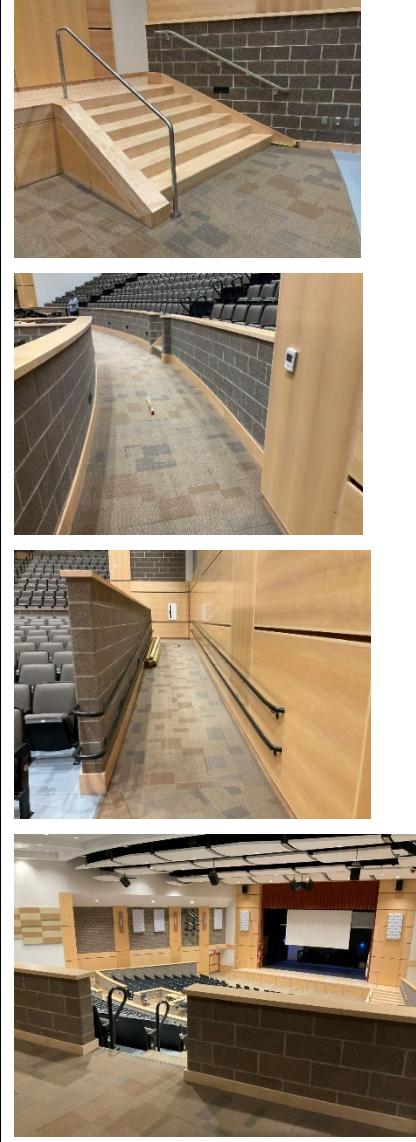
4.	<p>Auditorium</p> <p>The podium on the stage lacks the required knee/toe clearance for a forward approach and is too high.</p> <p>The handrails extend <12"+ one tread beyond the bottom riser.</p> <p>The sloped walkway along the mid-section and leading to the ramp (at stage right) has running slopes >5% and is not treated as a ramp, @ 6.4%.</p> <p>The running slope of the ramp (at stage right) is >8.3%, @ up to 9.3% near the top.</p> <p>The number of aisle seats (with no armrests or removable/folding armrests on the aisle side) is <5% of the total number of seats in the auditorium: 44 required, 6 provided.</p> <p>Wheelchair spaces are not dispersed vertically (front-to-back) at varying distances from the stage for an assembly area with more than 300 seats.</p>	<p>2010 ADAS 306.1 2010 ADAS 505.10.3 2010 ADAS 403.3 2010 ADAS 405.2 2010 ADAS 221.4 2010 ADAS 221.2.3.2</p>

<p>Replace the podium. Unit Cost: \$500 ea. Quantity: 1</p> <p>Install compliant handrail extensions on both sides of the stairs. Unit Cost: \$50/LF Quantity: 3</p> <p>Provide compliant handrails on both sides of the walkway. Unit Cost: \$50/LF Quantity: 40</p> <p>Rebuild the ramp. Unit Cost: \$5,000 ea. Quantity: 1</p> <p>Replace the armrest on the aisle seat with a folding or retractable armrest on the aisle side of the seat. Unit Cost: \$250 ea. Quantity: 38</p> <p>Reconfigure the balconies adjacent to the back row and provide additional wheelchair and companion spaces. Further design study is required. Unit Cost: \$5,000 ea. Quantity: 2</p>	\$22,650

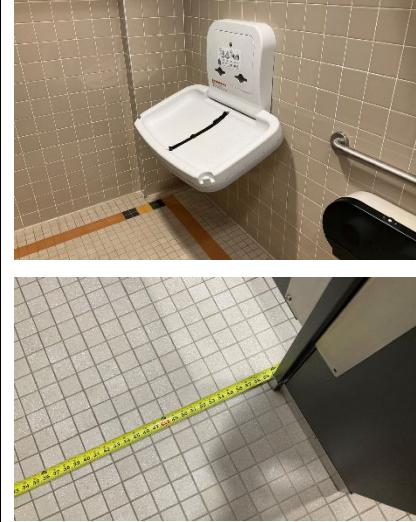
5.	<p>Men's Toilet Room</p> <p>The entry door requires >5lbs of force to operate.</p> <p>The baby changing station is malfunctioning.</p> <p>The accessible toilet stall is <60" wide, @ 59", near the stall door due to the uneven partition.</p> <p>There is no pull device on the push side of the door.</p> <p>The stall door is not self-closing.</p>	<p>2010 ADAS 404.2.9</p> <p>ADA Title II Maintenance</p> <p>2010 ADAS 604.3.1</p> <p>2010 ADAS 604.8.1.1</p> <p>2010 ADAS 604.8.1.2</p>

<p>Adjust the door closer. Unit Cost: \$50 ea. Quantity: 1</p> <p>Replace the baby changing station. Unit Cost: \$50 ea. Quantity: 1</p> <p>Relocate the stall partition. Unit Cost: \$900 ea. Quantity: 1</p> <p>Install a pull device on the door. Unit Cost: \$250 ea. Quantity: 1</p> <p>Install a self-closing door. Unit Cost: \$150 Quantity: 1</p>	\$1,400

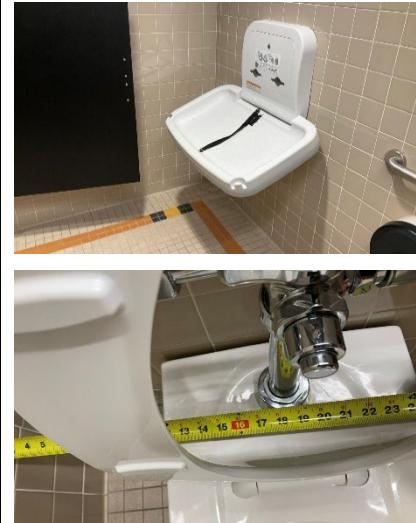
6.	<p>Women's Toilet Room</p> <p>The entry door requires >5lbs of force to operate.</p> <p>The baby changing station is malfunctioning.</p> <p>The toilet centerline is not 16"-18" from the nearest adjacent side wall, @ 18.5".</p> <p>There is no pull device on the push side of the door.</p> <p>The stall door is not self-closing.</p>	<p>2010 ADAS 404.2.9</p> <p>ADA Title II Maintenance</p> <p>2010 ADAS 604.2</p> <p>2010 ADAS 604.8.1.1</p> <p>2010 ADAS 604.8.1.2</p>

<p>Adjust the door closer. Unit Cost: \$50 ea. Quantity: 1</p> <p>Replace the baby changing station. Unit Cost: \$50 ea. Quantity: 1</p> <p>Reposition the toilet. Unit Cost: \$1,500 ea. Quantity: 1</p> <p>Install a pull device on the door. Unit Cost: \$250 ea. Quantity: 1</p> <p>Install a self-closing door. Unit Cost: \$150 Quantity: 1</p>	\$2,000
TOTAL FOR HIGH SCHOOL AUDITORIUM:					\$28,250
