STOUGHTON OUTDOOR FACILITIES AUDITS

KMA audited the following municipal outdoor facilities:

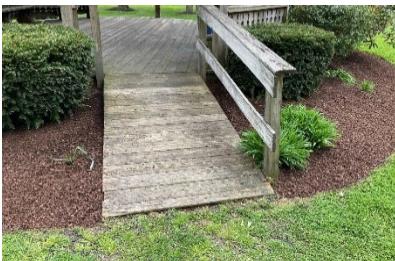
4.	Gazebo The gazebo is not on an accessible route, due to the grass surface. The ramp to the gazebo has running slopes >8.3%, @ up to 8.9%, and has changes in level > 1/4" at the bottom of the run, @ 1". The stair to the gazebo lacks the required handrails on both sides.	2010 ADAS 206.1 2010 ADAS 405.2 2010 ADAS 303.2 2010 ADAS 505.2

Provide an accessible route between the sidewalk and the gazebo. Unit Cost: \$25/SF Est. Quantity: 600 SF Rebuild the ramp. Unit Cost: \$5,000 ea. Quantity: 1 Install compliant handrails on both sides of the stairs. Unit Cost: \$50/LF Est. Quantity: 8	\$20,400
TOTAL FOR FAXON PARK:					\$52,900
