NAME OF SLUM & BLIGHT AREA:

45 Stoughton Downtown Redevelopment Area

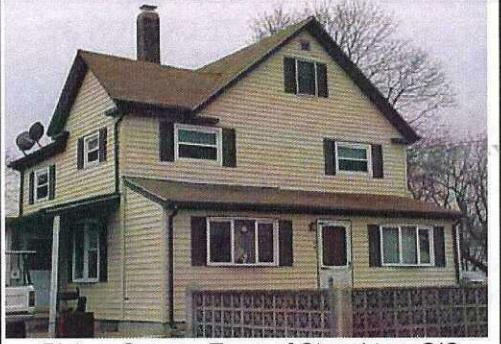
Physical Deterioration of Building
	Abandoned Property
	Chronic High Occupancy Turnover
	Chronic High Vacancy Rate
	Significant Decline in Property Value
	Abnormally Low Property Value
<input checked="" type="checkbox"/>	Known or Suspected Environmental Contamination
	Other (please explain)
<i>The property is not contributing to slum and blight</i>

<u>Component</u>	<u>Condition</u>
Roofing	
Windows and Doors	
Exterior Walls	
Porch/Stairs/Deck	
Foundation	
Storefront & Signage	
Parking Lots	
Environmental	Probable lead paint based on age of building
Other:	
Overall Property Rating: (Excellent / Good / Fair / Poor)	
briefly state why.

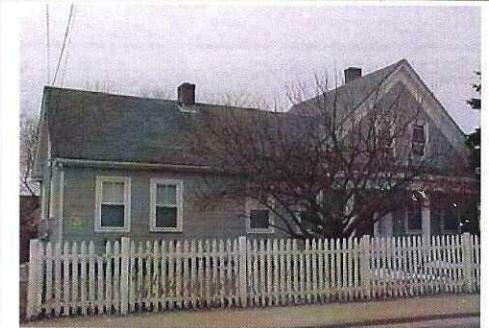
The property is not contributing to slum and blight

<u>Component</u>	<u>Condition</u>
Roofing	
Windows and Doors	
Exterior Walls	
Porch/Stairs/Deck	
Foundation	
Storefront & Signage	
Parking Lots	
Environmental	Probable lead paint based on age of building
Other:	
Overall Property Rating: (Excellent / Good / Fair / Poor)	
briefly state why.

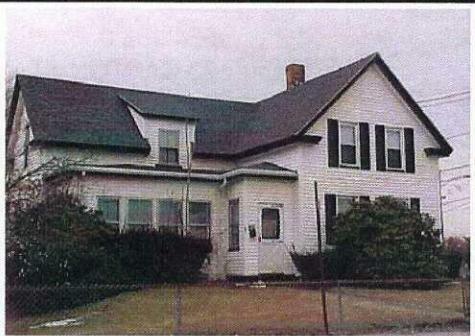
Roofing
 Windows and Doors
 Exterior Walls
 Porch/Stairs/Deck
 Foundation
 Storefront & Signage
 Parking Lots
 Environmental Probable lead paint based on age of building
 Other:

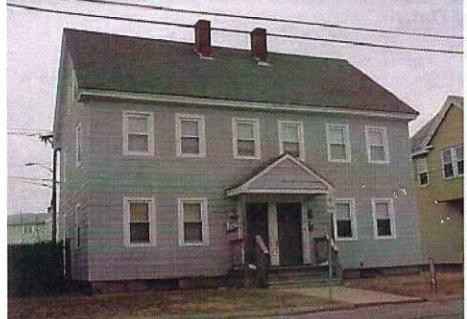
<u>Component</u>	<u>Condition</u>
Roofing	
Windows and Doors	
Exterior Walls	
Porch/Stairs/Deck	
Foundation	
Storefront & Signage	
Parking Lots	
Environmental	Probable lead paint based on age of building
Other:	
Overall Property Rating: (Excellent / Good / Fair / Poor)	
briefly state why.

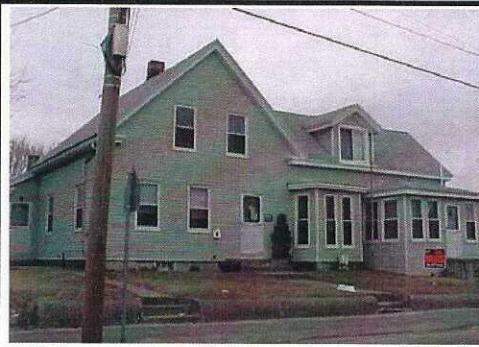
<u>Component</u>	<u>Condition</u>
Roofing	
Windows and Doors	
Exterior Walls	
Porch/Stairs/Deck	
Foundation	
Storefront & Signage	
Parking Lots	
Environmental	Probable lead paint based on age of building
Other:	
Overall Property Rating: (Excellent / Good / Fair / Poor)	
briefly state why.

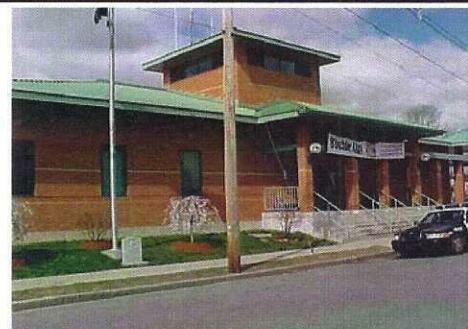
MassDEP: Tier 1D (see Existing Conditions Memorandum , April 2015)

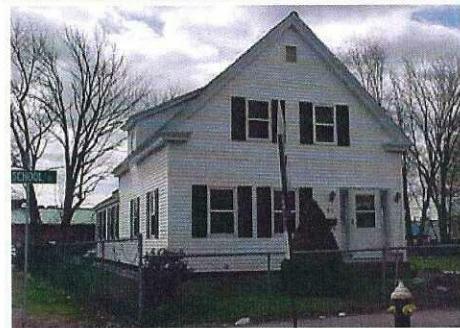
<u>Component</u>	<u>Condition</u>
Roofing	
Windows and Doors	
Exterior Walls	
Porch/Stairs/Deck	
Foundation	
Storefront & Signage	
Parking Lots	
Environmental	Probable lead paint based on age of building
Other:	
Overall Property Rating: (Excellent / Good / Fair / Poor)	
briefly state why.

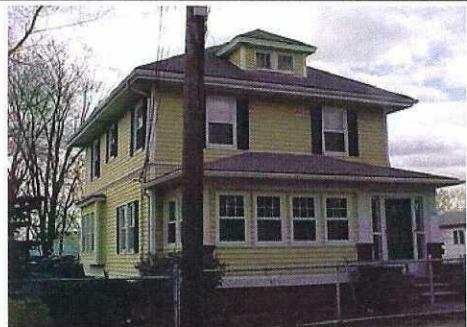
<u>Component</u>	<u>Condition</u>
Roofing	
Windows and Doors	
Exterior Walls	
Porch/Stairs/Deck	
Foundation	
Storefront & Signage	
Parking Lots	
Environmental	Probable lead paint based on age of building
Other:	
Overall Property Rating: (Excellent / Good / Fair / Poor)	
briefly state why.

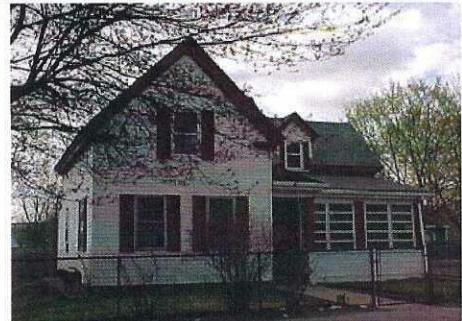
Roofing	
Windows and Doors	
Exterior Walls	
Porch/Stairs/Deck	
Foundation	
Storefront & Signage	
Parking Lots	
Environmental	Probable lead paint based on age of building
Other:	
Overall Property Rating: (Excellent / Good / Fair / Poor)	
briefly state why.

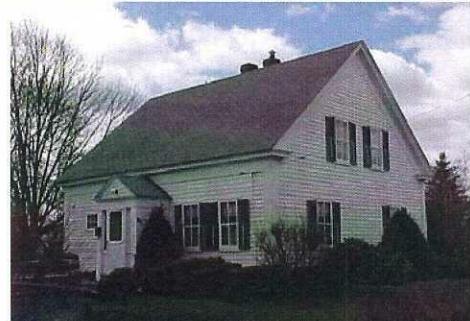
<u>Component</u>	<u>Condition</u>
Roofing	
Windows and Doors	
Exterior Walls	
Porch/Stairs/Deck	
Foundation	
Storefront & Signage	
Parking Lots	
Environmental	Probable lead paint based on age of building
Other:	Accessory building at rear is partially demolished
Overall Property Rating: (Excellent / Good / Fair / Poor)	
briefly state why.

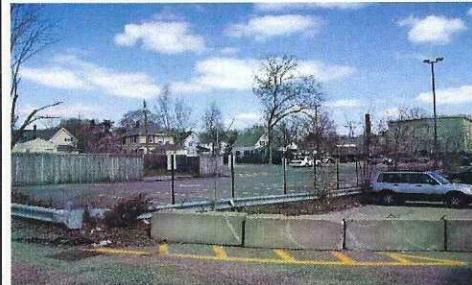
<u>Component</u>	<u>Condition</u>
Roofing	
Windows and Doors	
Exterior Walls	
Porch/Stairs/Deck	
Foundation	
Storefront & Signage	
Parking Lots	
Environmental	
Other:	Vacant lot - overgrown and no access to a street
Overall Property Rating: (Excellent / Good / Fair / Poor)	
briefly state why.

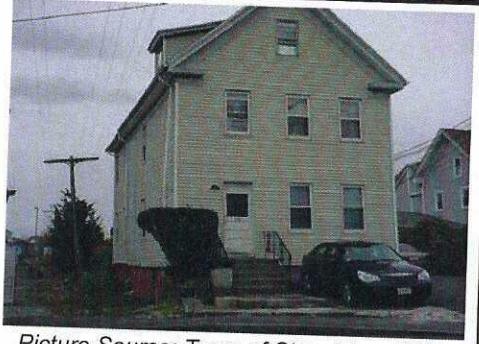
<u>Component</u>	<u>Condition</u>
Roofing	
Windows and Doors	
Exterior Walls	
Porch/Stairs/Deck	
Foundation	
Storefront & Signage	
Parking Lots	
Environmental	Probable lead paint based on age of building
Other:	
Overall Property Rating: (Excellent / Good / Fair / Poor)	
briefly state why.

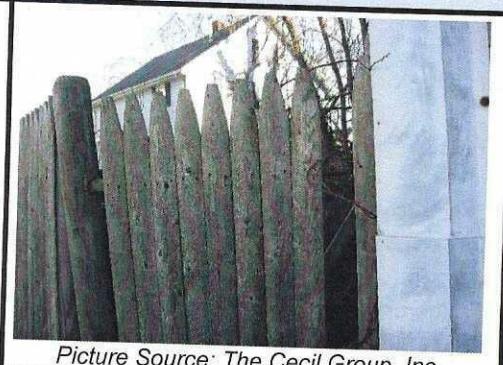
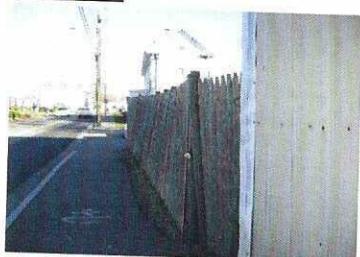
Fence in disrepair, lot vacant and overgrown. Part of 054-215?

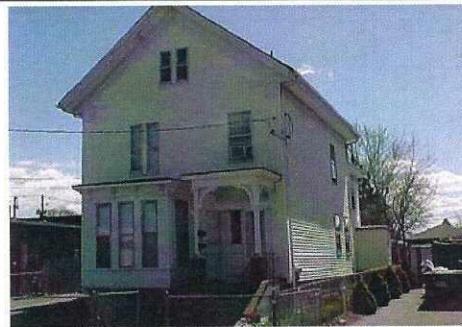
<u>Component</u>	<u>Condition</u>
Roofing	
Windows and Doors	
Exterior Walls	Needs paint, siding is missing
Porch/Stairs/Deck	Repairs to front stoop and sidewalk needed
Foundation	
Storefront & Signage	
Parking Lots	
Environmental	Probable lead paint based on age of building
Other:	
Overall Property Rating: (Excellent / Good / Fair / Poor)	briefly state why.

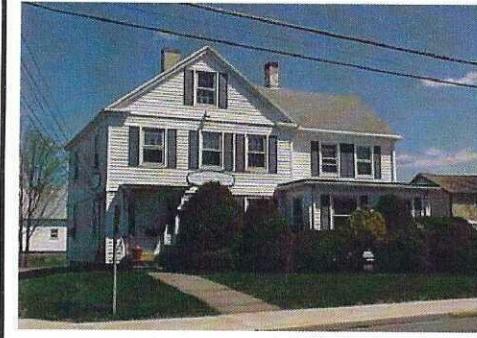
<u>Component</u>	<u>Condition</u>
Roofing	Minor roof repairs needed
Windows and Doors	
Exterior Walls	
Porch/Stairs/Deck	
Foundation	
Storefront & Signage	
Parking Lots	
Environmental	Probable lead paint based on age of building
Other:	
Overall Property Rating: (Excellent / Good / Fair / Poor)	
briefly state why.

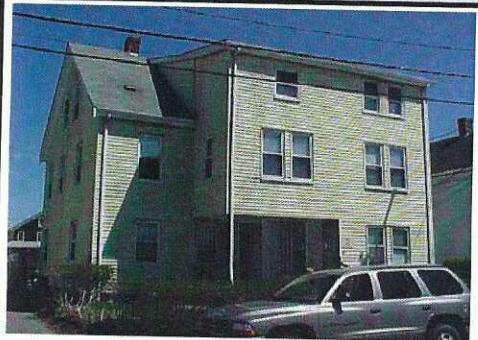
<u>Component</u>	<u>Condition</u>
Roofing	
Windows and Doors	
Exterior Walls	
Porch/Stairs/Deck	Railing on front steps appears to be temporary
Foundation	
Storefront & Signage	
Parking Lots	
Environmental	Probable lead paint based on age of building
Other:	
Overall Property Rating: (Excellent / Good / Fair / Poor)	
briefly state why.

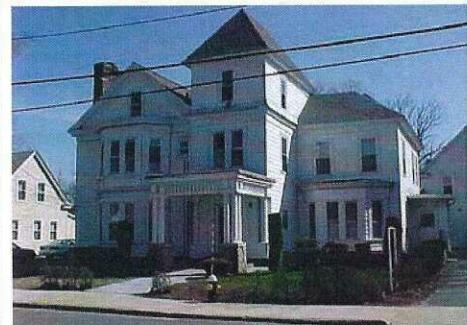
<u>Component</u>	<u>Condition</u>
Roofing	
Windows and Doors	
Exterior Walls	Repairs needed to aluminum siding
Porch/Stairs/Deck	
Foundation	
Storefront & Signage	
Parking Lots	
Environmental	Probable lead paint based on age of building
Other:	Repairs needed to brick chimney
Overall Property Rating: (Excellent / Good / Fair / Poor)	
briefly state why.

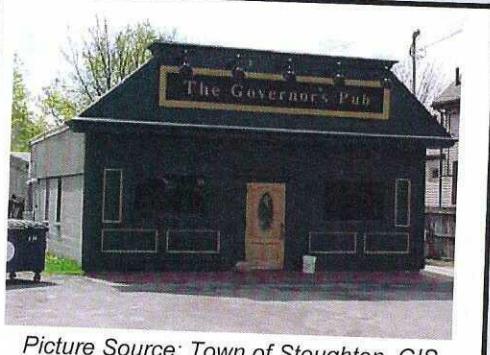
<u>Component</u>	<u>Condition</u>
Roofing	
Windows and Doors	
Exterior Walls	
Porch/Stairs/Deck	
Foundation	
Storefront & Signage	
Parking Lots	Front yard fully paved
Environmental	Probable lead paint based on age of building
Other:	
Overall Property Rating: (Excellent / Good / Fair / Poor) briefly state why.

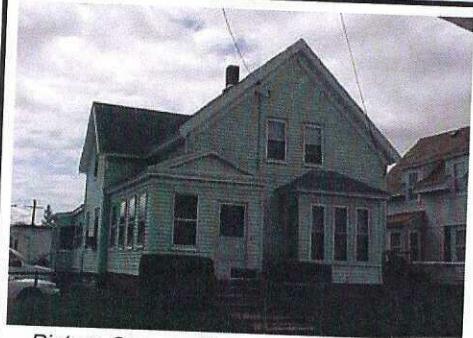
*The property is not contributing to slum and blight***Describe the condition of each applicable component using the category definitions. Also provide explanations if the turnover/vacancy, property value, and/or contamination boxes are checked above.****Component****Condition**

Roofing
Windows and Doors
Exterior Walls
Porch/Stairs/Deck
Foundation
Storefront & Signage
Parking Lots
Environmental
Other: Probable lead paint based on age of building
Overall Property Rating:
(Excellent / Good / Fair / Poor)
briefly state why.

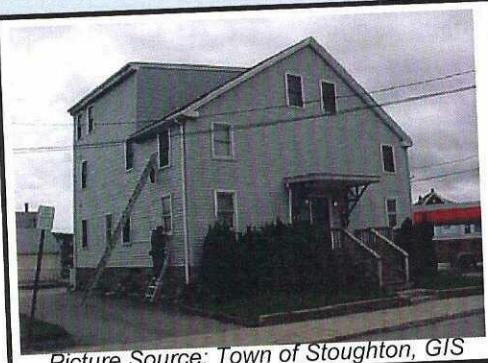
<u>Component</u>	<u>Condition</u>
Roofing	
Windows and Doors	
Exterior Walls	
Porch/Stairs/Deck	
Foundation	
Storefront & Signage	
Parking Lots	Probable lead paint based on age of building
Environmental	Low wall along sidewalk needs repairs
Other:	
Overall Property Rating: (Excellent / Good / Fair / Poor)	
briefly state why.

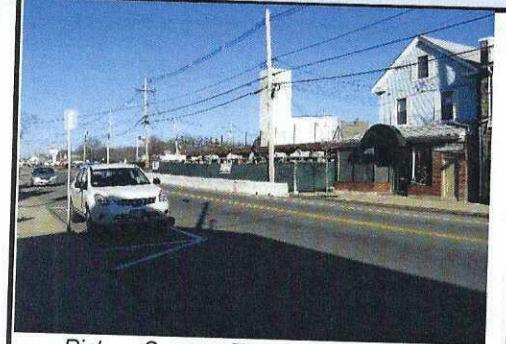
MassDEP: Closed (see *Existing Conditions Memorandum*, April 2015)

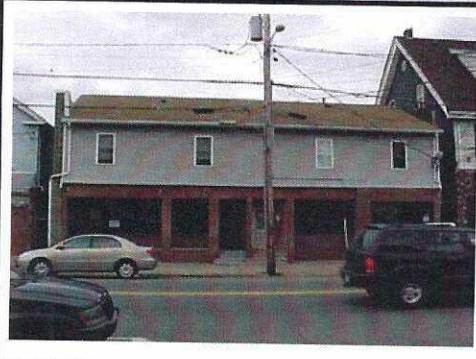
- Physical Deterioration of Building
- Abandoned Property
- Chronic High Occupancy Turnover
- Chronic High Vacancy Rate
- Significant Decline in Property Value
- Abnormally Low Property Value
- Known or Suspected Environmental Contamination
- Other (please explain)
The property is not contributing to slum and blight

<u>Component</u>	<u>Condition</u>
Roofing	
Windows and Doors	
Exterior Walls	
Porch/Stairs/Deck	
Foundation	
Storefront & Signage	
Parking Lots	
Environmental	Probable lead paint based on age of building
Other:	
Overall Property Rating: (Excellent / Good / Fair / Poor)	
briefly state why.

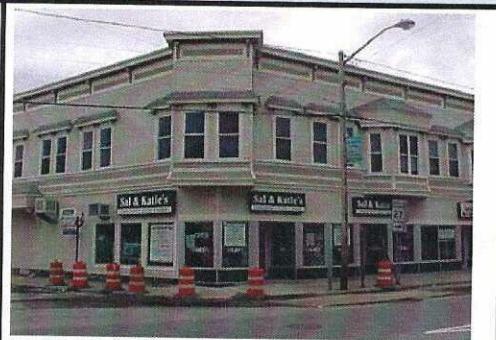
<u>Component</u>	<u>Condition</u>
Roofing	
Windows and Doors	
Exterior Walls	Minor repairs
Porch/Stairs/Deck	
Foundation	
Storefront & Signage	
Parking Lots	
Environmental	Probable lead paint based on age of building
Other:	
Overall Property Rating: (Excellent / Good / Fair / Poor)	
briefly state why.

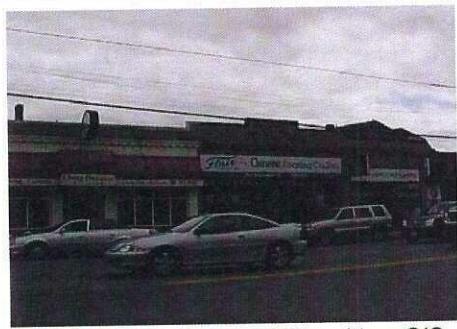
Parcel ID: 054 285 0
 Address: 760 WASHINGTON ST
 Land Use: 325
 Zoning: CBD
 Building Type: OFFICE
 Stories: 1
 Exterior Construction: BRICK
 Interior Construction: PLASTER
 Building Age: 1920
 Assessed Value: \$285,000
 Building Condition: Average
 Ownership: FREEMAN STREET CORP
 Commercial/Residential: C
 Storefront Construction:
 Vacant: yes no other: Partial - includes vacant spot where restaurant burned; murals

<u>Component</u>	<u>Condition</u>
Roofing	Partial demolition due to fire. Developer and owner in front of Planning Board to
Windows and Doors	
Exterior Walls	
Porch/Stairs/Deck	
Foundation	
Storefront & Signage	
Parking Lots	
Environmental	Probable lead paint based on age of building
Other:	
Overall Property Rating: (Excellent / Good / Fair / Poor)	briefly state why.

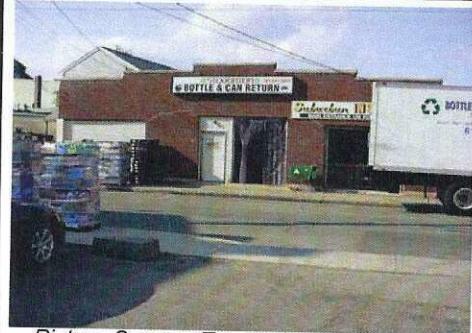
Roofing	
Windows and Doors	
Exterior Walls	
Porch/Stairs/Deck	
Foundation	
Storefront & Signage	
Parking Lots	Minor repairs to concrete apron needed
Environmental	Probable lead paint based on age of building
Other:

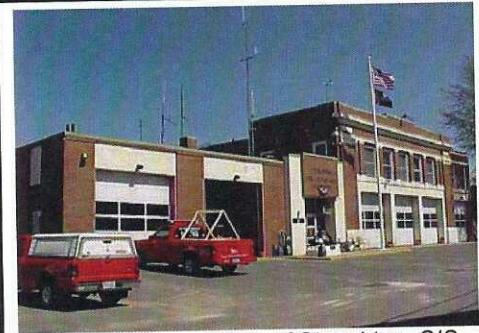
<u>Component</u>	<u>Condition</u>
Roofing	
Windows and Doors	
Exterior Walls	Needs paint, many minor repairs
Porch/Stairs/Deck	
Foundation	
Storefront & Signage	
Parking Lots	Frontage fully paved
Environmental	Probable lead paint based on age of building
Other:	
Overall Property Rating: (Excellent / Good / Fair / Poor)	
briefly state why.
