# SOUTH ELEMENTARY SCHOOL

Photo Tour for Town Meeting  
May 3, 2021

## SOUTH ELEMENTARY SCHOOL

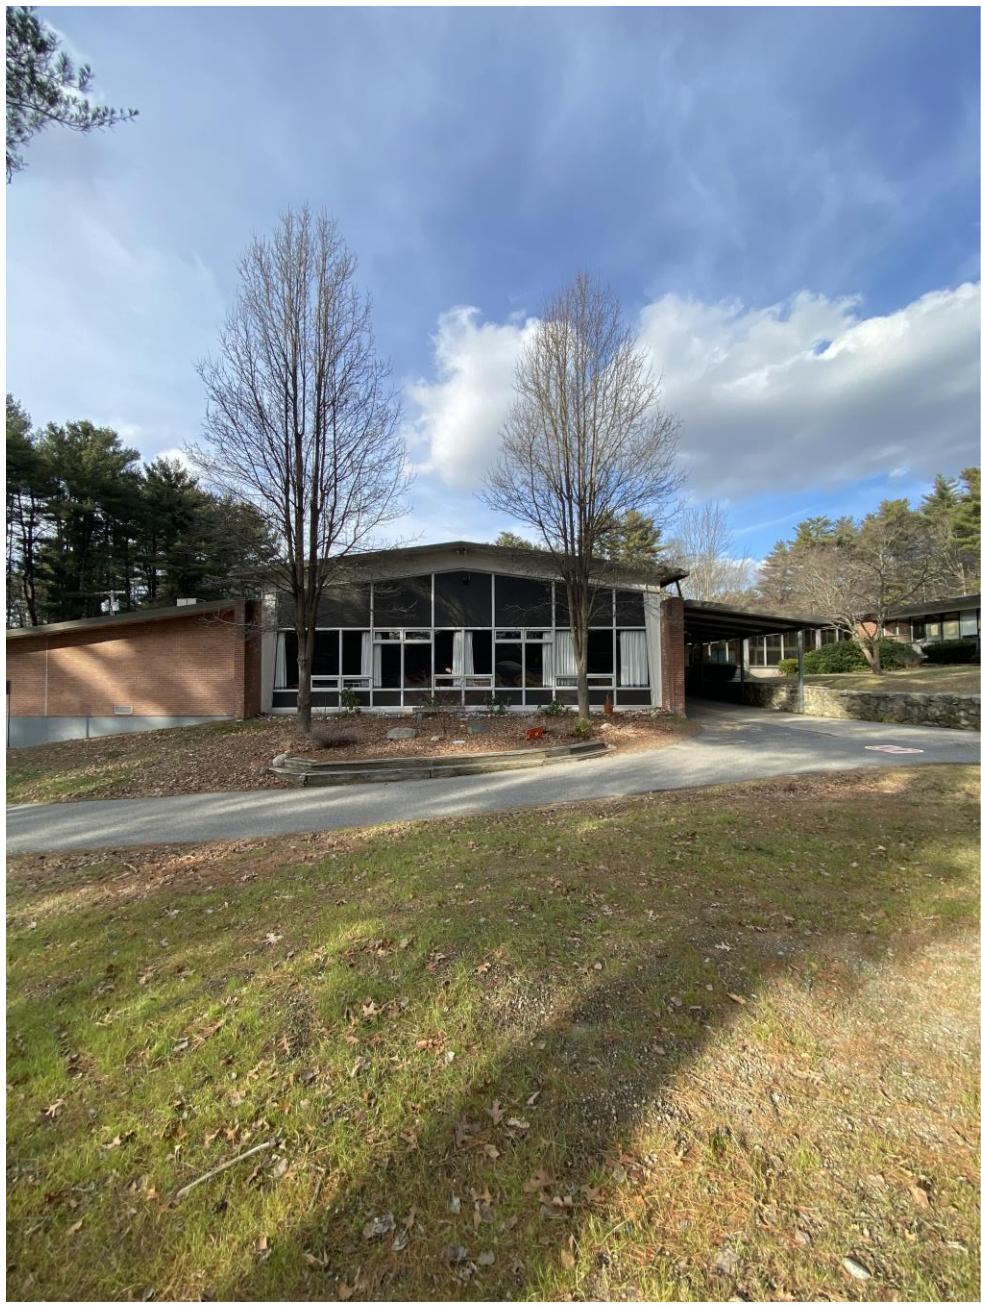
Built in 1958, and an addition built in 1967, the South School has 20 classrooms and serves a community today of about 250 students. It is a single story building that has five levels, with the elevation difference between the highest and lowest level of nearly 12 feet. It is on a densely wooded and sloped piece of land. The 1967 addition sits at the bottom of the slope and there are persistent drainage problems. The ramps are original to the school and are three times steeper than allowed by code..

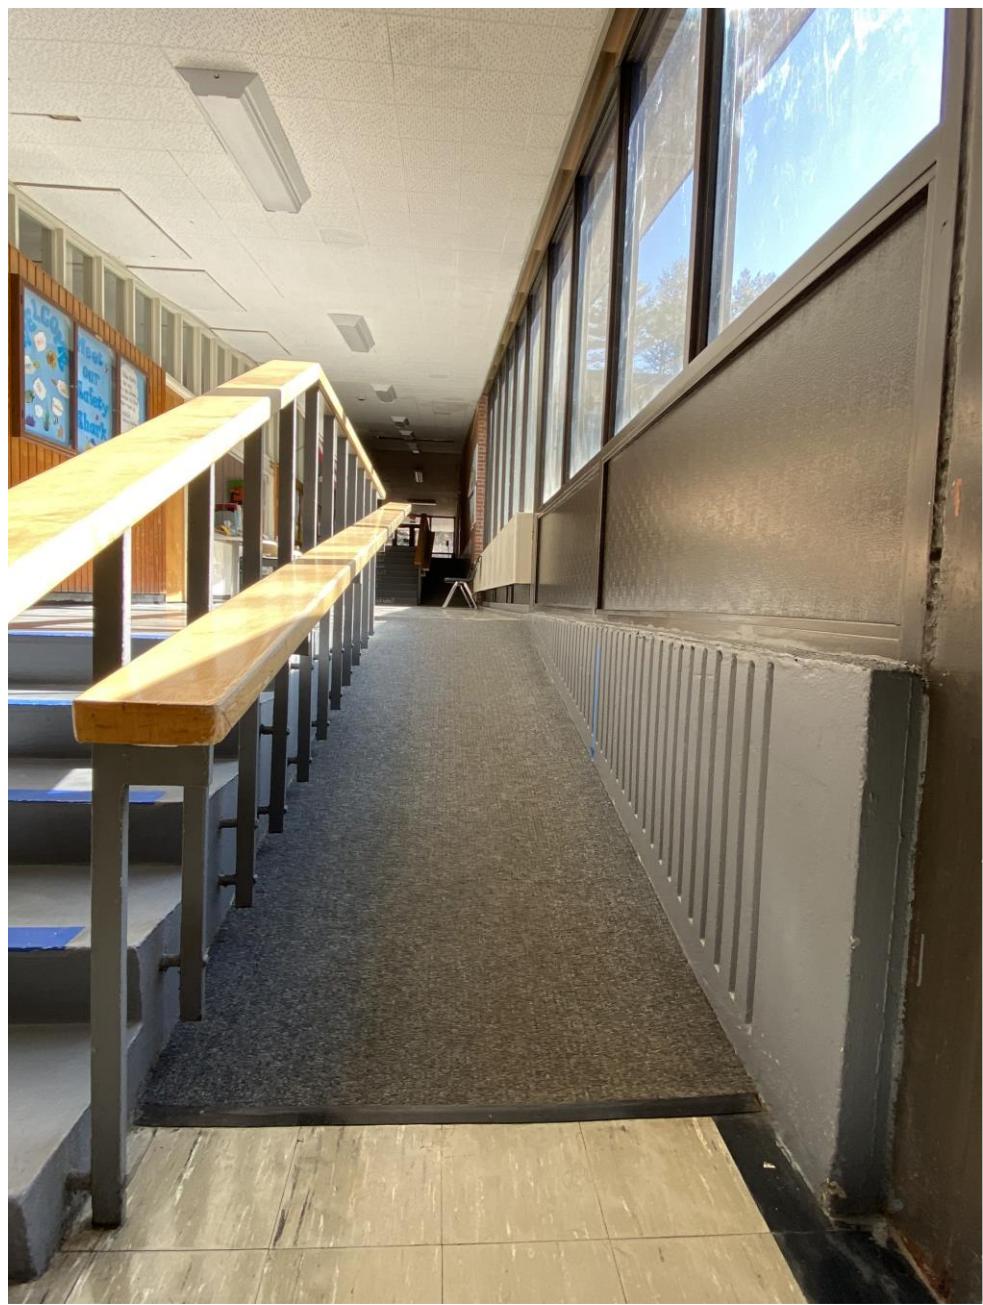
## ADA ACCESSIBILITY

There are four ramps and one lift that serve the five levels of the school. The ramps range from 23% to 26%. The maximum allowable standard is 8.3%.

The ramps are original to the building – 32 years before ADA (Americans with Disabilities Act) was the law.

It was determined in the 1990's ADA studies that there was no solution that could fix the accessibility problems at this school.
